NOAA FORM 76-35A  U.S. DEPARTMENT OF COMMERCE NATIONAL OCEANIC AND ATMOSPHERIC ADMINISTRATION NATIONAL OCEAN SURVEY  <b>DESCRIPTIVE REPORT</b>	
<i>Type of Survey:</i>	<b>Field Examination</b>
<i>Registry Number:</i>	<b>F00553</b>
<b>LOCALITY</b>	
<i>State:</i>	<b>New Hampshire</b>
<i>General Locality:</i>	<b>Portsmouth</b>
<i>Sub-locality:</i>	<b>Portsmouth Harbor and Piscataqua River</b>
<b>2008</b>	
CHIEF OF PARTY <b>LT(jg) Matthew Jaskoski, NOAA</b>	
DATE	LIBRARY & ARCHIVES

<table><tr> <td style="width: 20%;">State:</td> <td colspan="3"><b>New Hampshire</b></td> </tr><tr> <td>General Locality:</td> <td colspan="3"><b>Portsmouth</b></td> </tr><tr> <td>Sub-Locality:</td> <td colspan="3"><b>Portsmouth Harbor and Piscataqua River</b></td> </tr><tr> <td>Instructions Dated:</td> <td><b>N/A</b></td> <td>Project Number:</td> <td><b>OPR-A321-NRT5-08</b></td> </tr></table>

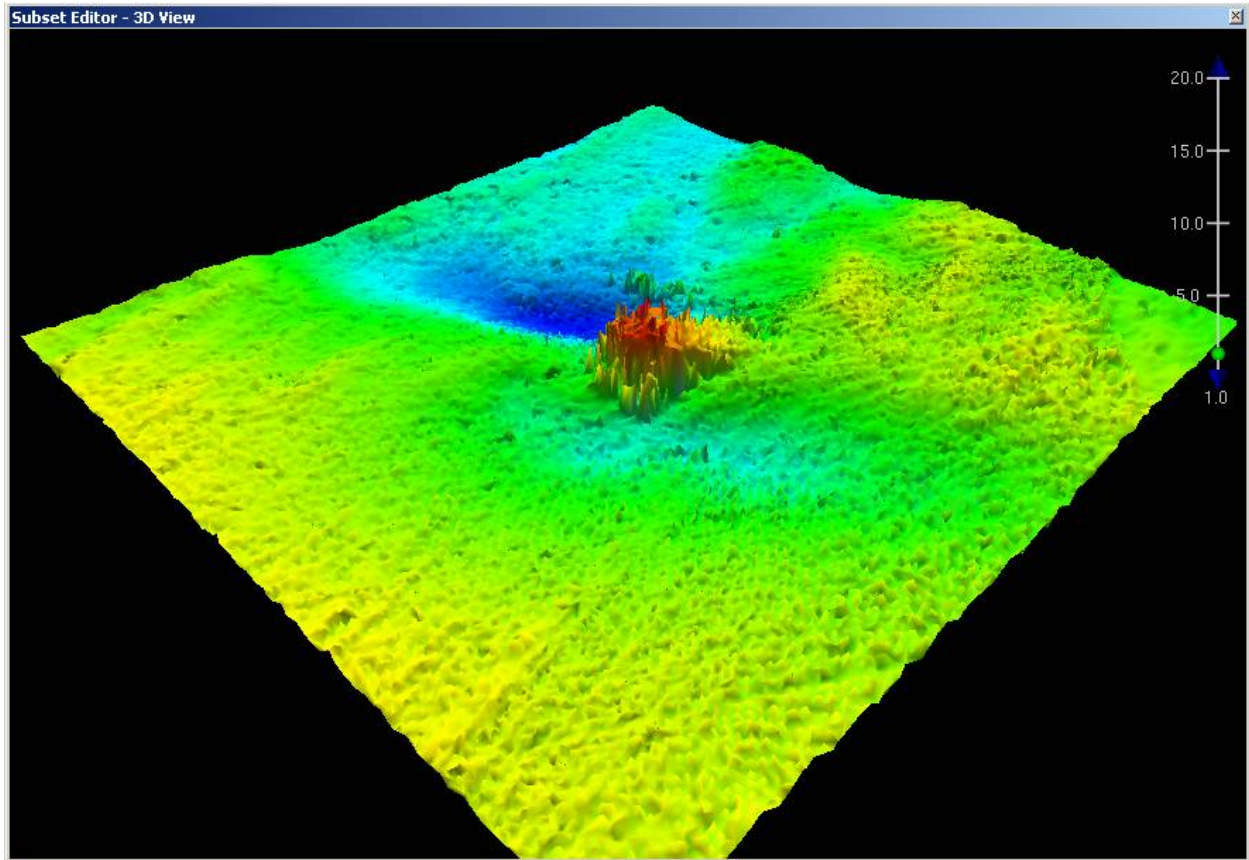
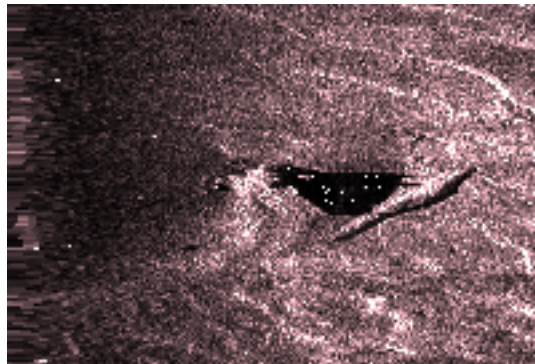
*Figure 1.1.1*

Concur with clarification. Final least depth verified is 34-ft, 10.459m. Recommend to delete 33-ft obstruction at the charted location. Recommend to add 34-ft obstruction at the surveyed location (43°05'13.785"N , 070°45'44.151"W).

The hydrographer recommends the object be charted as a OBSTN, LD and position as surveyed.

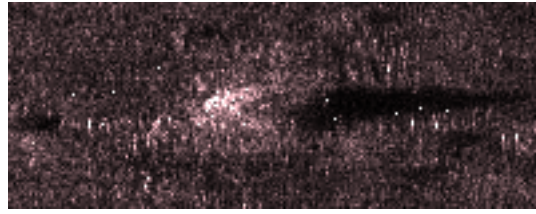
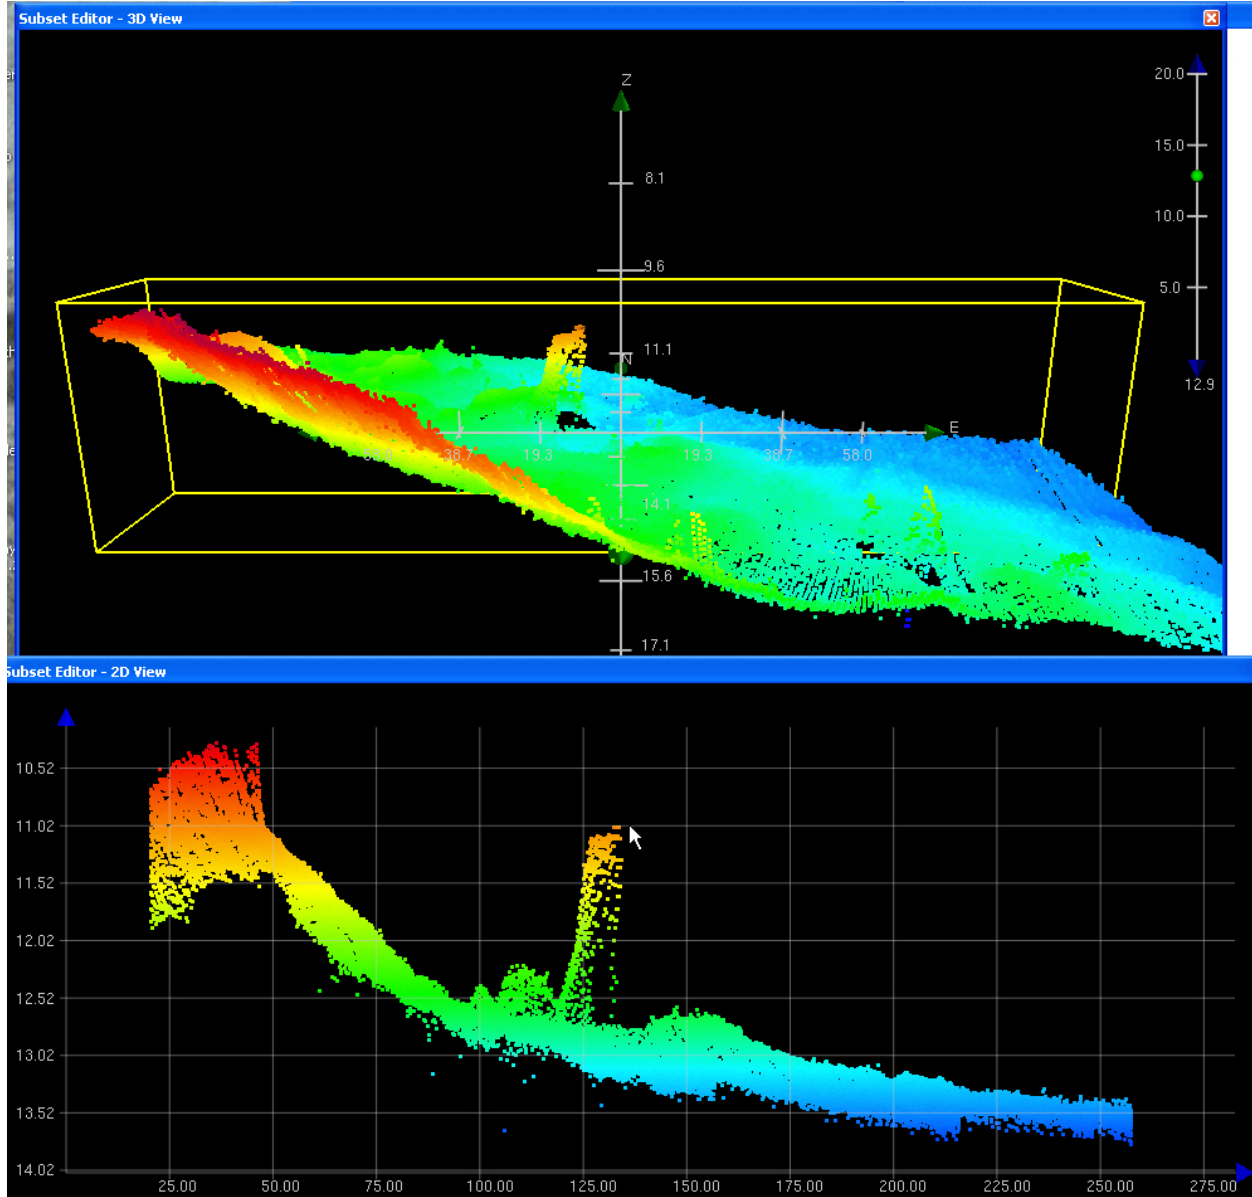
Figure 1.2.1

Concur with clarification. Submitted data indicates least depth of feature is 36'. Recommend to delete 33' charted OBSTN. Bearing in mind the controlling depth of the USACE maintained channel (35-ft), recommend not to append the chart with 36' Rock.

The hydrographer recommends the object be charted as an OBSTN, LD and position as surveyed.

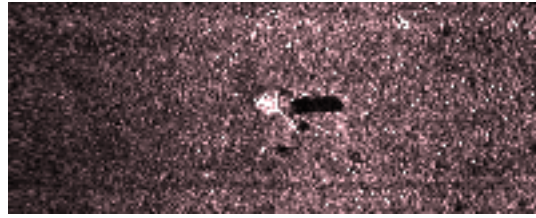
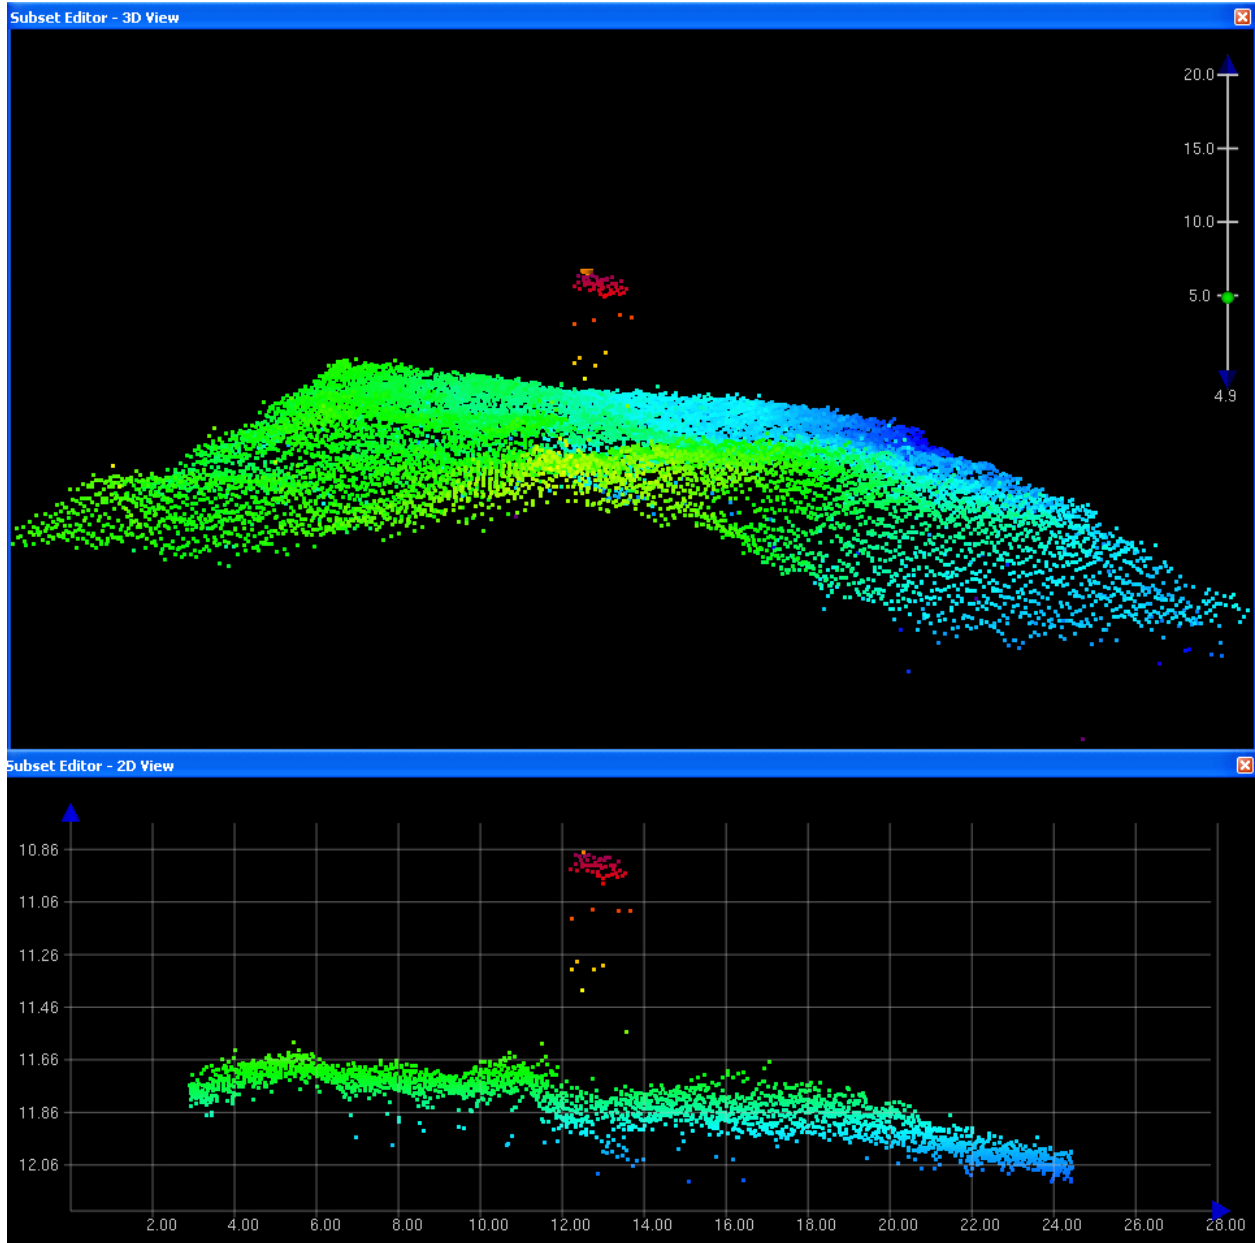
Figure 1.3.1

Concur with clarification. Submitted data indicates least depth of feature is 35'. Recommend to delete 33' charted OBSTN. Bearing in mind the controlling depth of the USACE maintained channel (35-ft), recommend not to append the chart with 35' OBSTN.

The hydrographer recommends the object be charted as an OBSTN, LD and position as surveyed.

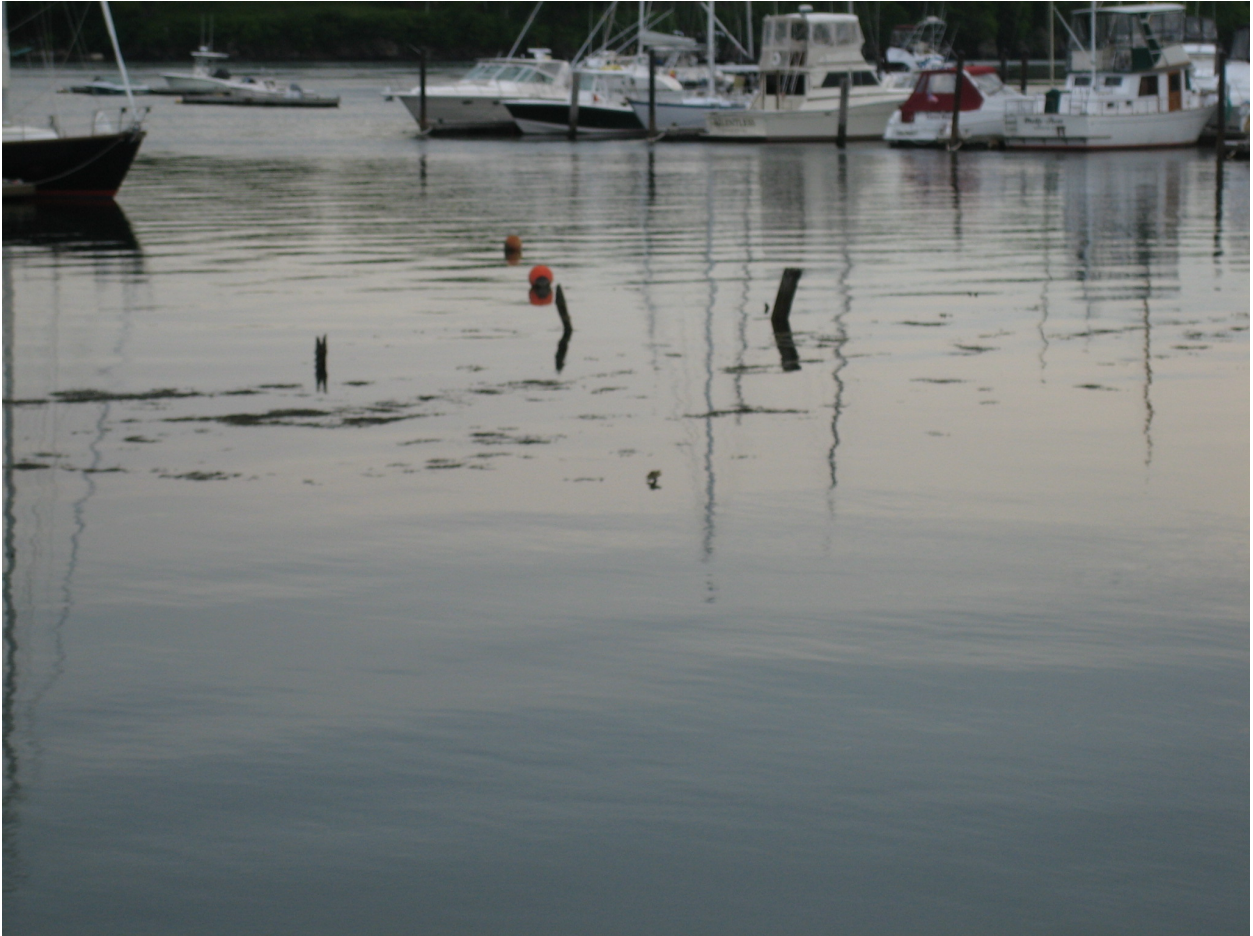
*Figure 1.1.1*

Concur. Retain wreck as charted, no cartographic action necessary.

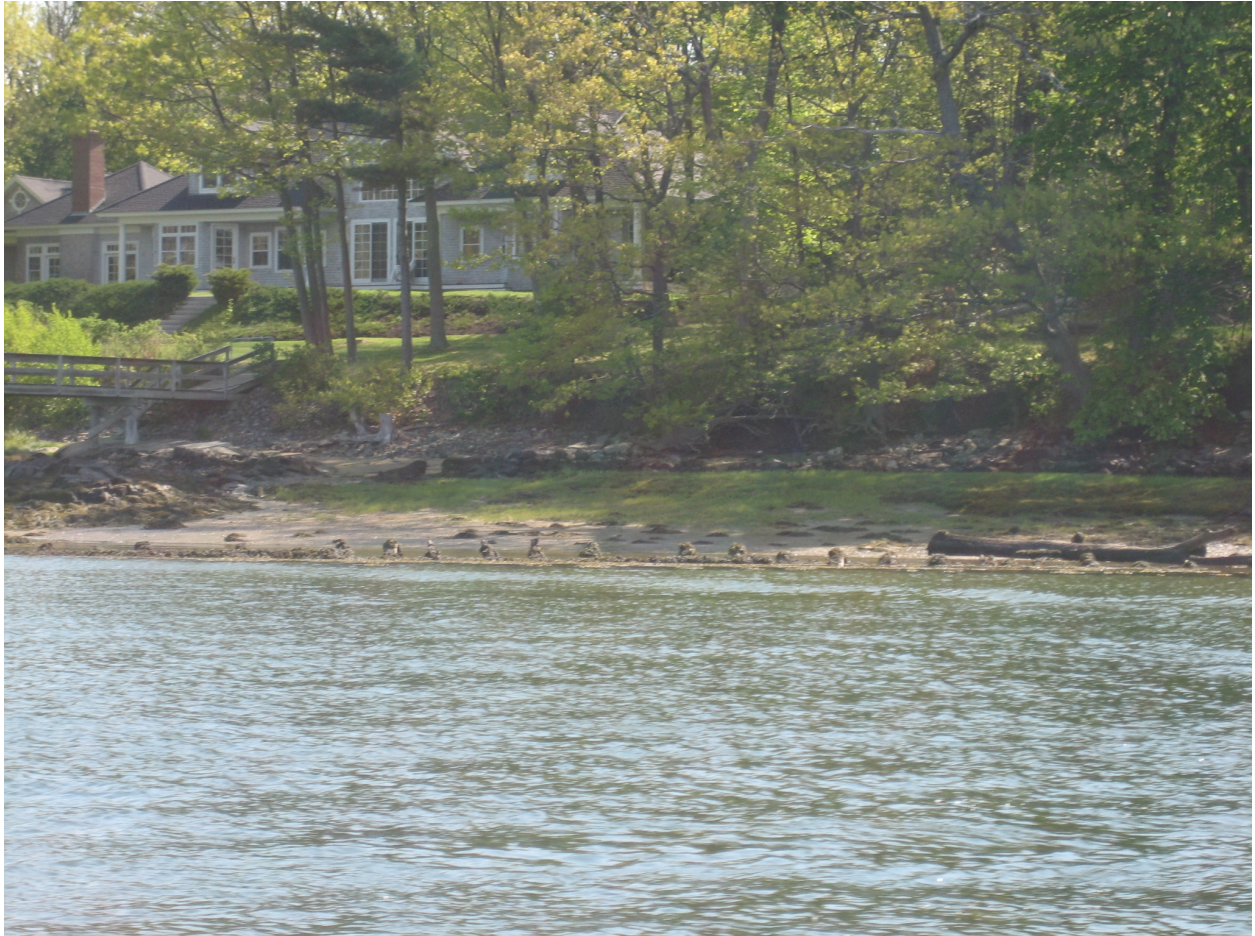
*Figure 1.3.1*

The hydrographer recommends the object be retained as charted.

**Geo object 1:** Wreck (WRECKS)  
**Attributes:** CATWRK - 2:dangerous wreck  
CONVIS - 1:visual conspicuous  
TECSOU - 2:found by side scan sonar  
VERDAT - 12:Mean lower low water  
WATLEV - 1:partly submerged at high water

Concur. Retain object as charted. No cartographic action necessary.

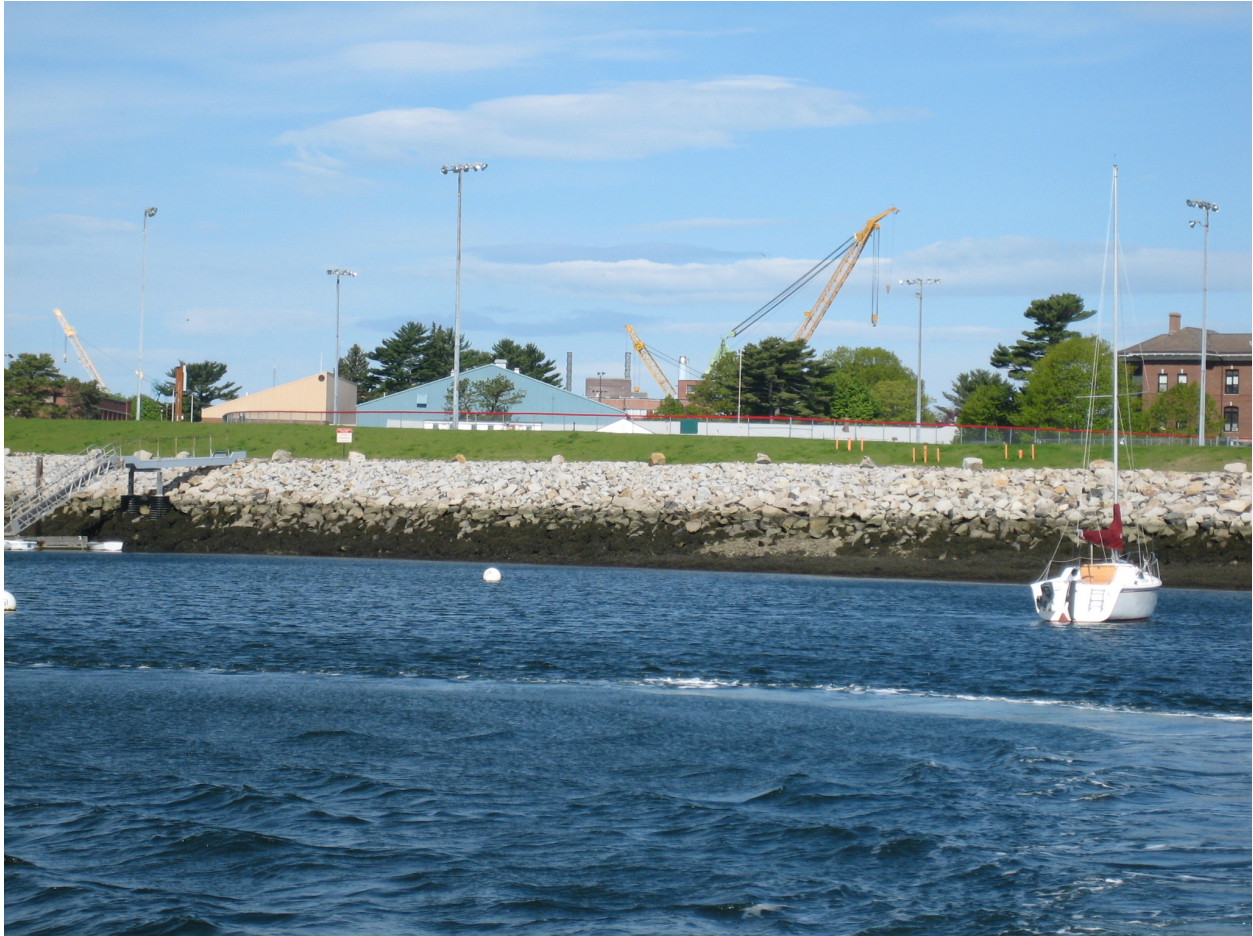
*Figure 1.4.1*

There was no visually conspicuous object noted during visual scan at low tide. Sonar data could not be obtained to adequately cover the AWOIS search radius due to the presence of a dense mooring field to the south and a shoal to the north. The object is located inshore of the NALL.

Do not concur. Retain AWOIS #10755 as charted. No cartographic action necessary.

The hydrographer recommends the object be charted as an OBSTN.

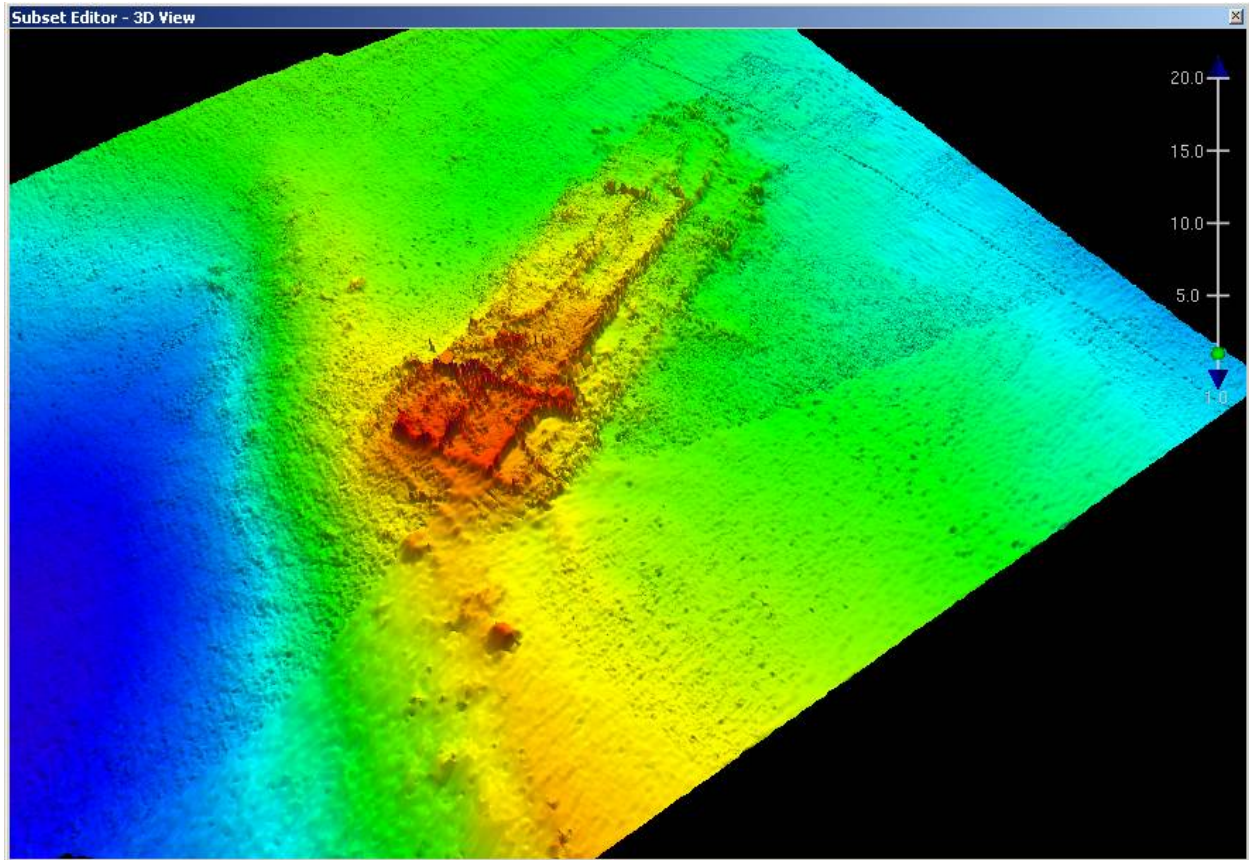
*Figure 1.11.1*

The area was covered with 200% Klein 3000 SSS and developed with Simrad EM3002 MBES, final tides applied. The object is a charted wreck, observed LD deeper than that charted.

Concur.

The hydrographer recommends the OBSTN LD be updated to reflect current Bathy data.

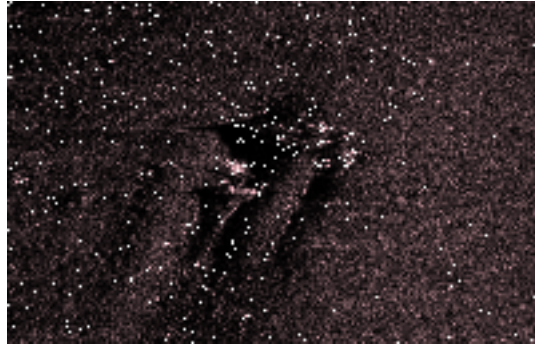
Figure 1.12.1

The navigable area was covered with 100% Klien 3000 SSS and developed with Simrad EM3002 MBES. The charted piles were confirmed with visual scan. A small OBSTN was noted in the SSS trace.

Concur.

The hydrographer recommends the object be charted as an OBSTN, LD and position as surveyed.

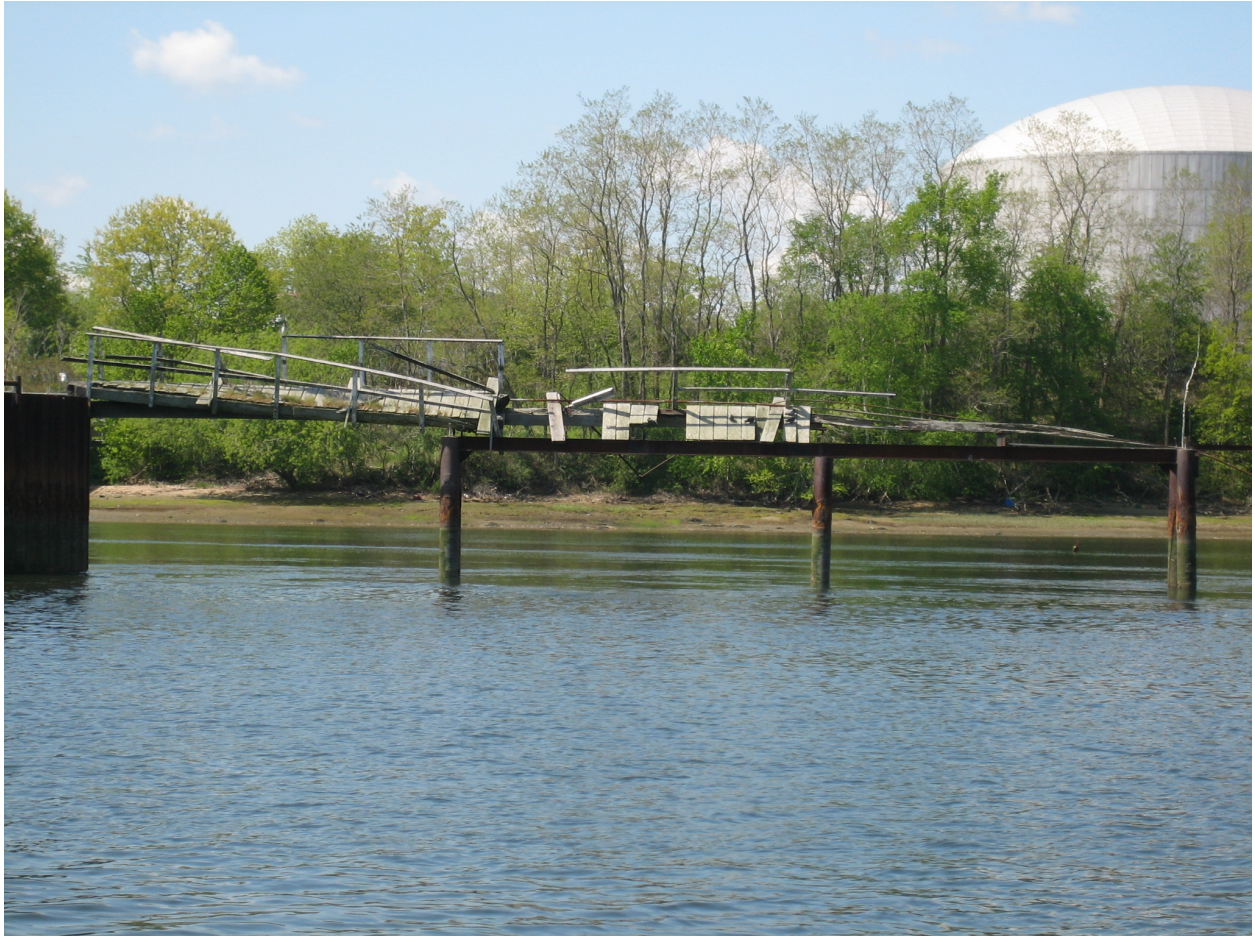
*Figure 1.1.1*

Structure is in a ruinous condition.

Concur. No cartographic action necessary. Pier retained from ENC and CONDTN attribute updated to "ruined".

The hydrographer recommends the the object be charted as ruins.

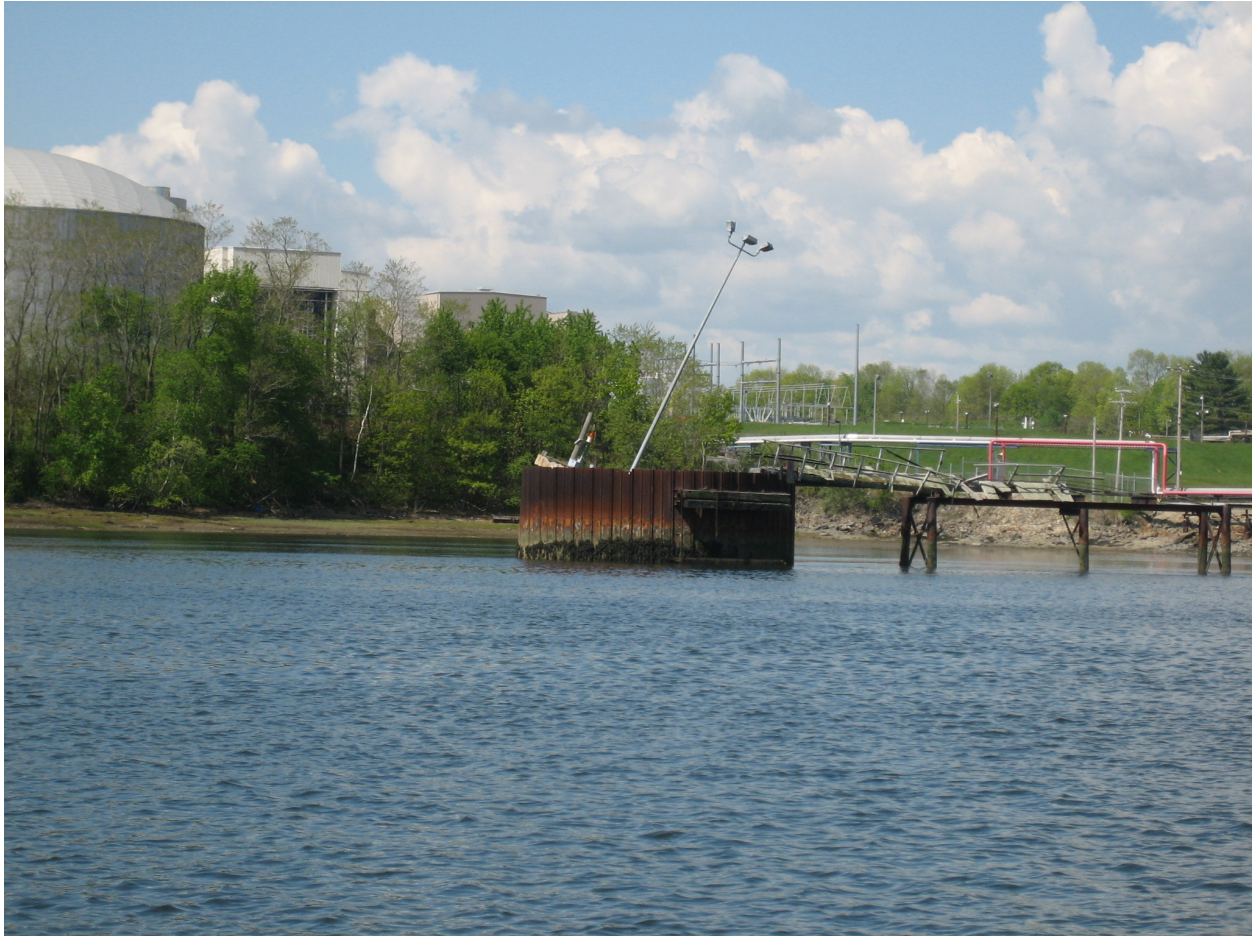
*Figure 1.2.1*

Light structure is damaged. Structure is in a ruinous condition.

Concur. No cartographic action necessary. Pier retained from ENC and CONDTN attribute updated to "ruined".

The hydrographer recommends the the object be charted as ruins.

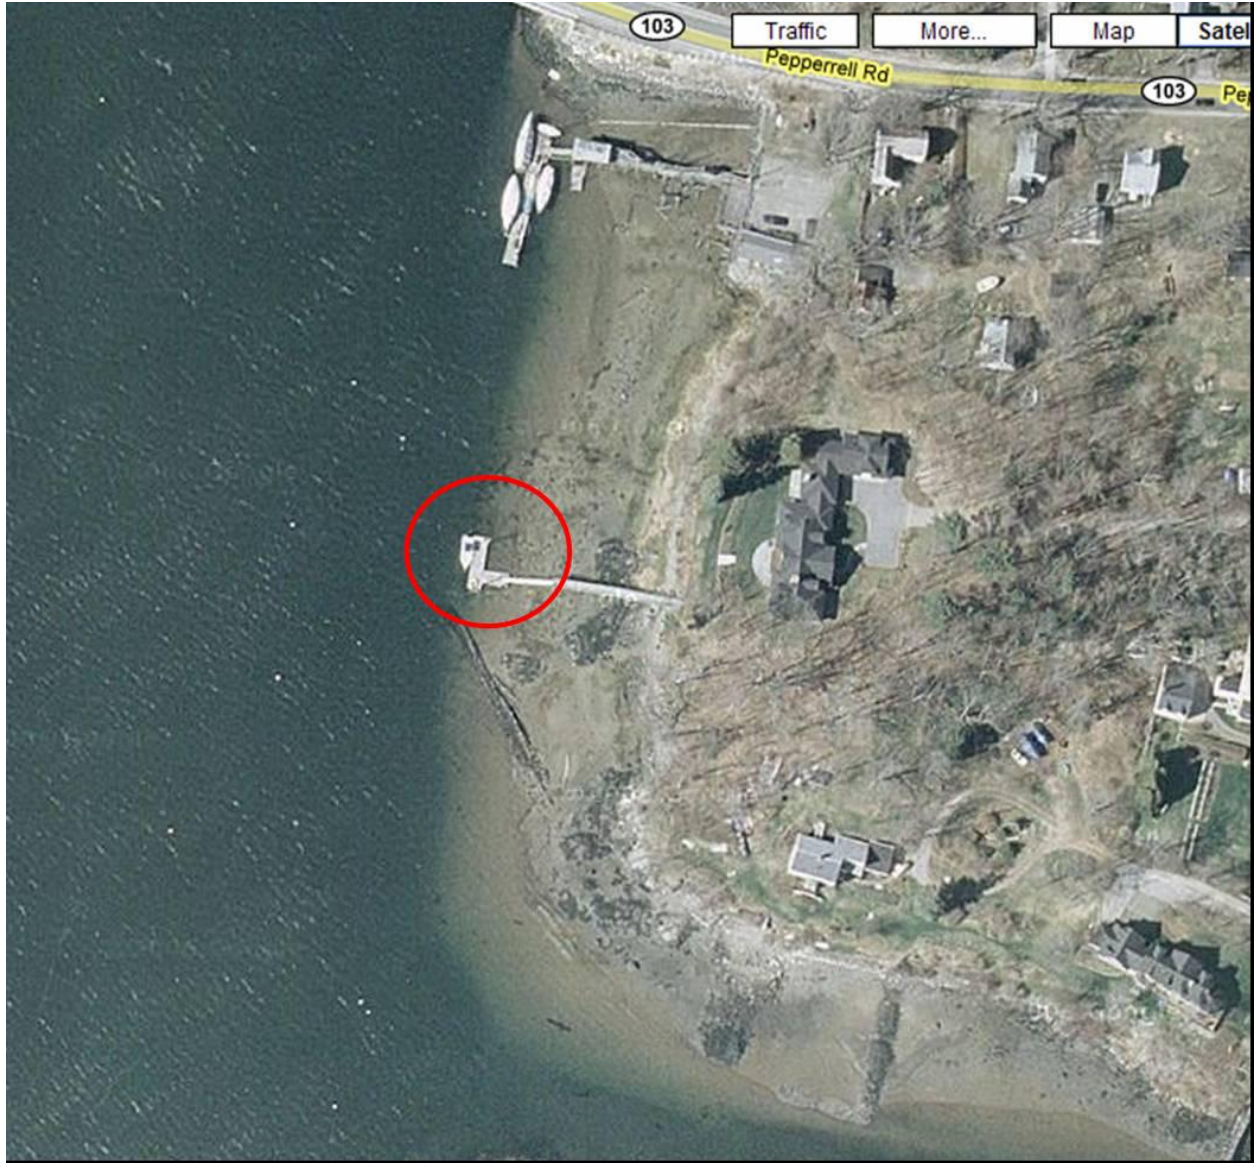
Figure 1.6.1

The area was covered with 100% Klein 3000 SSS no evidence of this wreck was noted in the SSS trace. There was no visually conspicuous wreckage located at charted position at low tide. Currently a private floating pier is located over the charted wreck. The hydrographer believes that this wreck is mis-charted and is intended to describe the charted wreck immediately to the south of the charted wreck (AWOIS 10753).

Concur with clarification. Remove charted wreck from chart. The peir is discussed as a seperate feature in the evaluation report.

The hydrographer recommends the charted wreck be removed from the chart and the pier structure added.

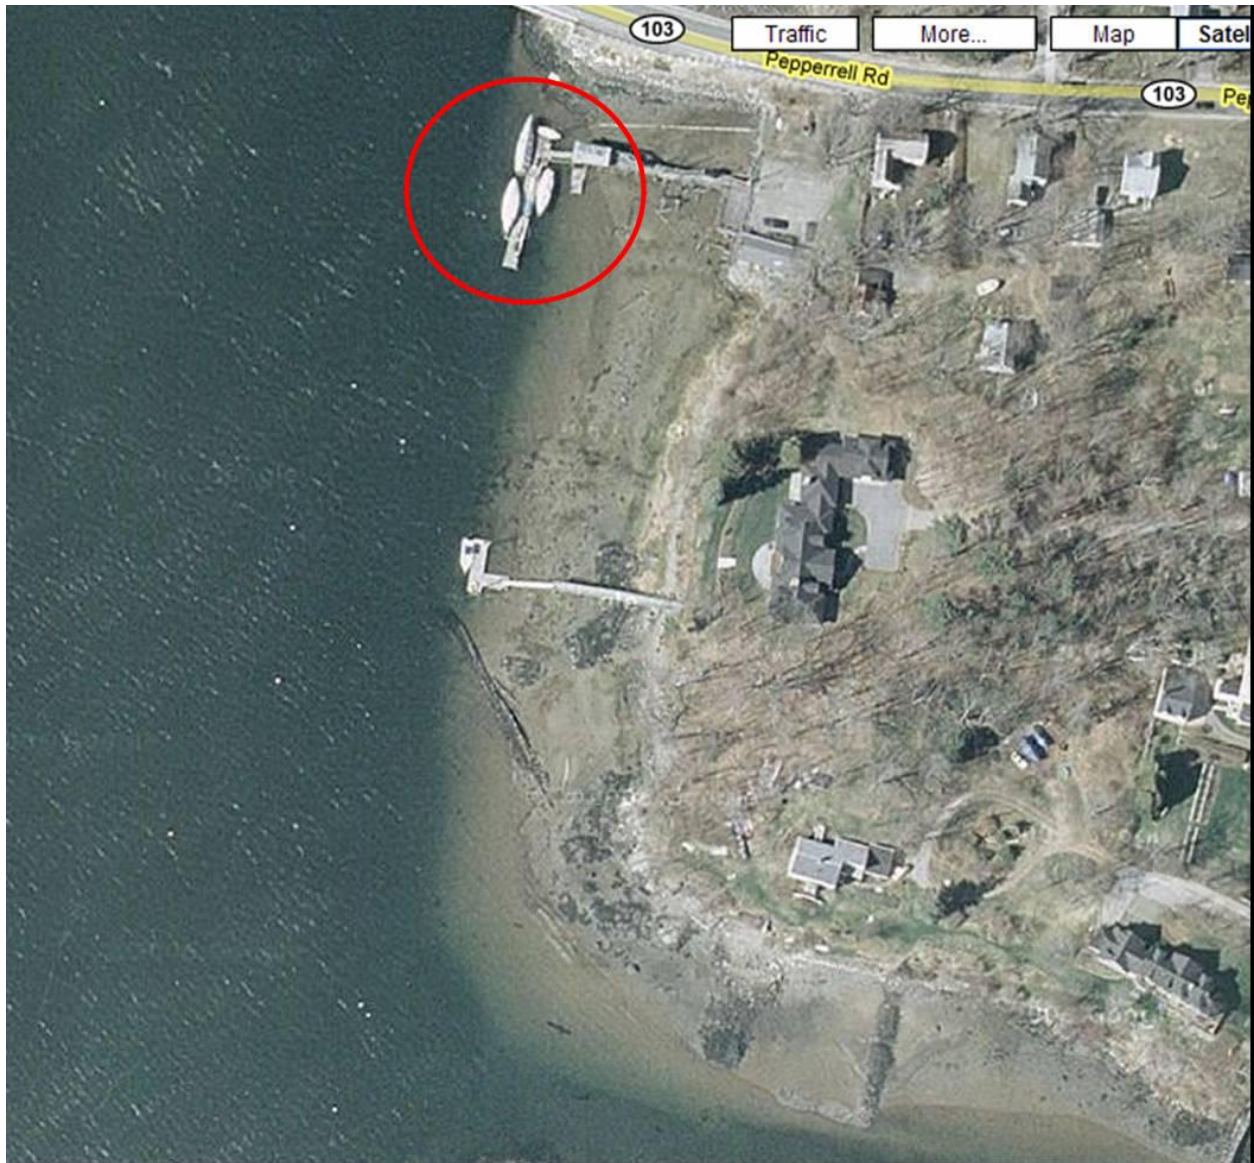
Figure 1.7.1

Concur. No cartographic action necessary.

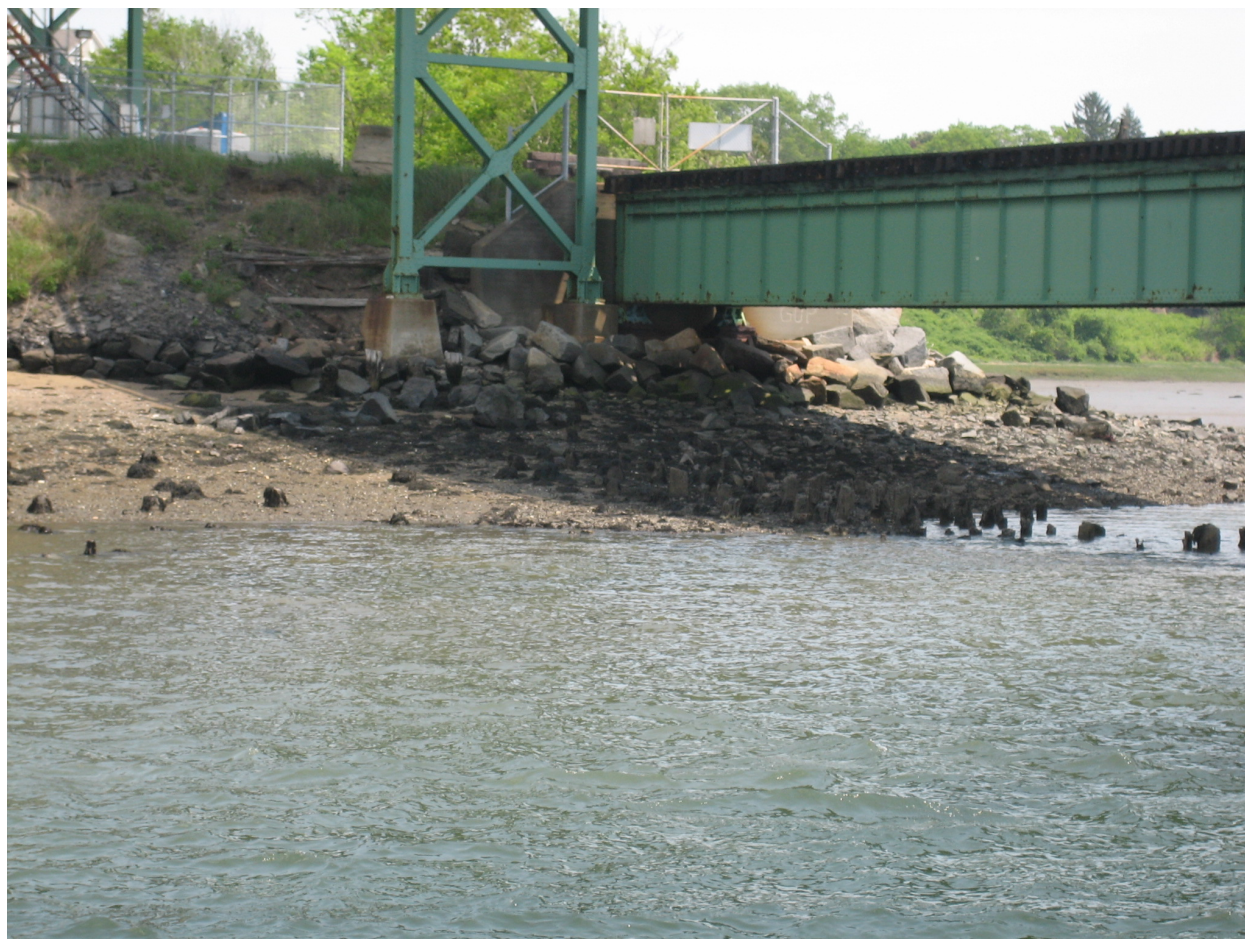
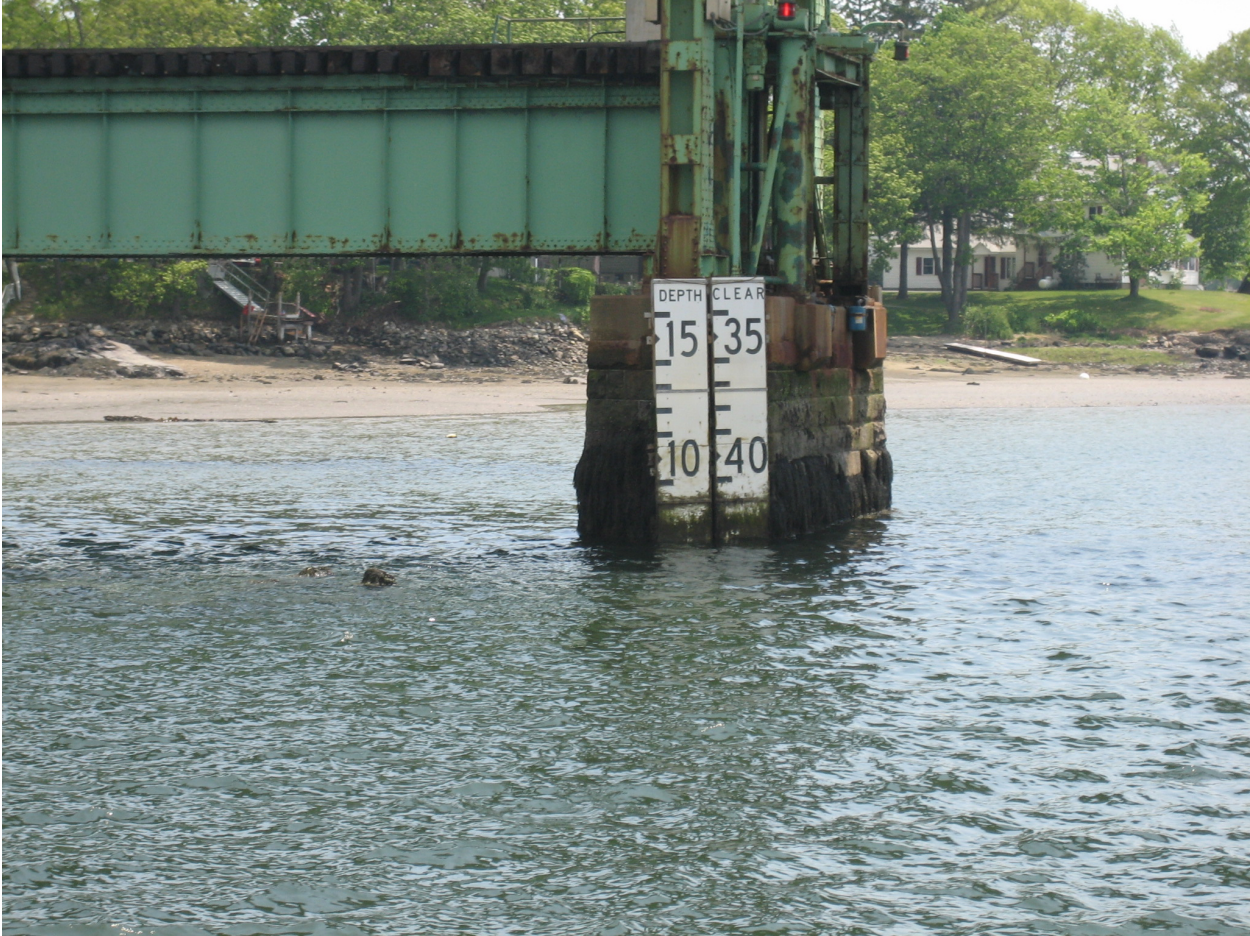
*Figure 1.1.1*

Do not concur. There is no room to chart the obstruction considering the charted features. Obstruction in not navigationally significant. No cartographic action necessary.

The hydrographer recommends the object be charted as ruins extending to the SW end of the "exposed at low tide" line.

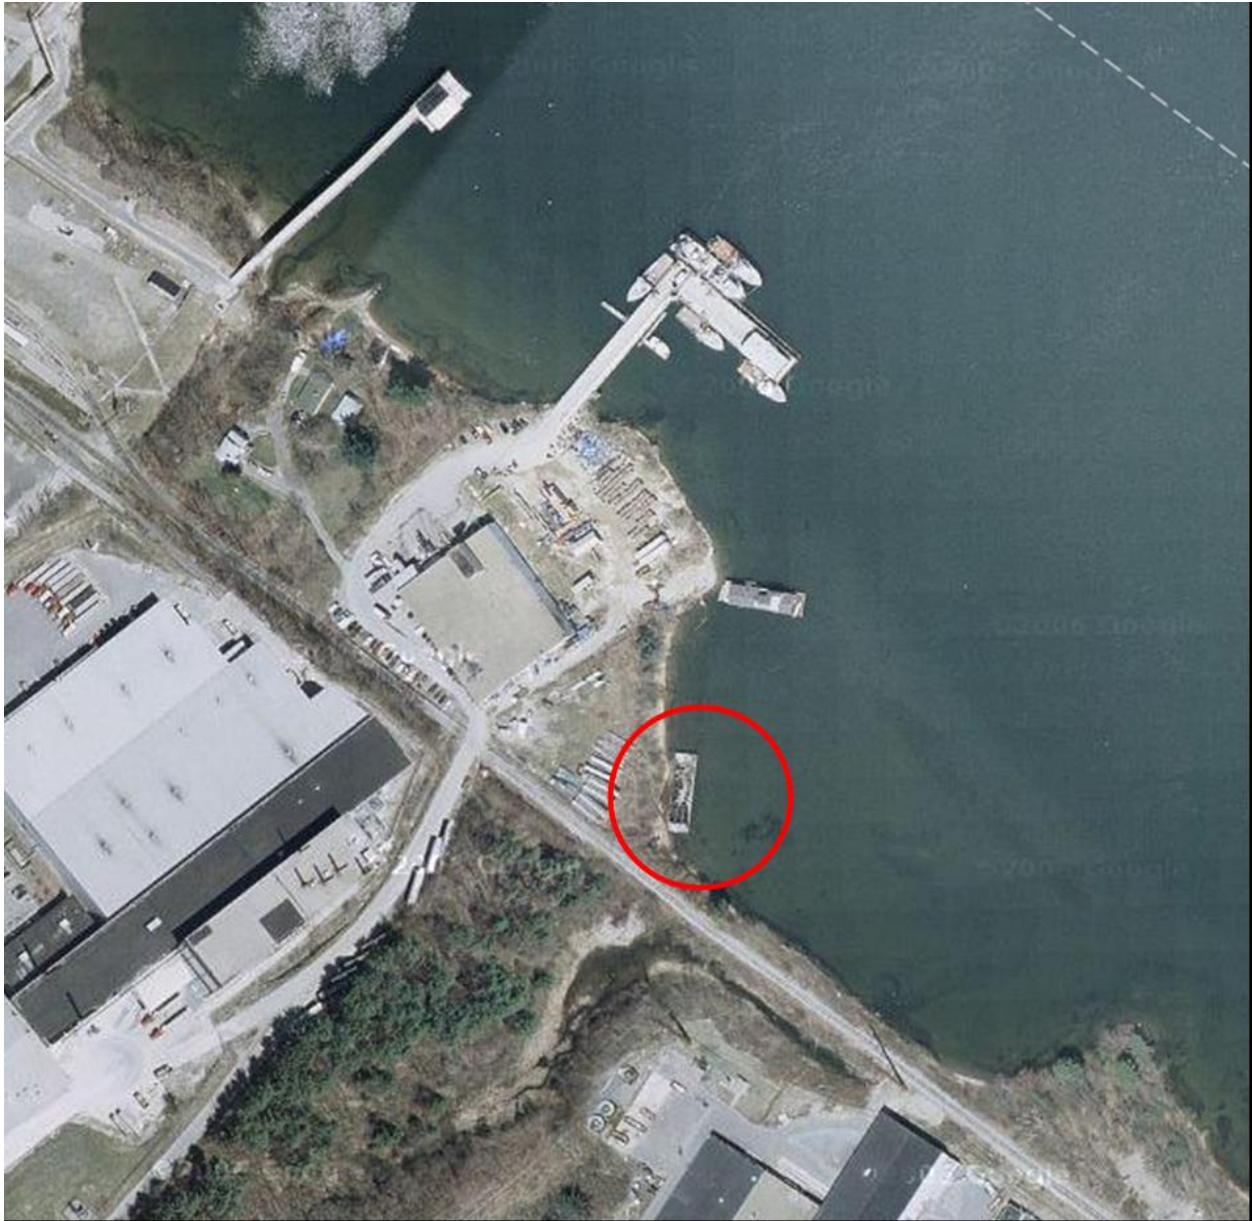
*Figure 1.4.1*

Visually conspicuous wreck noted during ENC verification. The object is located in a shallow area and a DP could not be safely obtained over the item. GP generated in Pydro.

Concur with clarification. Chart as wreck area based on most up to date orthoimagery available.

The hydrographer recommends the object be charted as an exposed wreck.

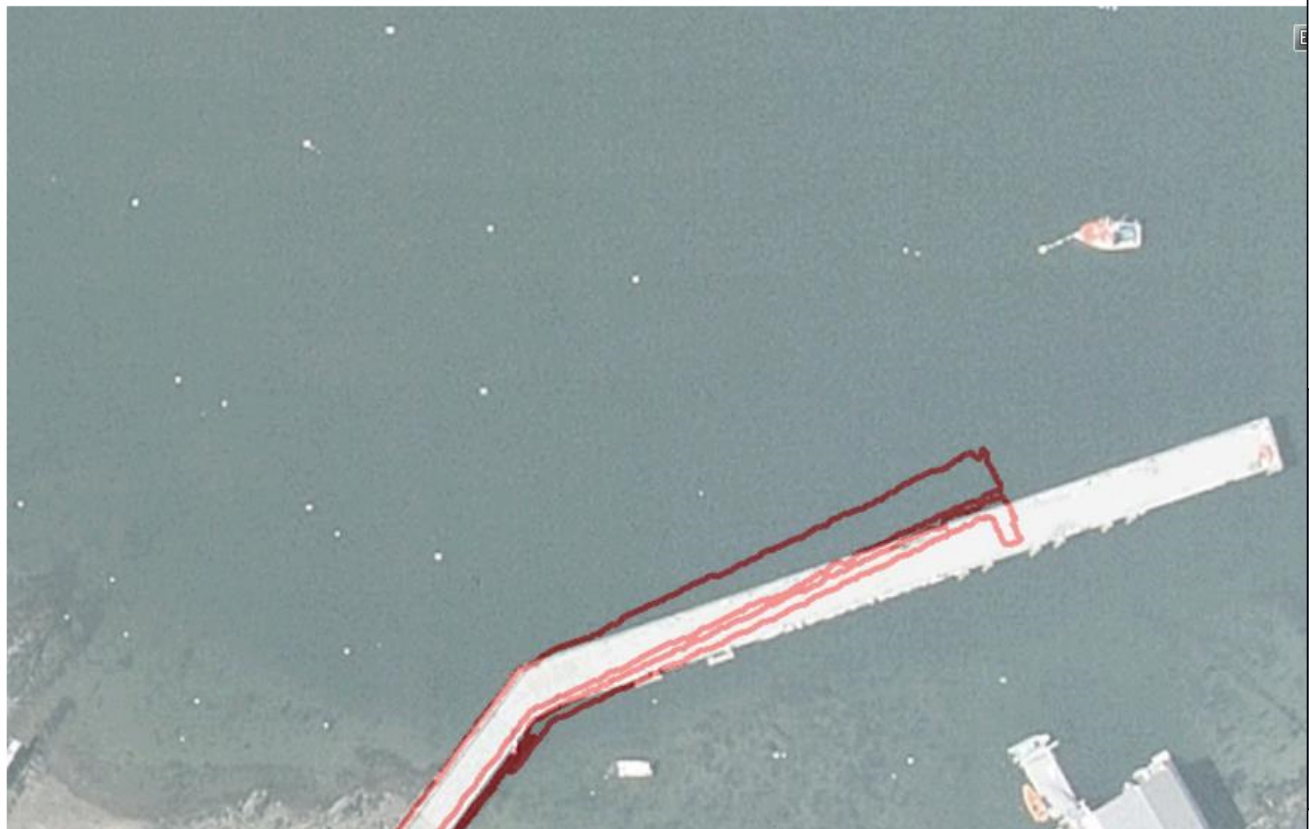
I was told to send this correction to you. We walked the new UNH/NOAA pier for the HASSLER while we were up there with our Trimble backpack. The chart is drawn based on the old USCG pier...which is not there anymore (new pier is built in its place). Anyways, not sure if this all goes to you or if you want us to send it elsewhere. I've included the raw Trimble Pathfinder office file, the raw Mapinfo Table, and an image from our data overlayed on Google Earth. Ok, let me know if you have any problems viewing it. Thanks.

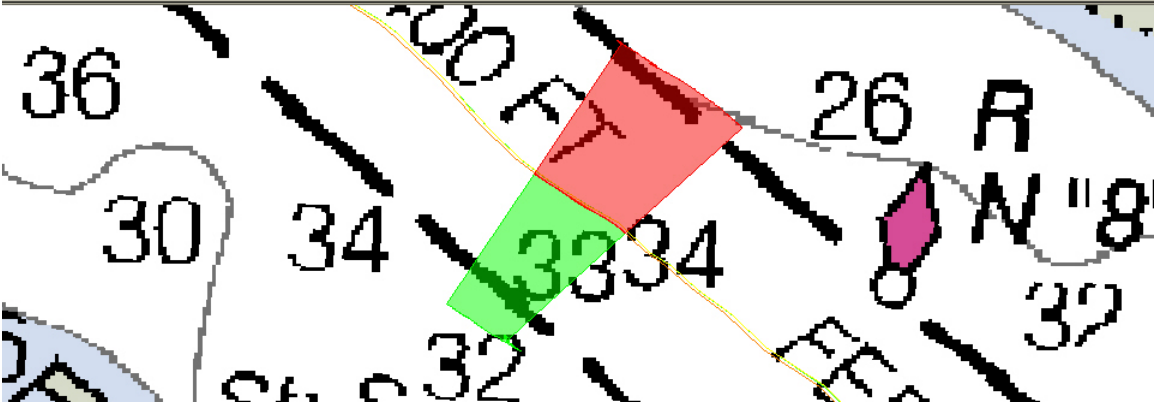
A 34-ft sounding (43°06'26.0309"N 070°47'37.0259"W) obtained from VBES is within the USACE channel that has a controlling depth of 35-ft. The sounding is located about 50 meters away from charted 33 and 34-ft soundings (also within the channel) and is shown in red in the image. It was not submitted as a DTON due to the location of nearby similar soundings. Side scan sonar showed a natural rise but no noticeable obstruction in the survey position. Recommend informing Army Corps of Engineers of the sounding depth so appropriate action can be taken.

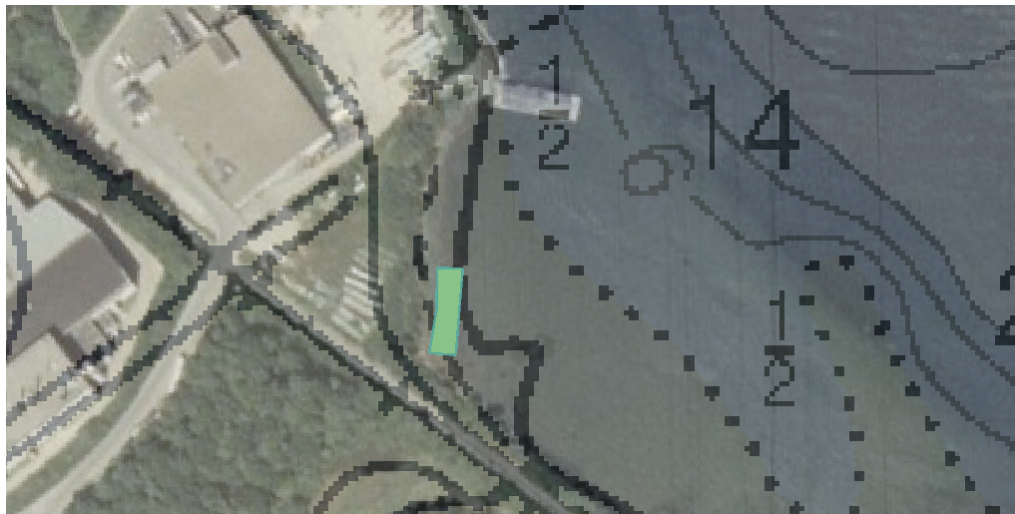
- a. The field unit was directed to obtain bottom samples in the Letter Instructions but did not. Therefore, charted sea bed characteristic (SBDARE) objects within the M\_COVR were retained as charted. The spatial and feature attributes of the SBDARE point features were carried forward from the ENC (US5NM02M).
- b. The hydrographer recommended that the wreck positioned approximately at 43°06'16.0399"N, 070°47'48.8266"W be charted. The AHB compiler concurs that the wreck be charted but as an area feature rather than a point. It is included in the H-Cell as a WRECKS area feature.

- c. The hydrographer mentioned the location of an uncharted pier (43°04'54.9317"N, 070°43'06.5194"W) and recommended it be added to the chart. Chart the observed pier, included in the H-Cell as a SLCONS feature.
