H12023

DESCRIPTIVE REPORT

Type of Survey: **Navigable Area**
Registry Number: **H12023**

State: Rhode Island
General Locality: Block Island Sound
Sub-locality: Point Judith to Green Hill Point

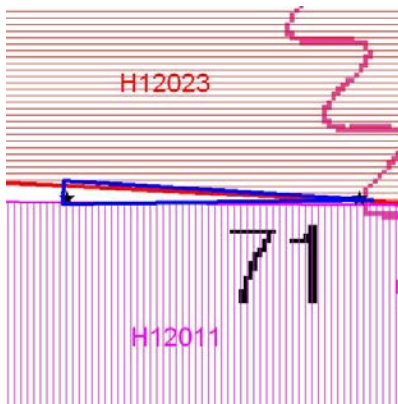
Figure 3: Coverage gap between H12023 and H12011

A coverage gap exists between H12023 and the adjoining survey H12011. Neither survey has soundings in this section. The width of the area is 16m in the east to 4m in the west starting at 41-19-04 N 071-30-07.1W and ending at 41-19-04 N 71-30-29.0 W approximately 500m long.

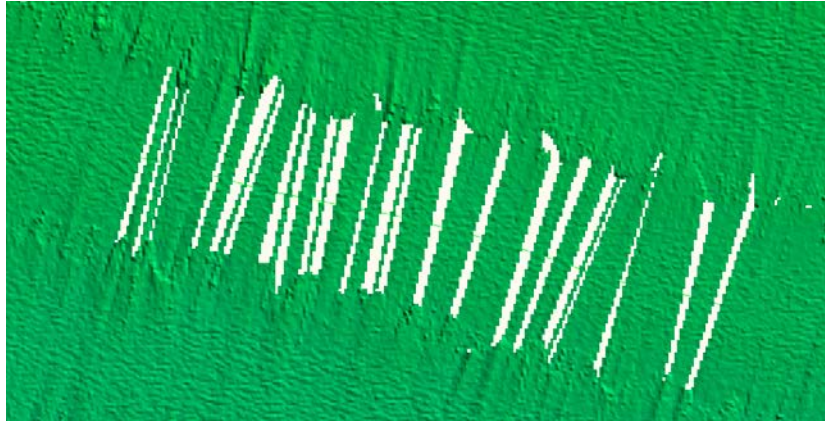
Figure 5: Data gaps from rejected data where heave artifacts exceeded 40cm.

On DNs 243, 267 and 268, the Reson 7125 computer on Launch 3102 had an intermittent timing error. The error can be observed throughout the data as a wave in the surface. This generally does not exceed 40 cm in the grid. Where it exceeded this, the swaths were rejected, leaving gaps in the data (Figure 5). See correspondence in Appendix V.

On the 7th Dec, 2009 after a pre-content review of H12023, two separate timing problems were identified on 3102. CO requested help to come up with solutions from AHB and HSTP. Later in the afternoon, PS Shelf and LT Hauser came aboard and were briefed on these survey issues. They both concurred that since both datasets have variable timing issues, it would be counterproductive to continue working on the dataset. In other words, the end results would not improve much after tweaking with the latency values in the HVF. Their recommendation was to remove the erroneous data from finalize base surfaces, include a descriptive paragraph in the DR about the issues, and if there are any features deal with it accordingly.

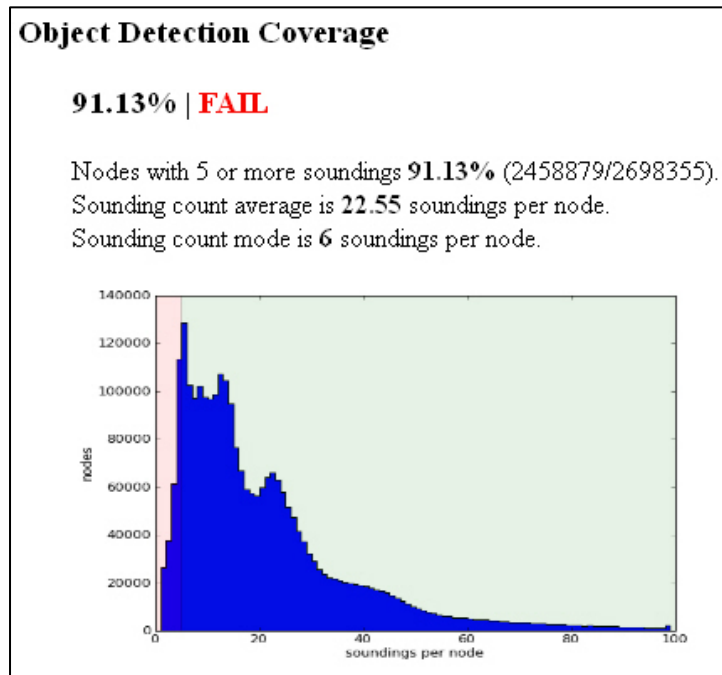
Figure 6: Sounding density plot produced with Python script

Areas of sounding rarefaction (reduction in density) occur with the Reson 8125 system in depths approaching 20m. As the sonar system reaches the deeper limit of its range scale, the survey vessel must slow down significantly to maintain adequate coverage. Partly as a result of this issue, only 91% of nodes met the minimum density requirement of 5 soundings per node (Figure 6).

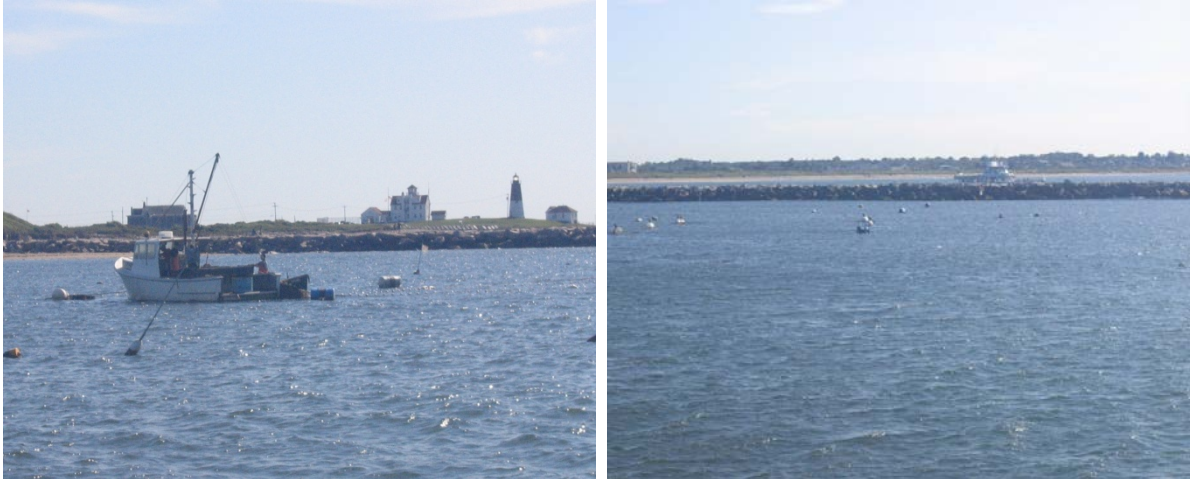
Figure 10: Fish traps photos.

There are 3 fish traps found by ortho-imagery. The fish traps at West Wall and East Wall were verified visually and positioned by launch 3102. The Brickwater Village Trap was not in place at the time, but its intended position was verified by Captain Tom Hoxsie of the *North Star*. The three traps are intermittent as they get serviced and replaced at the same location. Below is the *North Star* servicing the trap and a view of a typical layout of a fish trap (Figure 10). There are barrels anchored to the bottom supporting the trap gear. See Appendix II and V.

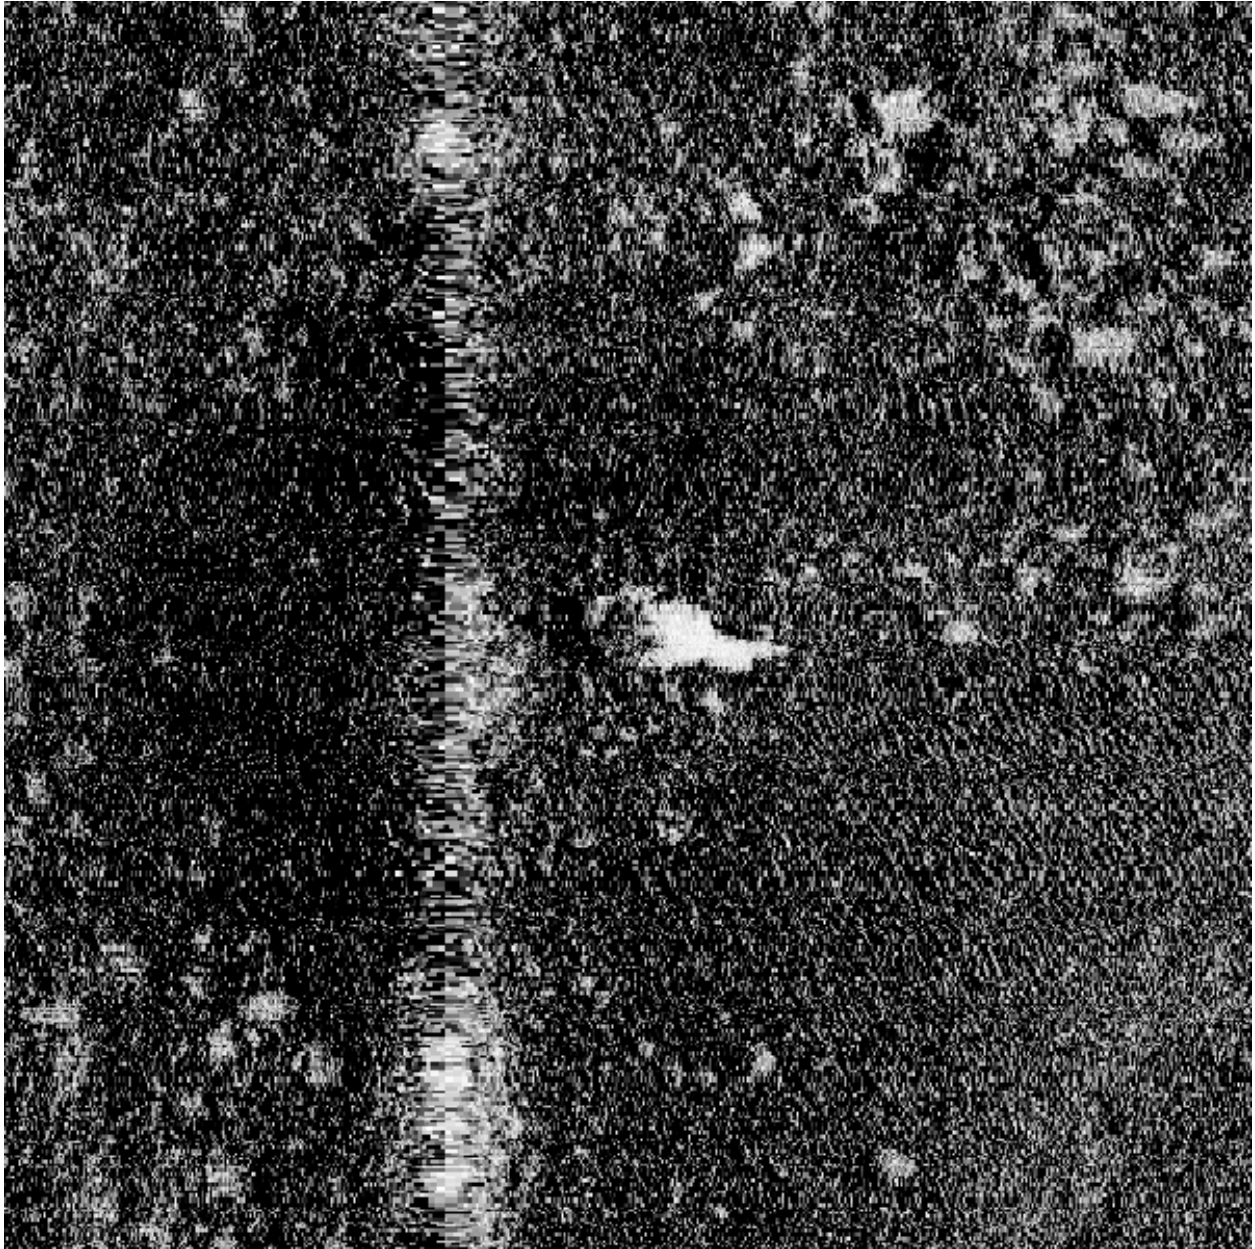
1.4) DTON-12ft UWTRC

AHB SAR: Danger to Navigation located at survey position with 100% SSS and Object Detection MB.
Feature has been applied to the chart. Compile: Add rock

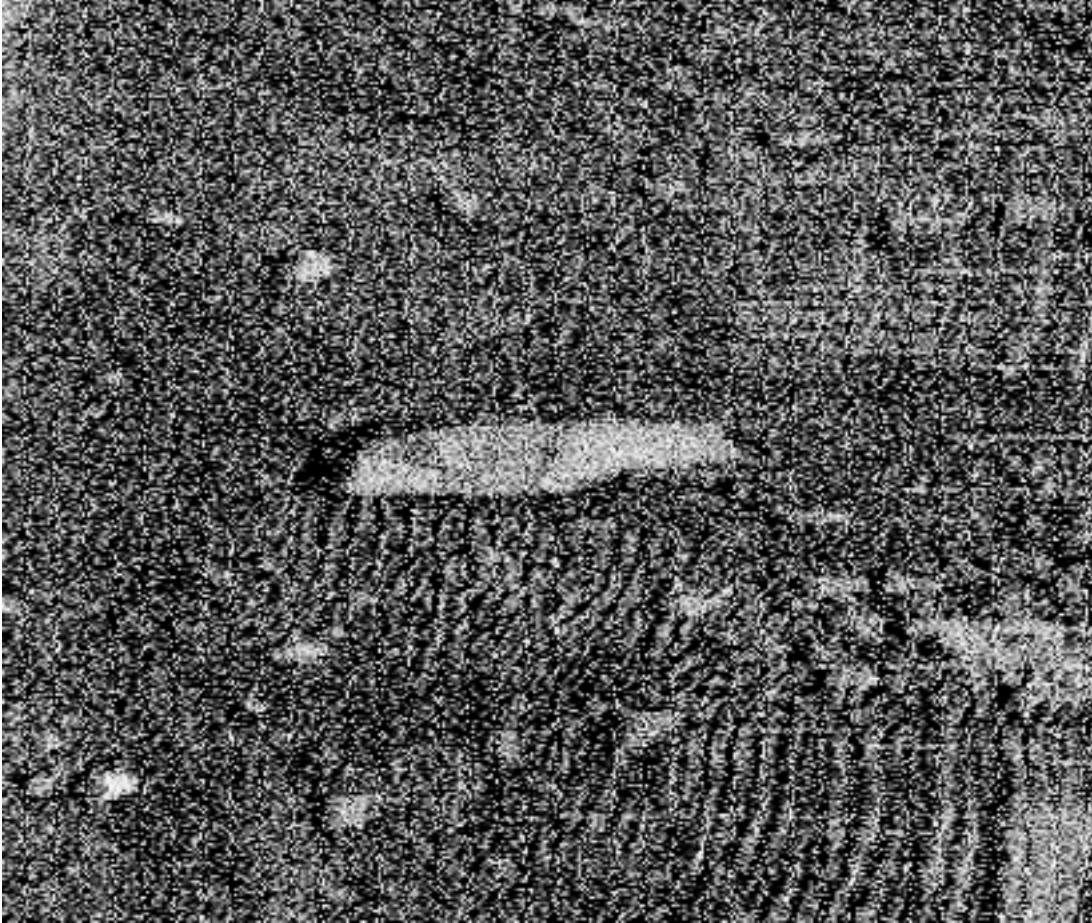
1.5) DTON-11ft UWTRC

AHB SAR: Danger to Navigation located at survey position with 200% SSS and Object Detection MB.
Feature has been applied to the chart. Compile: Add rock

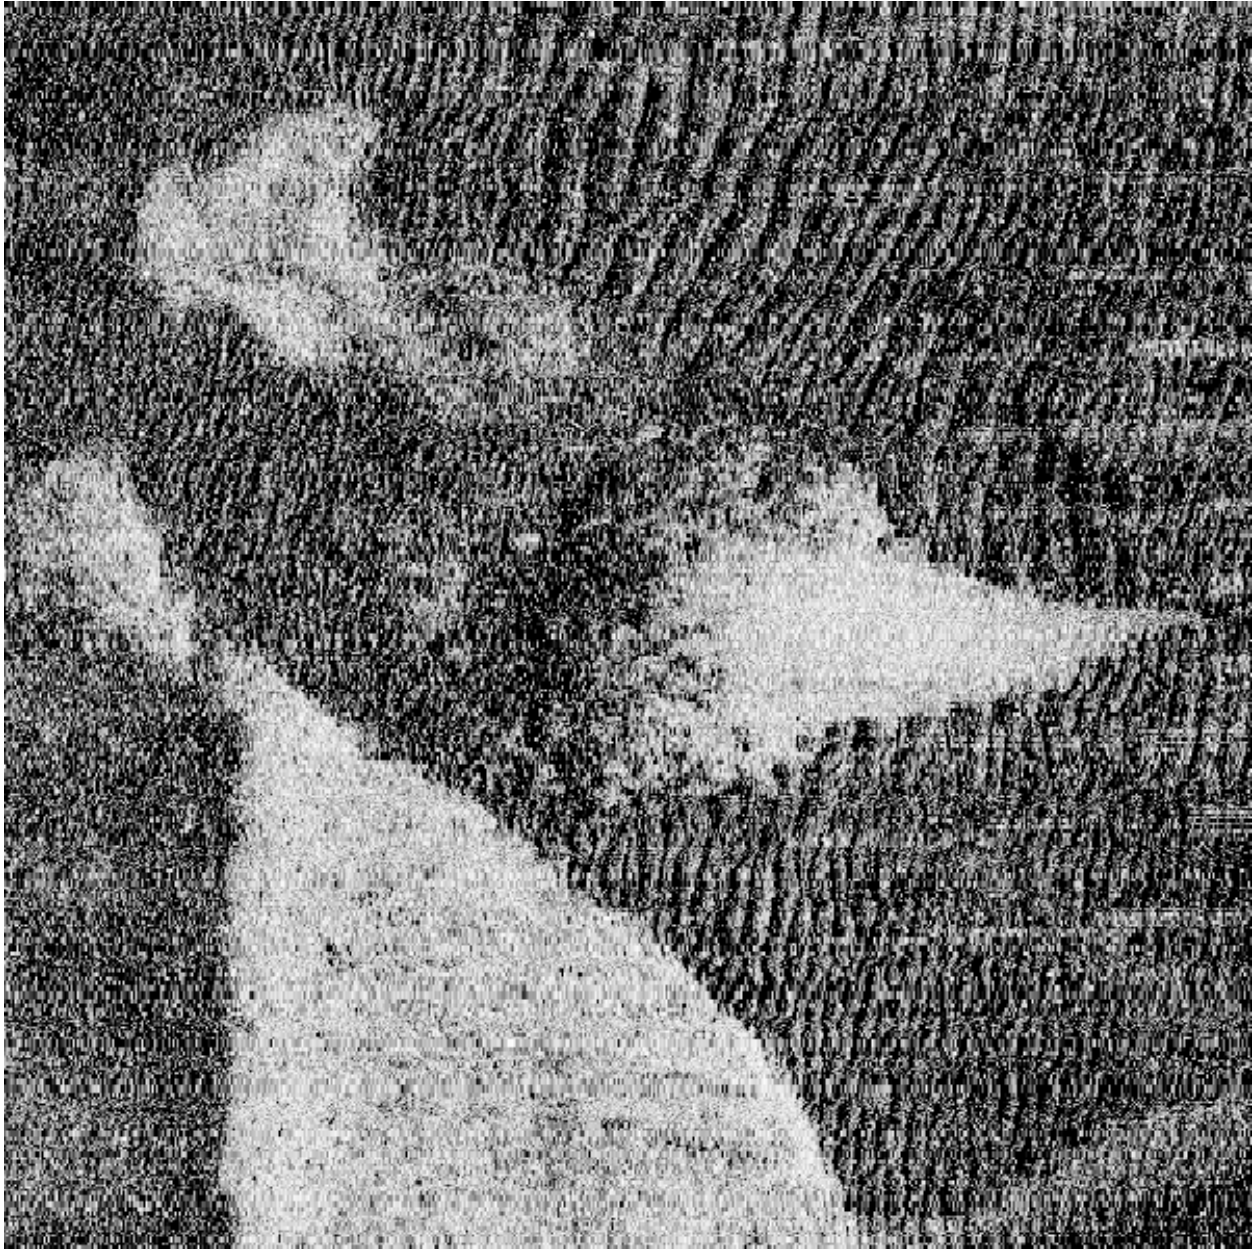
OBSTRN/remrks: 4.0m high uncharted obstruction found with 200% Klein 5000 side scan sonar and Reson 7125 object detection multibeam. Soundings were corrected to MLLW with final verified water levels and final TCARI zoning.

AHB SAR: Uncharted feature located at survey position with 200% SSS and Object Detection MB. Feature interpreted as a pile of debris based on SSS imagery and MB data. Compile: Add obstruction

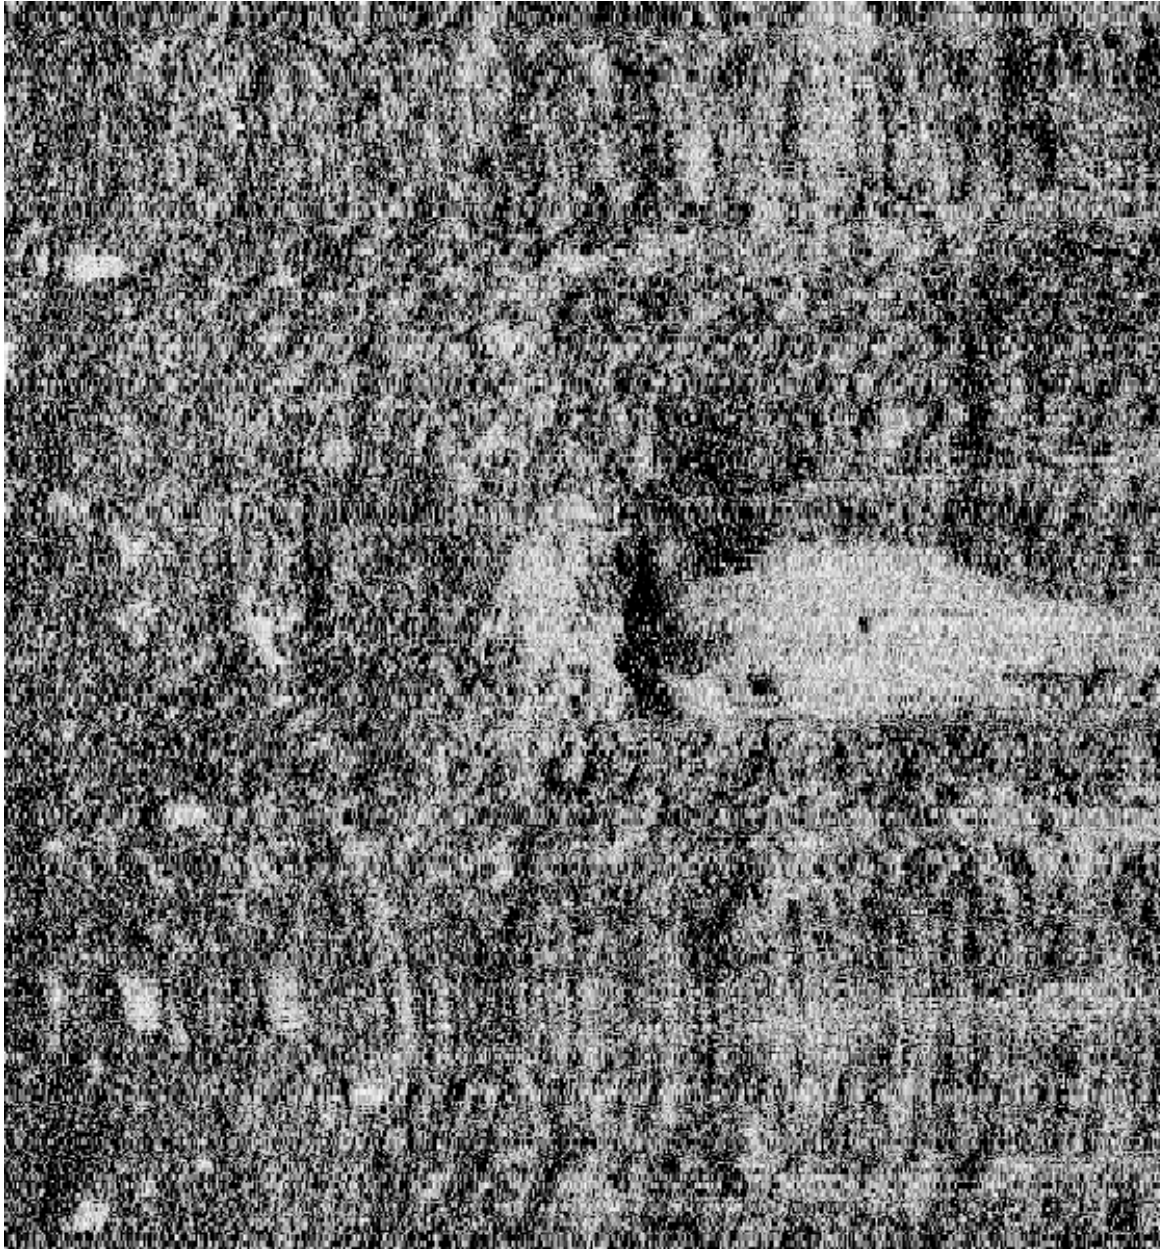
1.10) DTON-20ft UWTRC

AHB SAR: Danger to Navigation located at survey position with 100% SSS and Object Detection MB.
Feature has been applied to the chart. Compile: Add rock
