DESCRIPTIVE REPORT

Type of Survey: Navigable Area

Registry Number: H12324

General Locality: Narragansett Bay

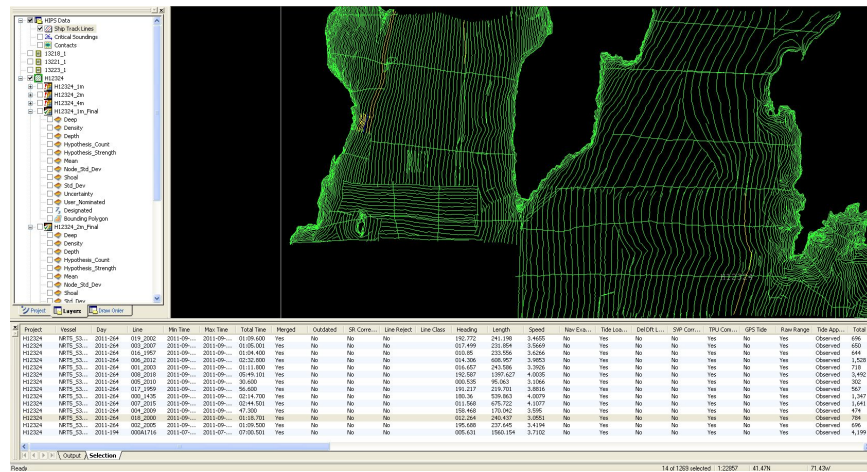
TrueHeave was not able to be applied during post-processing of 15 survey lines on two days. DN194 has 2 lines with no TrueHeave and DN264 has 13 lines with no TrueHeave. Refer to the supplemental document in Separates\I Acquisition_& Processing_Logs\DN194 & 264 True Heave Issues.txt for listing of the lines and Caris error messages. The lines were visually compared to adjacent lines and no heave artifacts or other vertical discrepancies were noted.

Figure 4: Lines highlighted in yellow do not have TrueHeave applied.

The data is adequate for charting despite not having true heave applied to the lines noted.

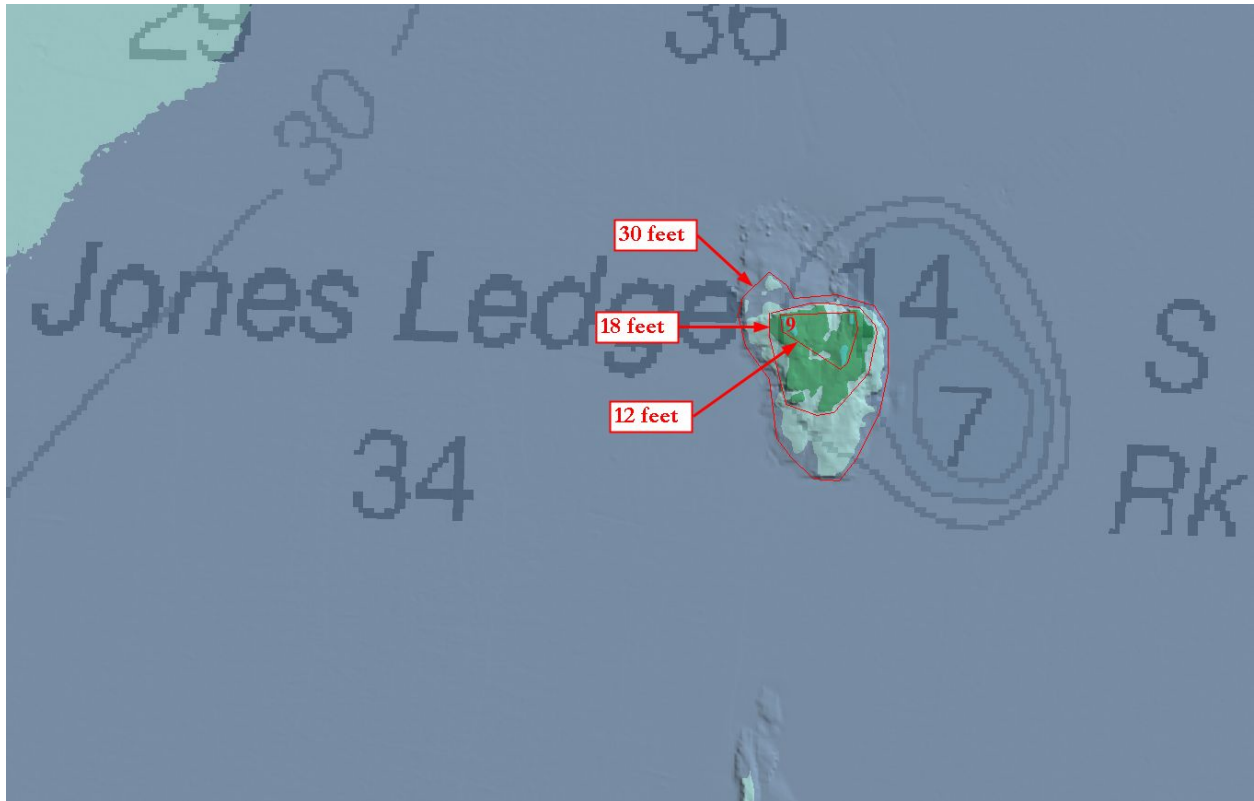
Geo object 1: Underwater rock / awash rock (UWTROC)
Attributes: SORDAT - 20111011
 SORIND - US,US,graph,H12324
 TECSOU - 3:found by multi-beam
 VALSOU - 2.807 m
 WATLEV - 3:always under water/submerged

Hydrographer recommends charting a new rock and contours. New contours have been provided in ...H12324_DtoN_2.zip\Contours_for_Jones_Ledge\ in ESRI *.shp format and MapInfo *.tab format. Existing contours and soundings for Jones Ledge should be removed.

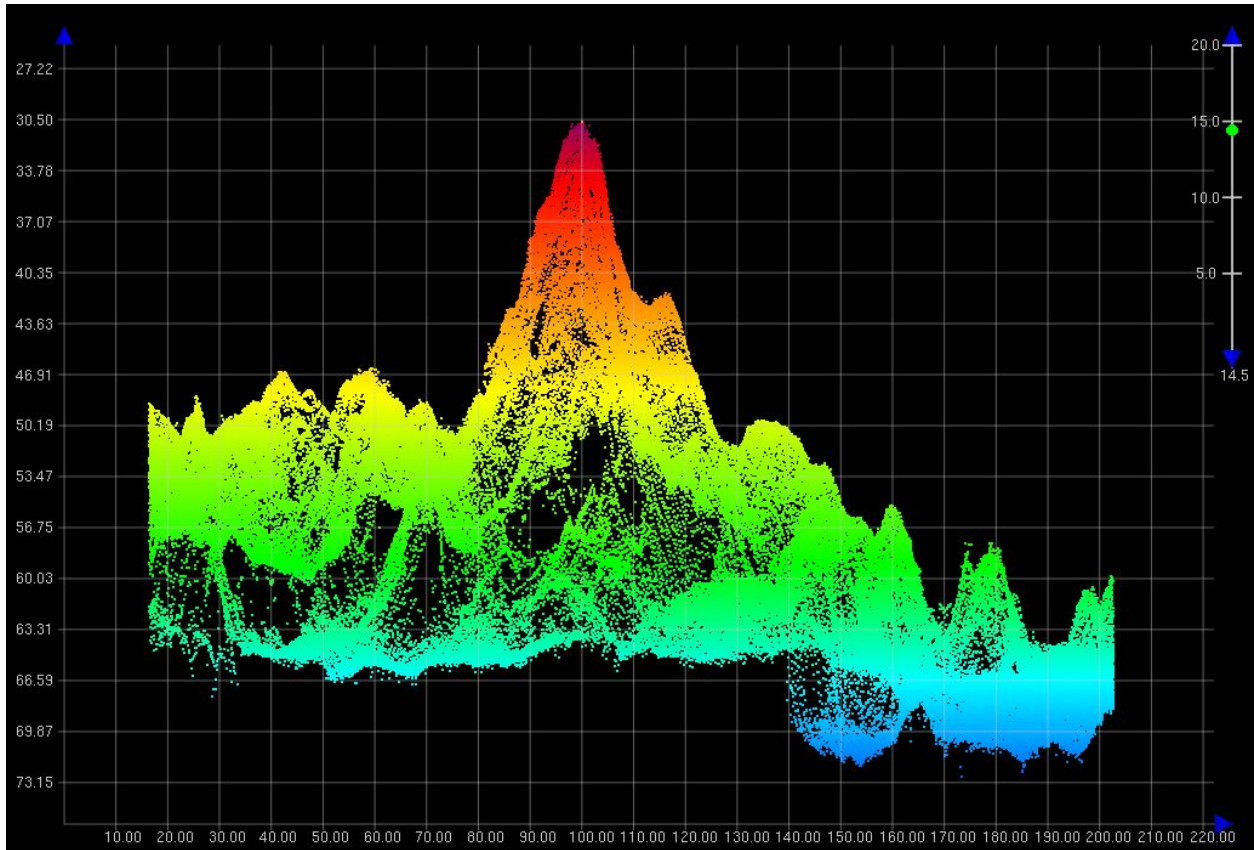
Geo object 1: Underwater rock / awash rock (UWTROC)
Attributes: SORDAT - 20111011
 SORIND - US,US,graph,H12324
 TECSOU - 3:found by multi-beam
 VALSOU - 9.322 m
 WATLEV - 3:always under water/submerged

Recommend charting new rock with a least depth of 30 ft.

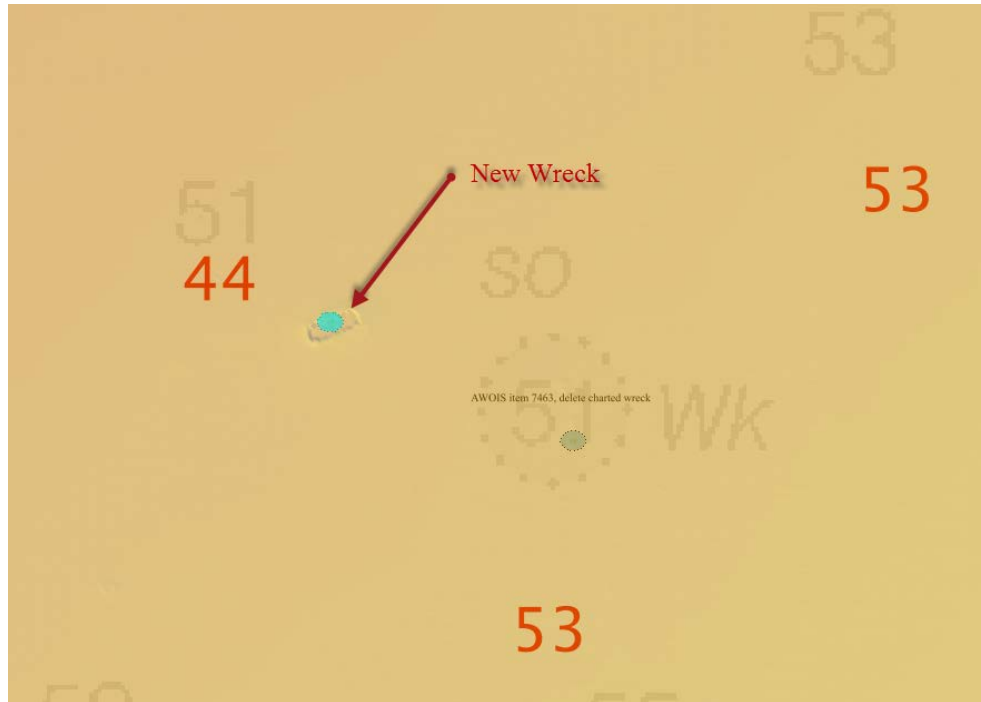
A new wreck with a least depth of 45.1 ft. was found at position 41-27-08.02N, 071-25-00.29W and is shown in the image below. The compiler recommends adding this new wreck to the AWOIS database.

Note that the wreck is in the vicinity of another charted wreck (AWOIS item 7463) but is a different wreck as the AWOIS wreck was confirmed by divers at the location charted and there is evidence in the hydrography of an obstruction at the location.
