**DESCRIPTIVE REPORT**

Type of Survey: Navigable Area

Registry Number: H12488

Sub-locality: East of Nissequogue River to Crane Neck Point NY.

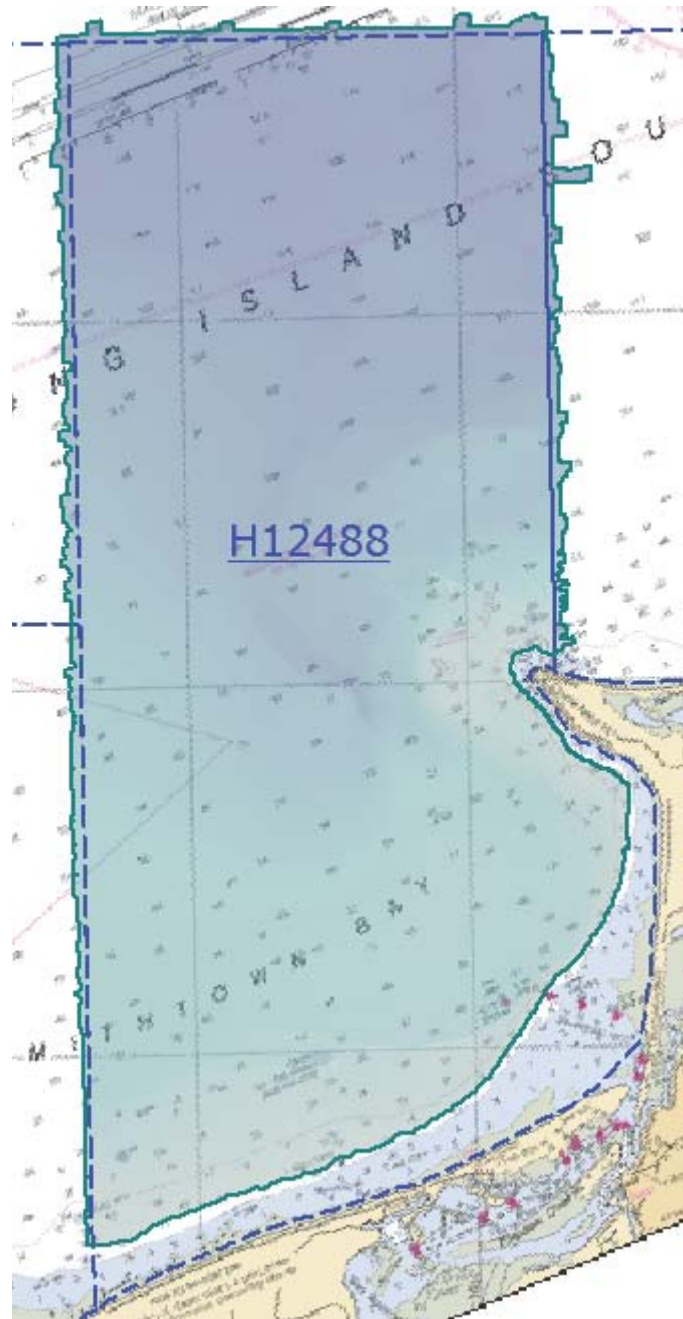
*Figure 1: Limit to 4m Curve*

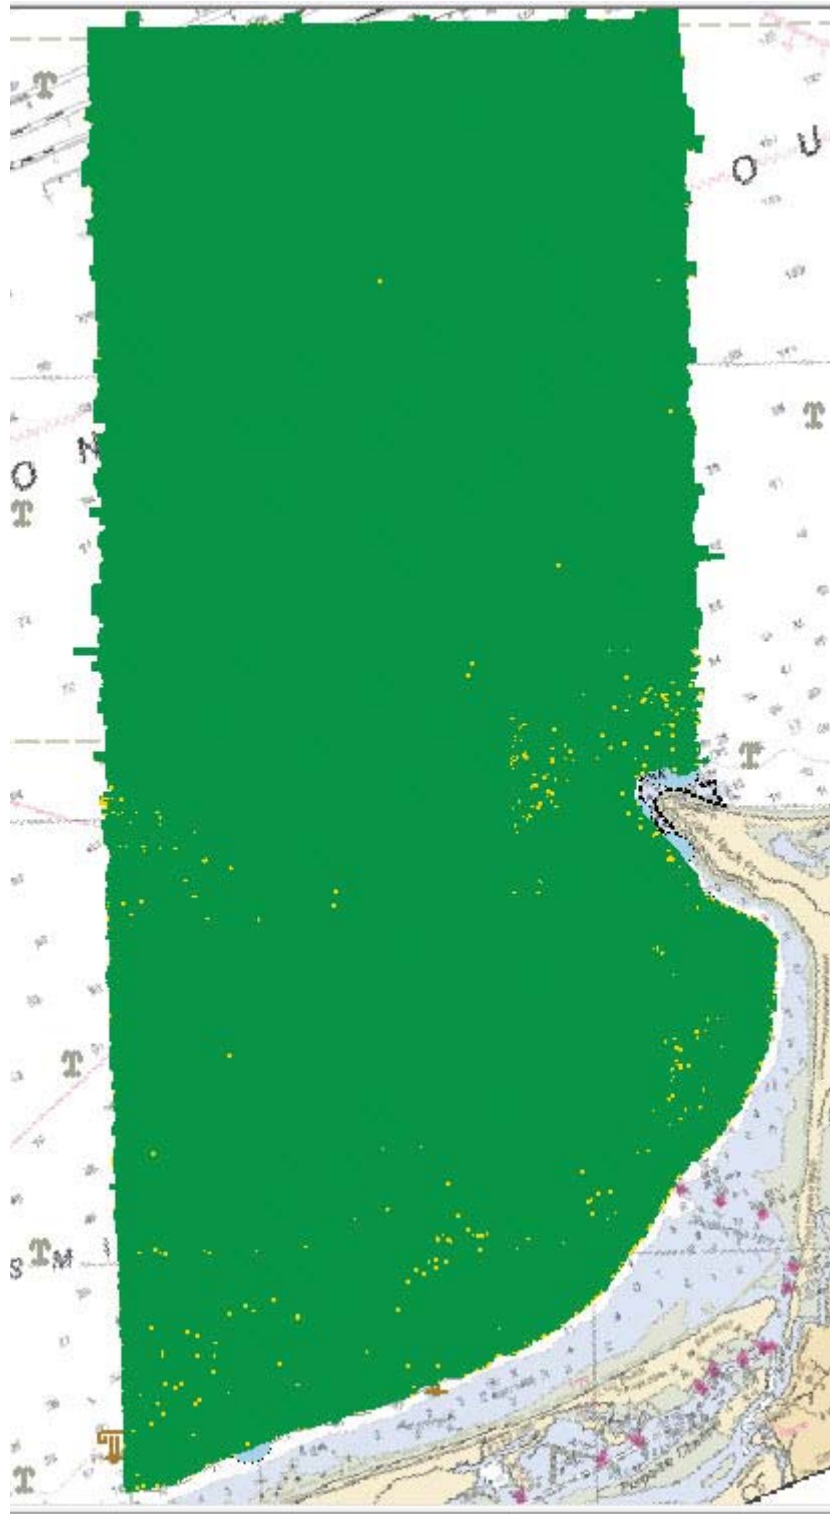
Data acquired on survey H12488 met complete multibeam coverage requirements. Ninety five percent of the survey met the 5 soundings per node data density requirements outlined in section 5.2.2.2 of the HSSDM (Figure 2 and 3.). Most areas that did not meet the requirement were from acoustic shadows.

*Figure 3: Total Coverage by Density Limit. Yellow indicates less than 5 pings per node*

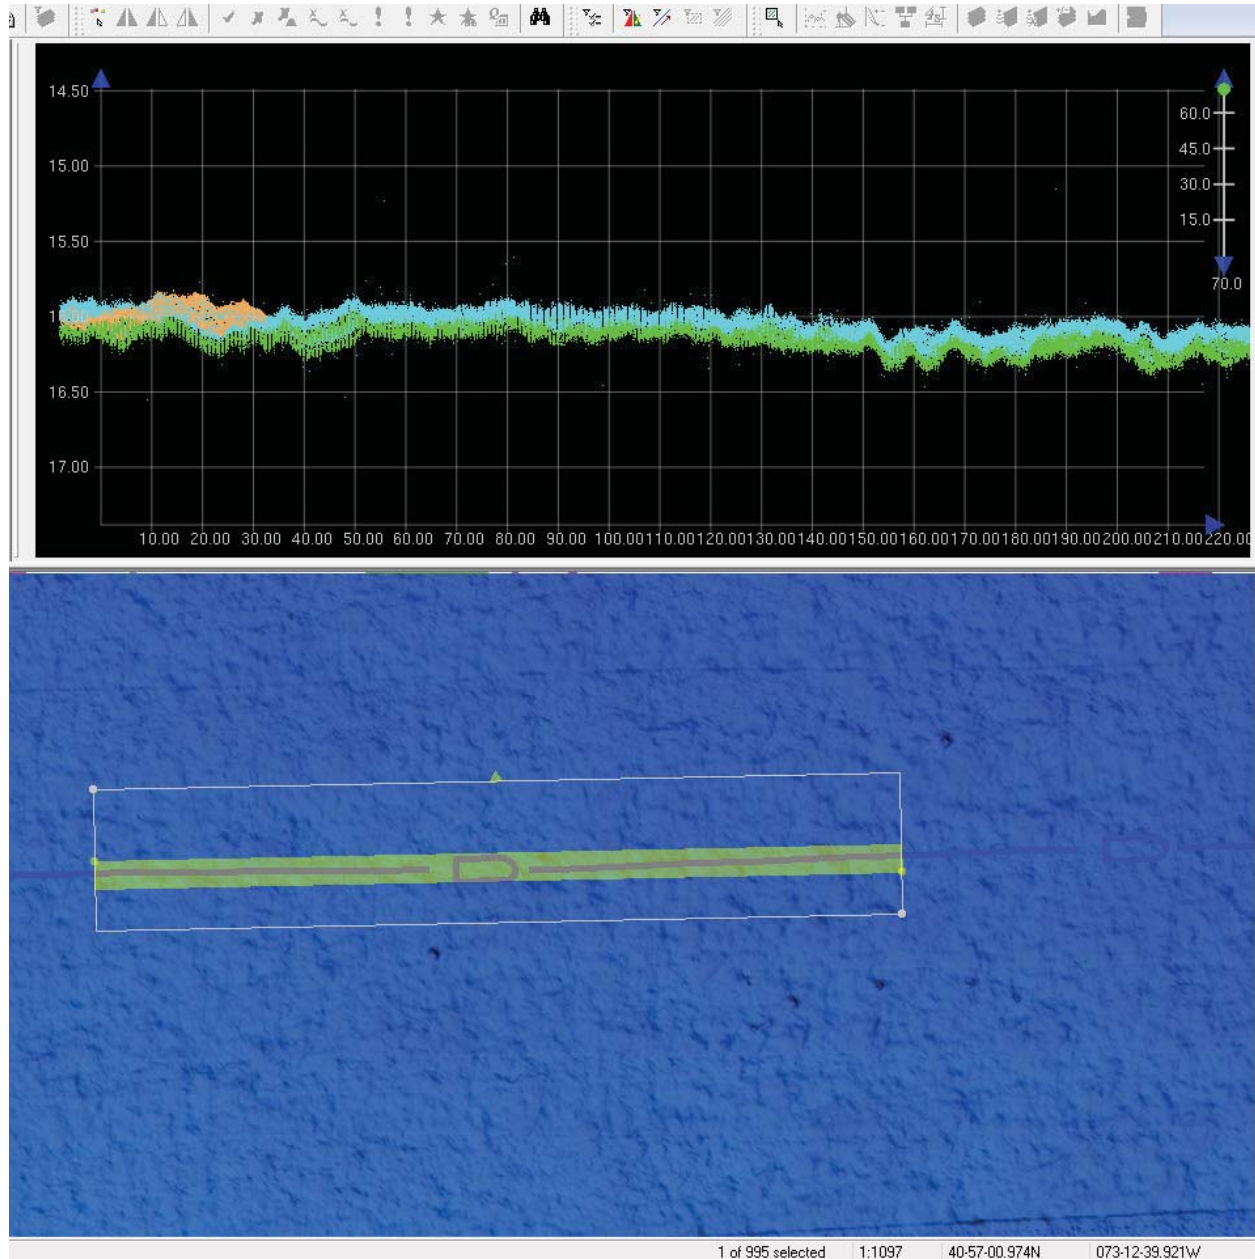
In addition a Sound Speed Comparison Tool script developed by Matt Wilson was used on ship data. This tool will retroactively plot the real-time sound speed input to a multibeam echo sounder (SSP) versus the sound speed at the commensurate water level taken from the Moving Vessel Profiler (MVP). Out of 1007 MVP profiles for the ship, 13 comparisons failed the 2m/sec criteria on ship data. The 2m/sec criteria was chosen because the tool can better access the data then by monitoring it in acquisition. On inspection of the most excessive of the comparisons, data was either rejected completely or rejected to a reduced swath width(outside beams). Most excesses were within IHO specification for differences in depth caused by excess velocity error. The sample refers to a high reading from the results that occurred on S222 data DN181 at 2100. On inspection in subset editor the data was in fact within specification. The mean difference and standard deviation between surface and cast measurements was (m/s)=0.611, +/-0.927. See Fig. 11 and Separates H12488\_Soundspeed\_comarisons\_All.txt for a list of times that were in excess.

*Figure 10: S222 DN181. Data Flagged by SSP tool in excess. Several lines are shown in addition to the line in error. All the lines have depths well within range.*

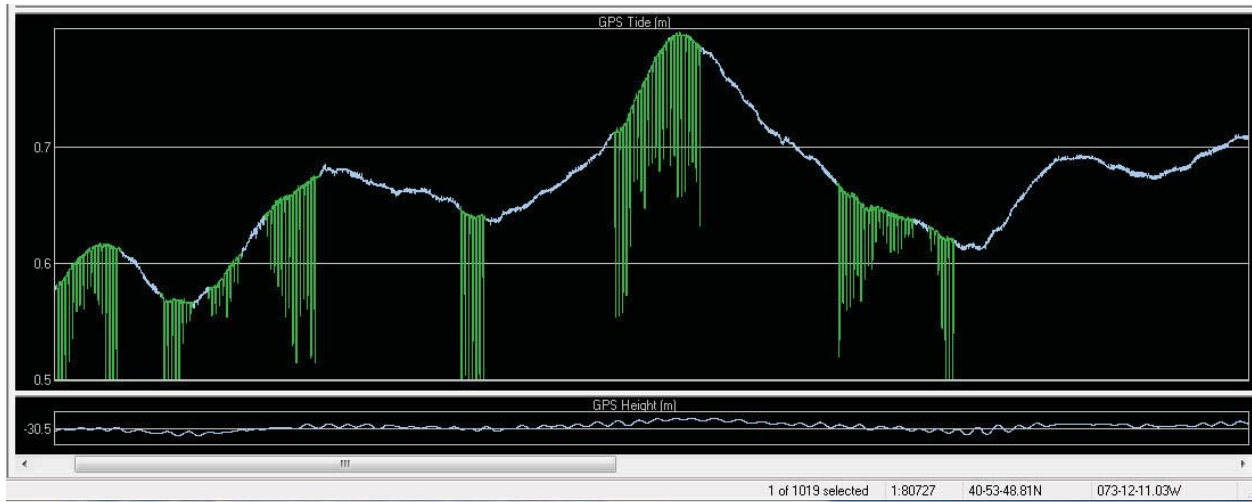
The majority of this survey was processed with IAPPK ellipsoid heights, reduced to MLLW via a VDatum separation file. Some lines after processing with GPS Tides, produced depths inconsistent with the rest of the mainschem multibeam and failed IHO specifications. The possible causes for those failures ranged from incomplete POSPAC data, operator error, system failure and anomalies due to satellite interference. Uncertainty and standard deviation layers of the grids were the best indication of major discrepancies. When alternative methods of processing in the POSPac MMS software failed, those lines were then processed

using TCARI. If a small section of GPS Tide/Altitude was observed, that area was smoothed in the attitude editor. Care must be taken during application of correctors so the smoothing is not over written. A list of lines using TCARI can be found in Separates, I\_Acquisition\_&\_Processing\_Logs, Processing\_Logs, H12488\_SBET\_QC\_Log.xlsx. Examples of the anomalies are listed below.

*Figure 11: Altitude Anomaly as viewed in Attitude Editor (GPS Tide). The green is displaying unusual GPS Tide levels.*

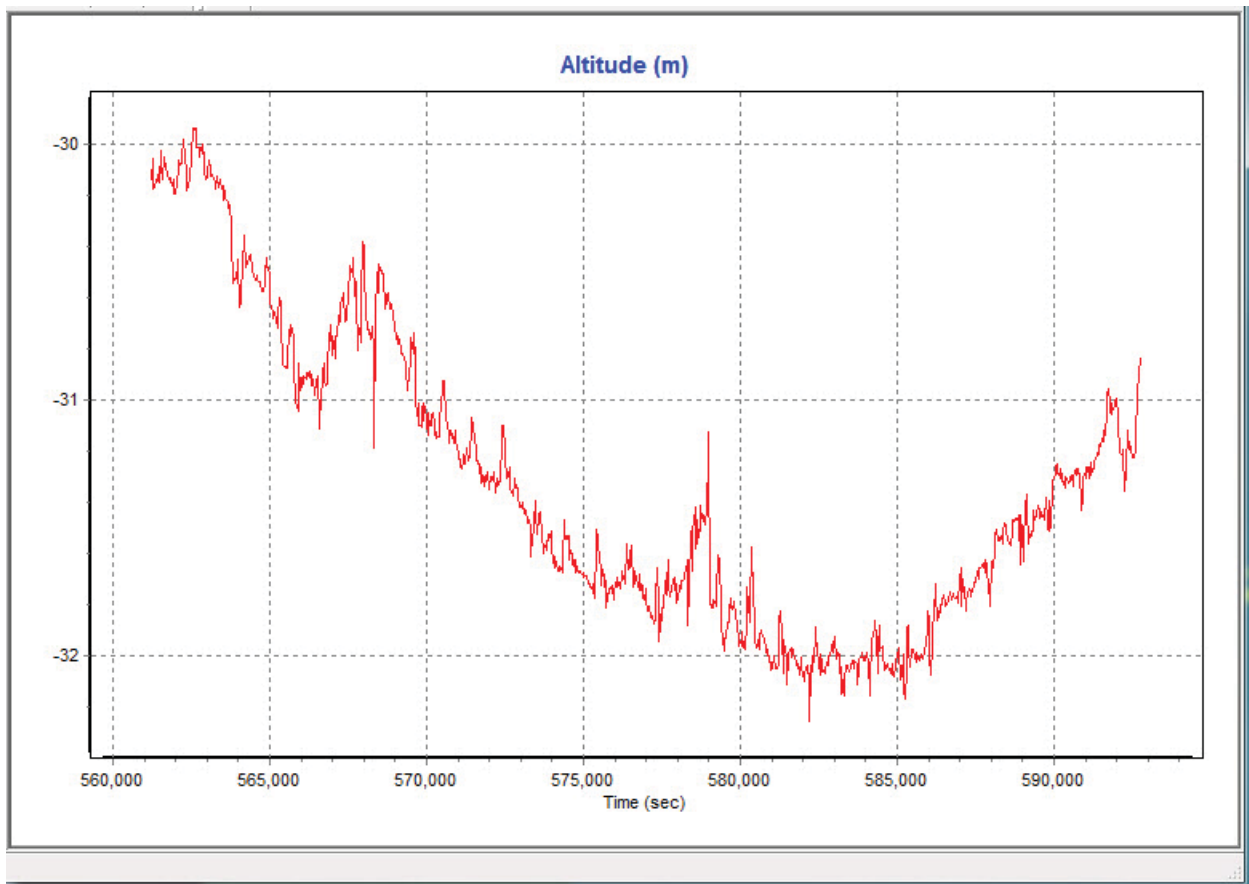
*Figure 12: Altitude Anomaly POS/PAC MMS Altitude PLOT*

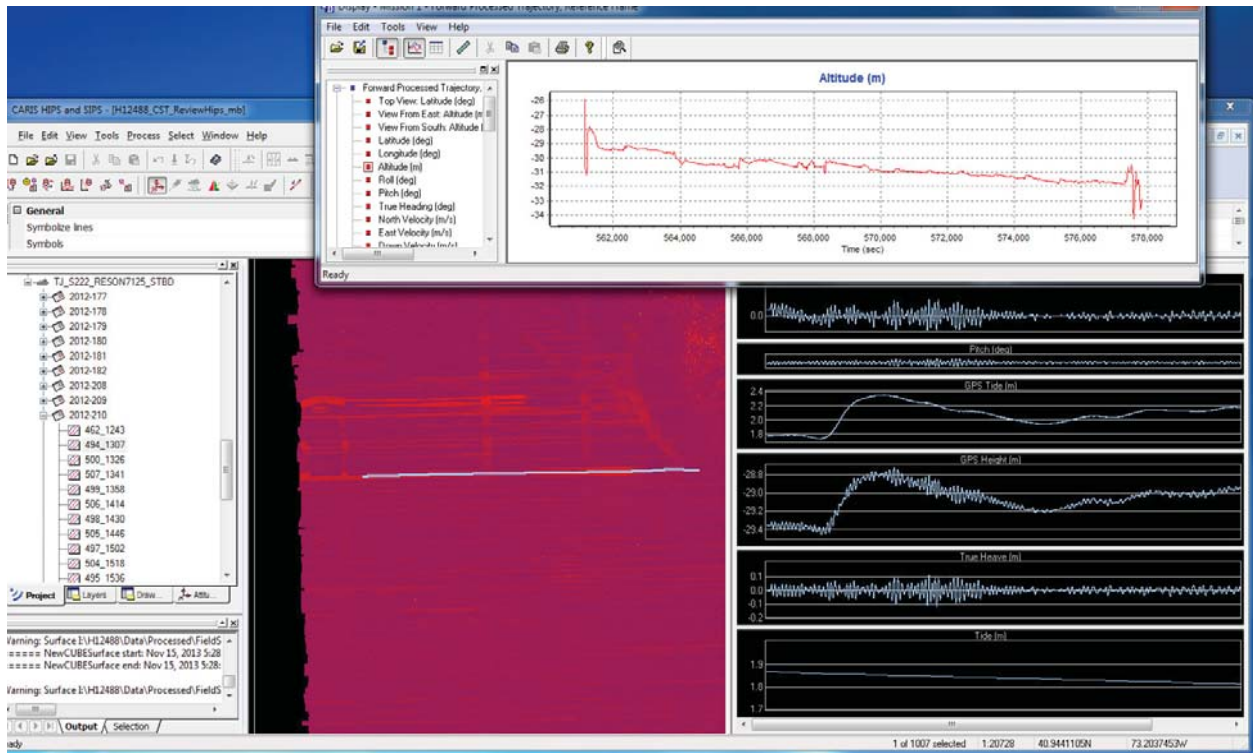
Figure 13: *Altitude Anomaly as viewed in Attitude Editor. This compares GPS Tide and Height to TCARI Tide.*

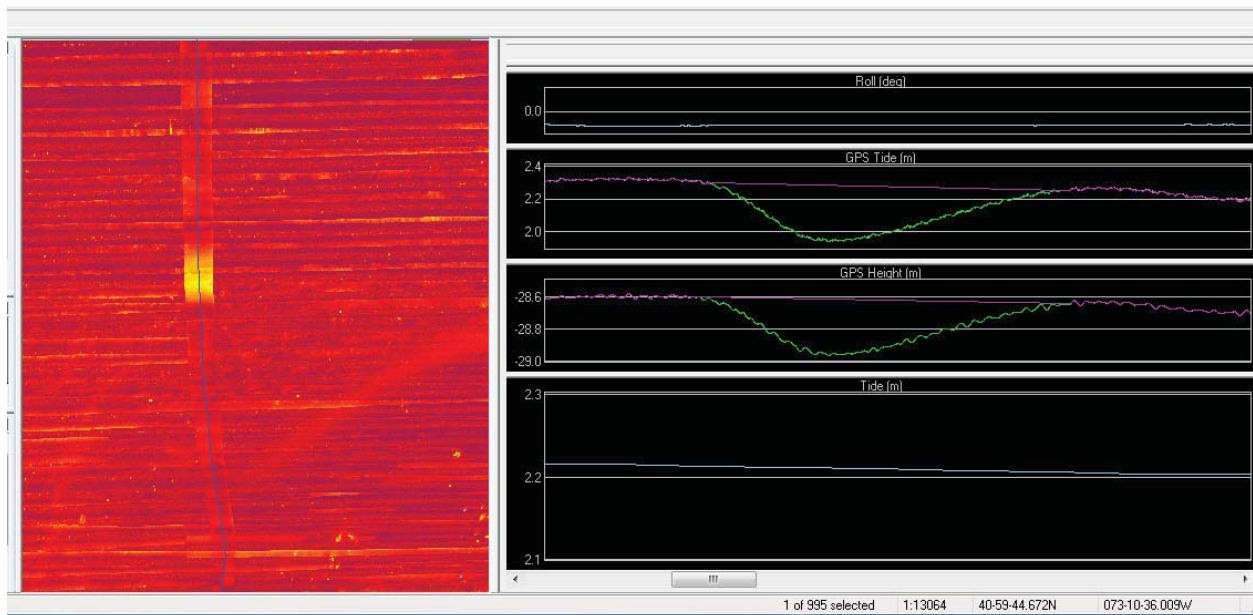
Figure 14: *Altitude Anomaly as viewed in Attitude Editor as seen by isolated yellow rectangle. This also compares GPS Tide and Height to TCARI Tide. In this case Graph shows how smoothing is applied.*

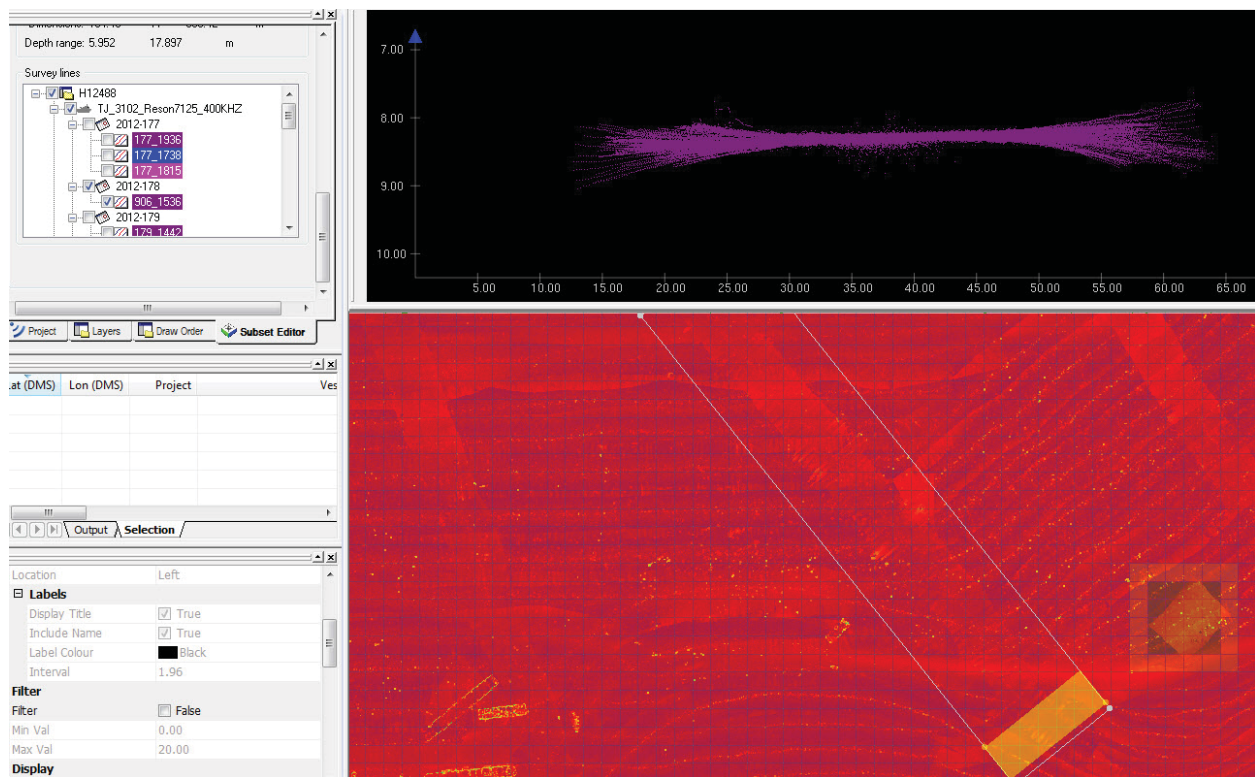
All the platforms experienced various attitude problems at one time or another. Uncertainty and standard deviation layers of the grids were also the best indication of major discrepancies. In cases where appropriate, data was either filtered to 45 degrees or deleted in subset editor. The types of attitude error observed could be heave, roll, or cocked pings. Examples are listed below. Although within specification, there was a slight Attitude error observed on both launches covering days 178 and 179 from west part of the sheet to crane neck. It can be seen as a wavy line when the grid is placed in high exaggeration. The weather was wind northeast at 10 to 15kts with 2ft chop. The majority of the anomaly was within the 8-14 meter curve, and due to possible dynamic sea conditions.

Figure 15: Attitude Anomaly XL 3102 Possible timing

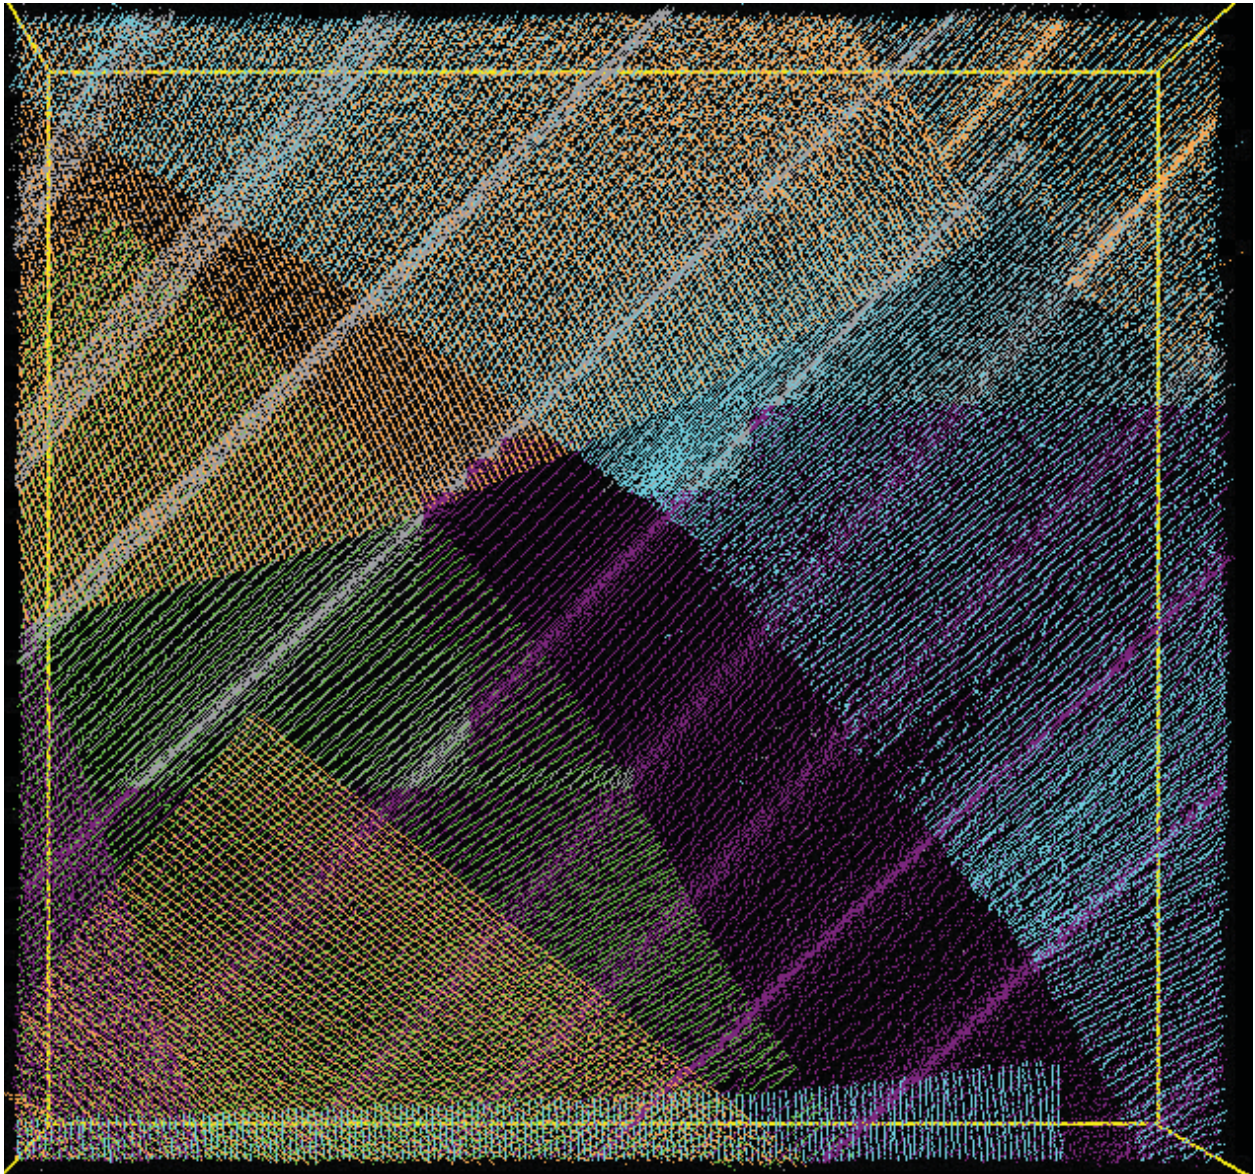
*Figure 16: Attitude Anomaly Heave Artifact*

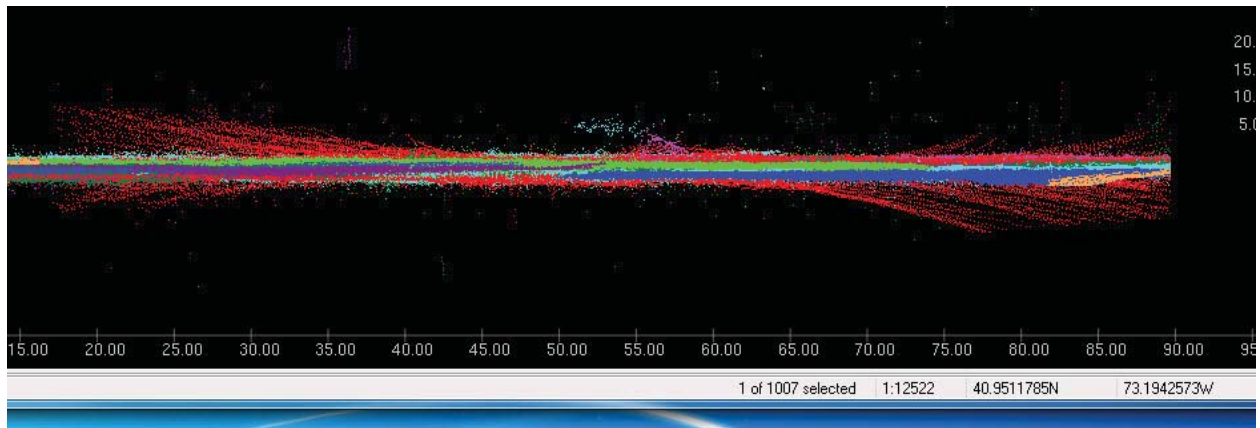
*Figure 17: Attitude Anomaly 3101 DN 178 cocked Pings*

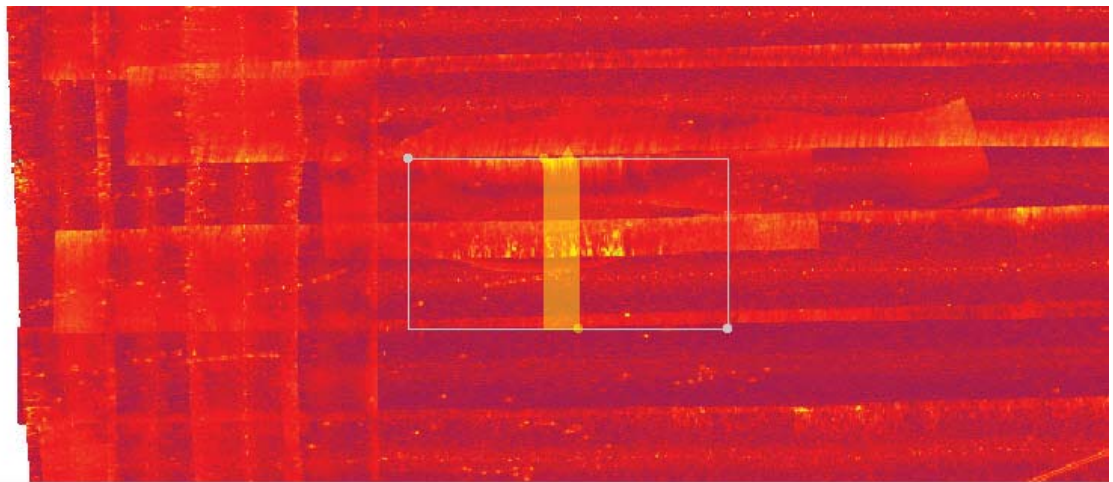
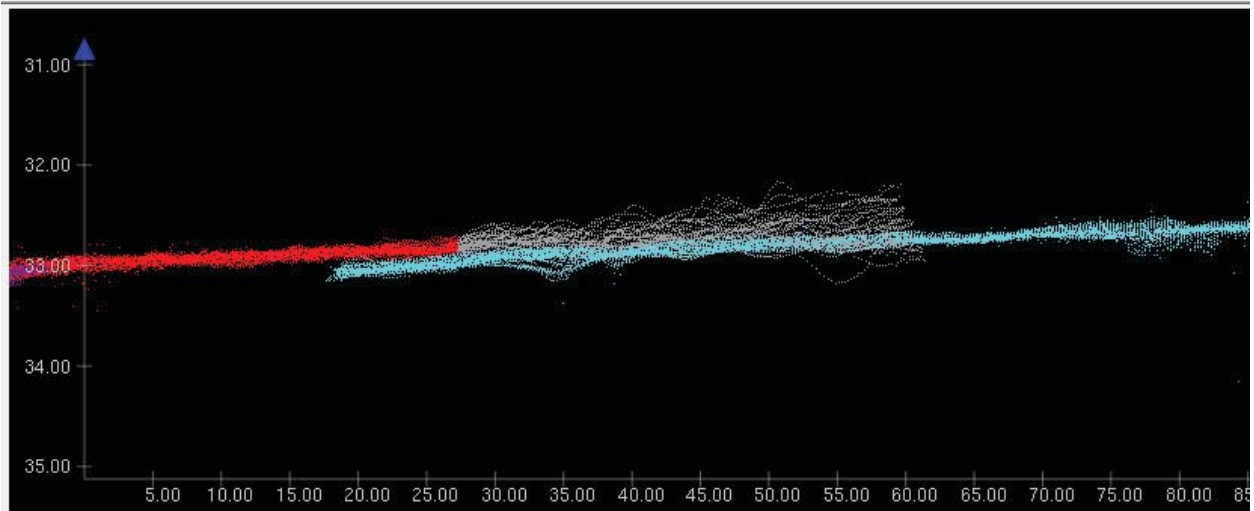
*Figure 18: Attitude Anomaly outerbeam flareup*

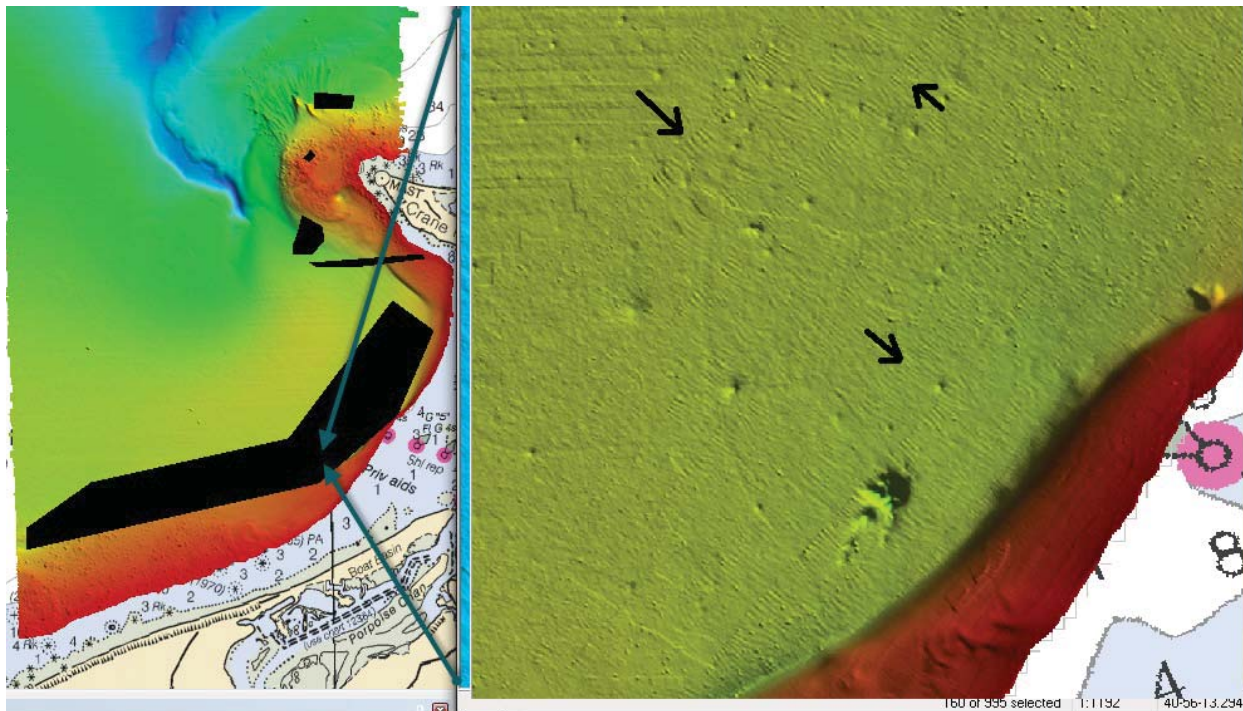
Figure 19: *Attitude Anomaly* days 178- 179 timing

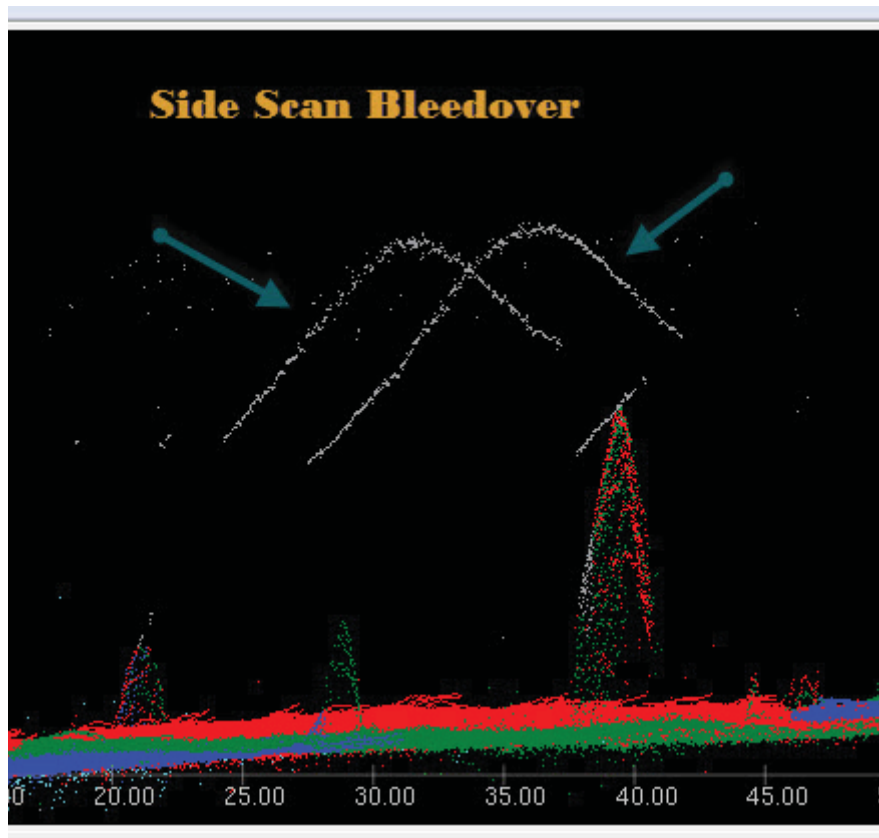
Some Dual MB/SSS was acquired simultaneously for near shore reconnaissance. The Reson 7125 MB and the Klein5000 SSS both have a frequency of 455khz. The triggering is set up in such a way that a pulse of SSS triggers the multibeam with minute delay so that for the most part there is no cross talk between the two sonars. The range of the SSS is much greater than the multibeam dependent on depth. The greater range of the SSS can cause the return to take a longer period of time between pulses. The multibeam may pick up what is known as a second sweep return. These were scanned in subset and where observed rejected.

*Figure 20: SSS Bleedover or crosstalk*

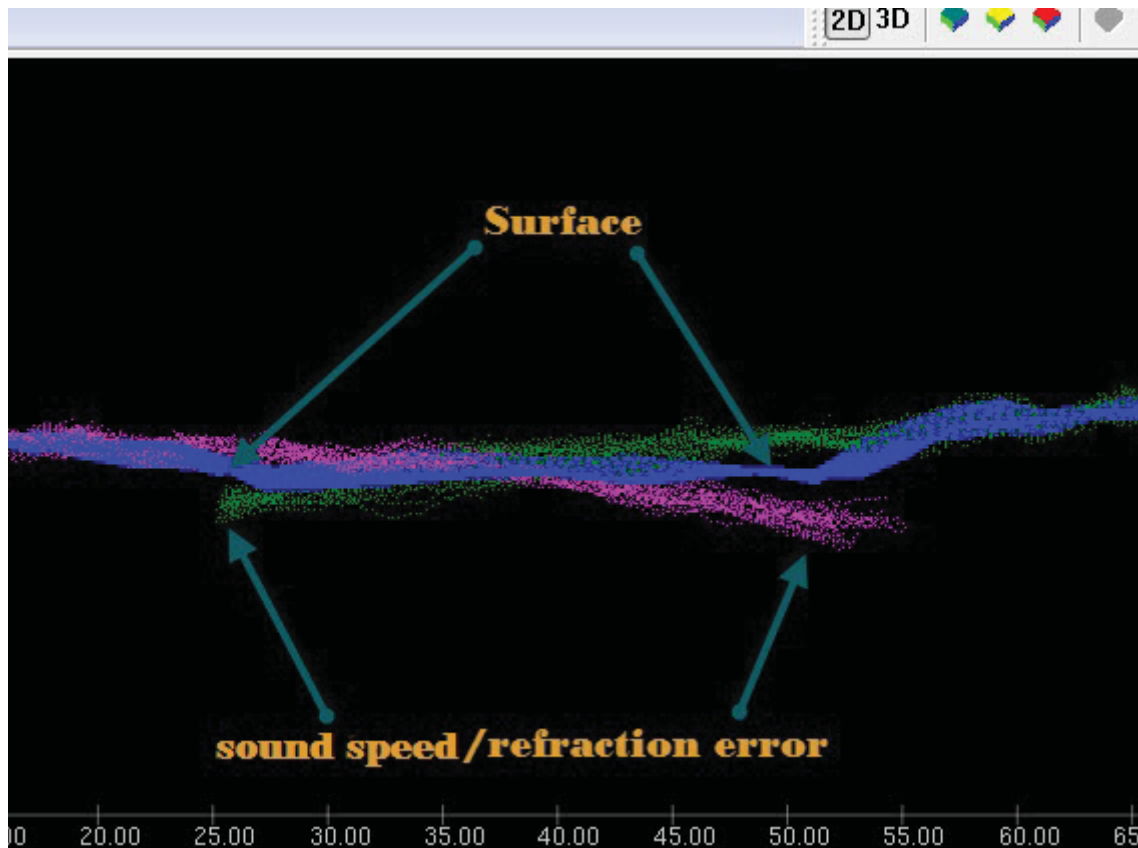
Occasional errors due to sound speed or refraction were seen in outside beams. Where the observed surface exceeded specification the outside beams were deleted. In most cases the grid honored the surface.

*Figure 21: Sound Speed/Refraction of outside beams*

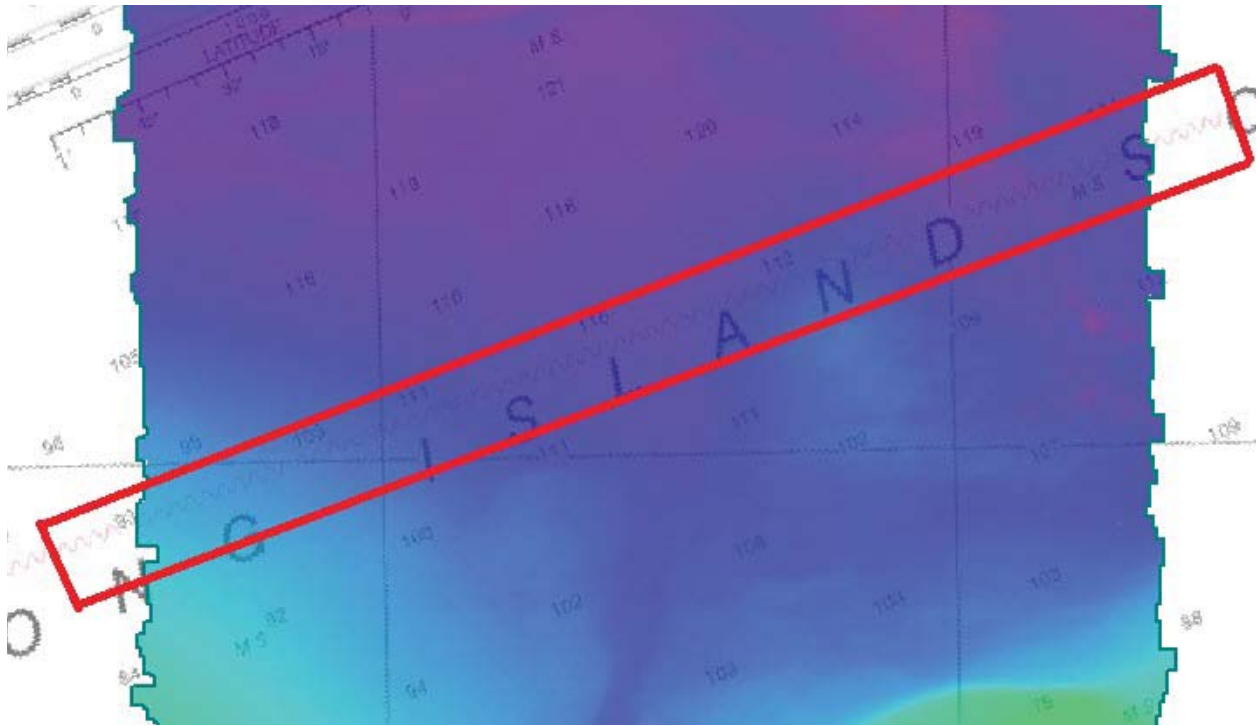
One cable line crosses the north portion of H12488.

*Figure 33: Under Water Cable*

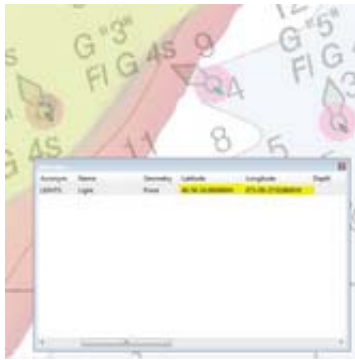
**3 attachments****StonyBrook\_3\_Chart\_Pos.PNG**

The private aid was noted by the field surveyors to be not in existence. The aid is, however, listed in the Light List as an existing lighted buoy at position:

Thank you very much for the notification. Currently, that aid is not listed in our LNM as discrepant/missing. I will contact the owner and local ANT in Long Island Sound and a BNM will issued.

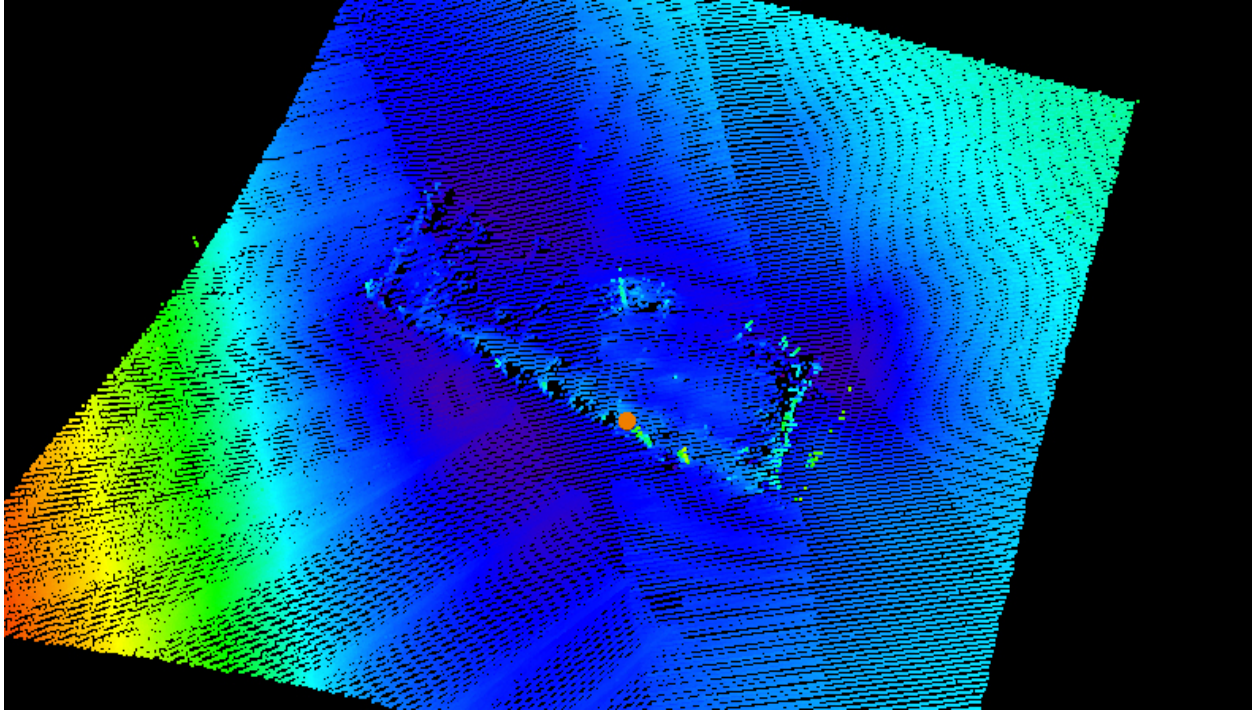
Figure 1.1.1

WRECKS/remrks: Wreck remains found correlating to a Detached Position. There is pipe or mast south in danger circle radius. The appear simialr to AWOIS 2640 description. These have been missplaced when dropped for the fish haven

Compile: Chart a 43ft wreck at the survey position.

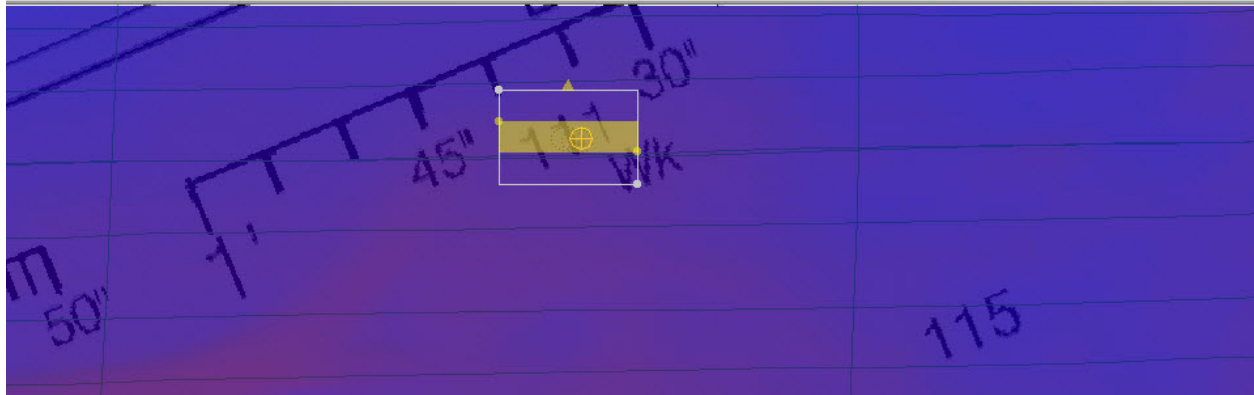
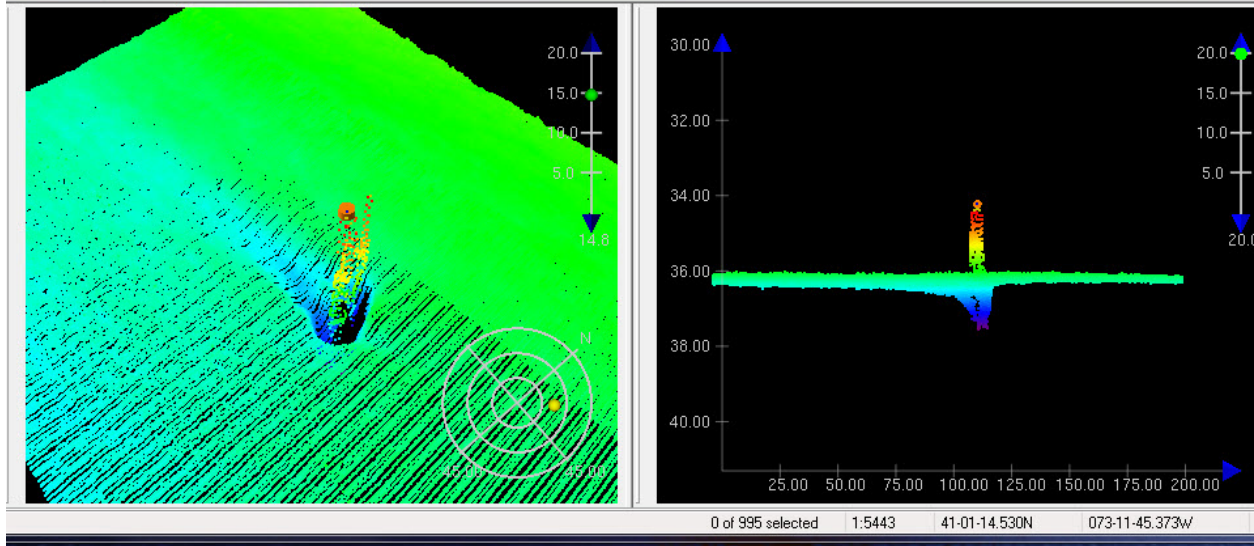
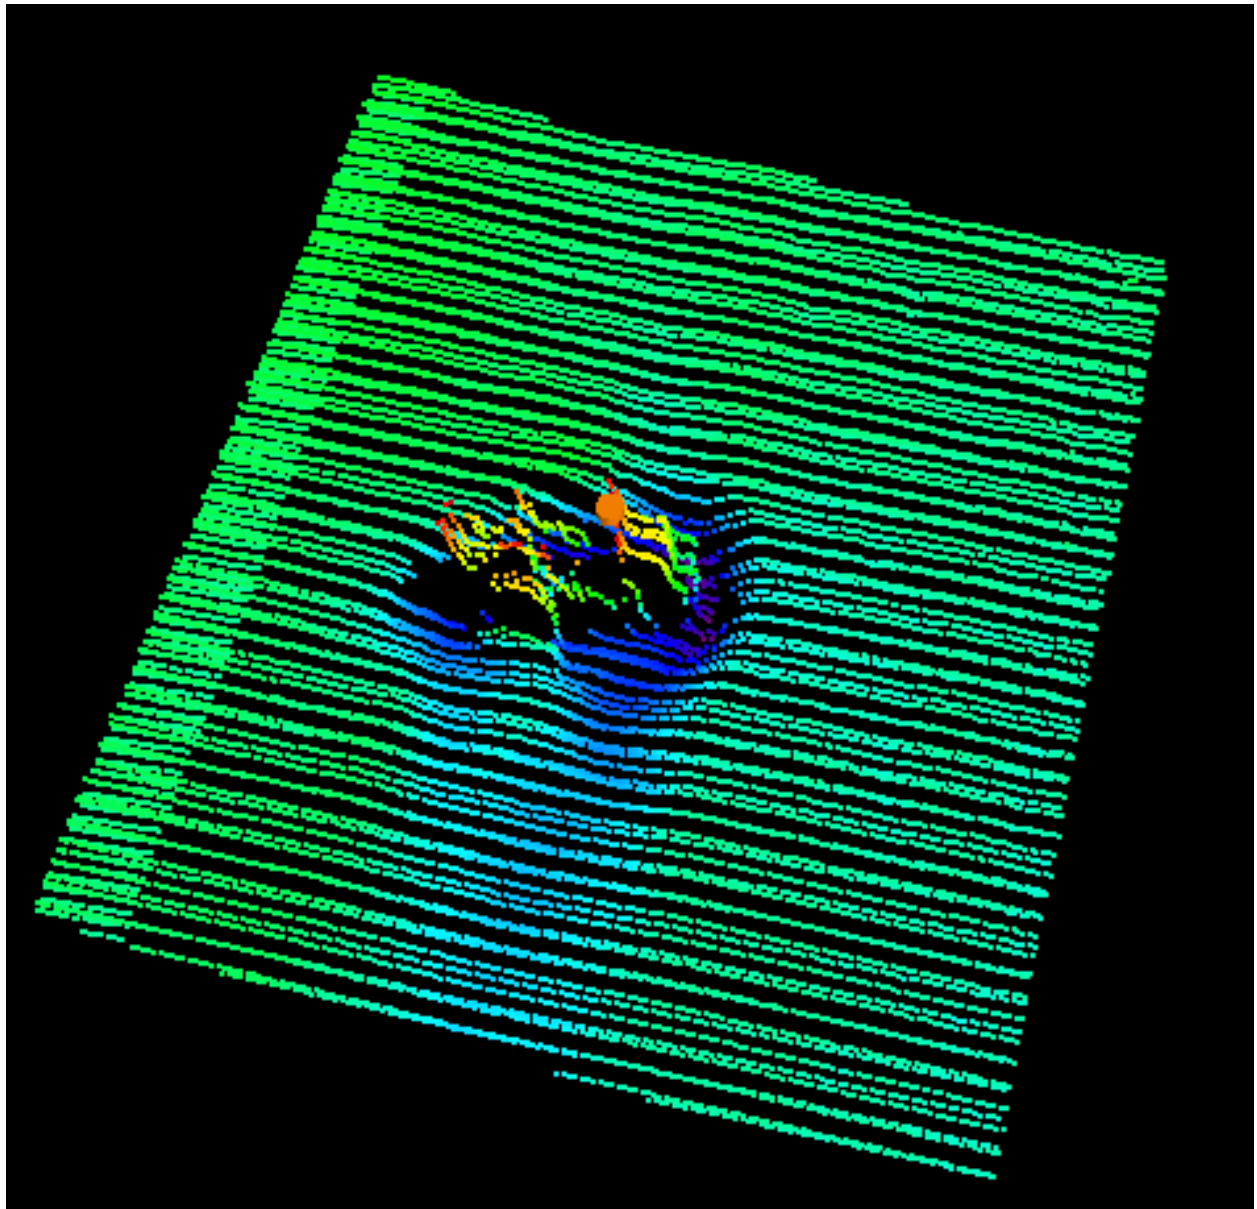
Figure 2.1.1

WRECKS/remrks: charte Wk found new location depth
