**DESCRIPTIVE REPORT**

Type of Survey: Navigable Area

Registry Number: H12488

Sub-locality: East of Nissequogue River to Crane Neck Point NY.

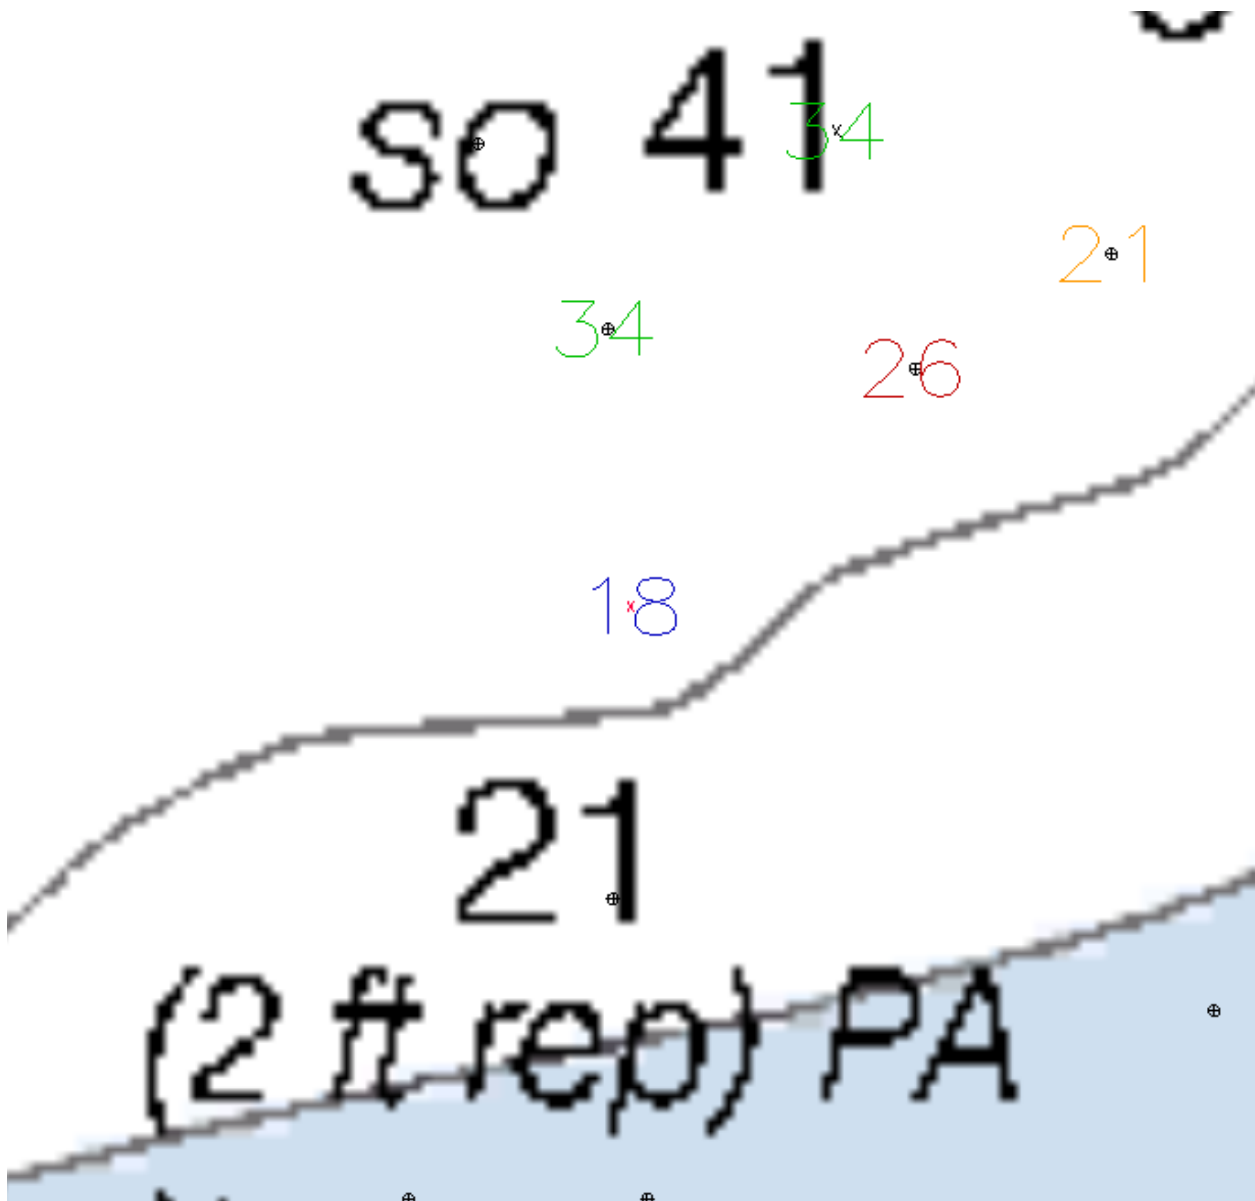
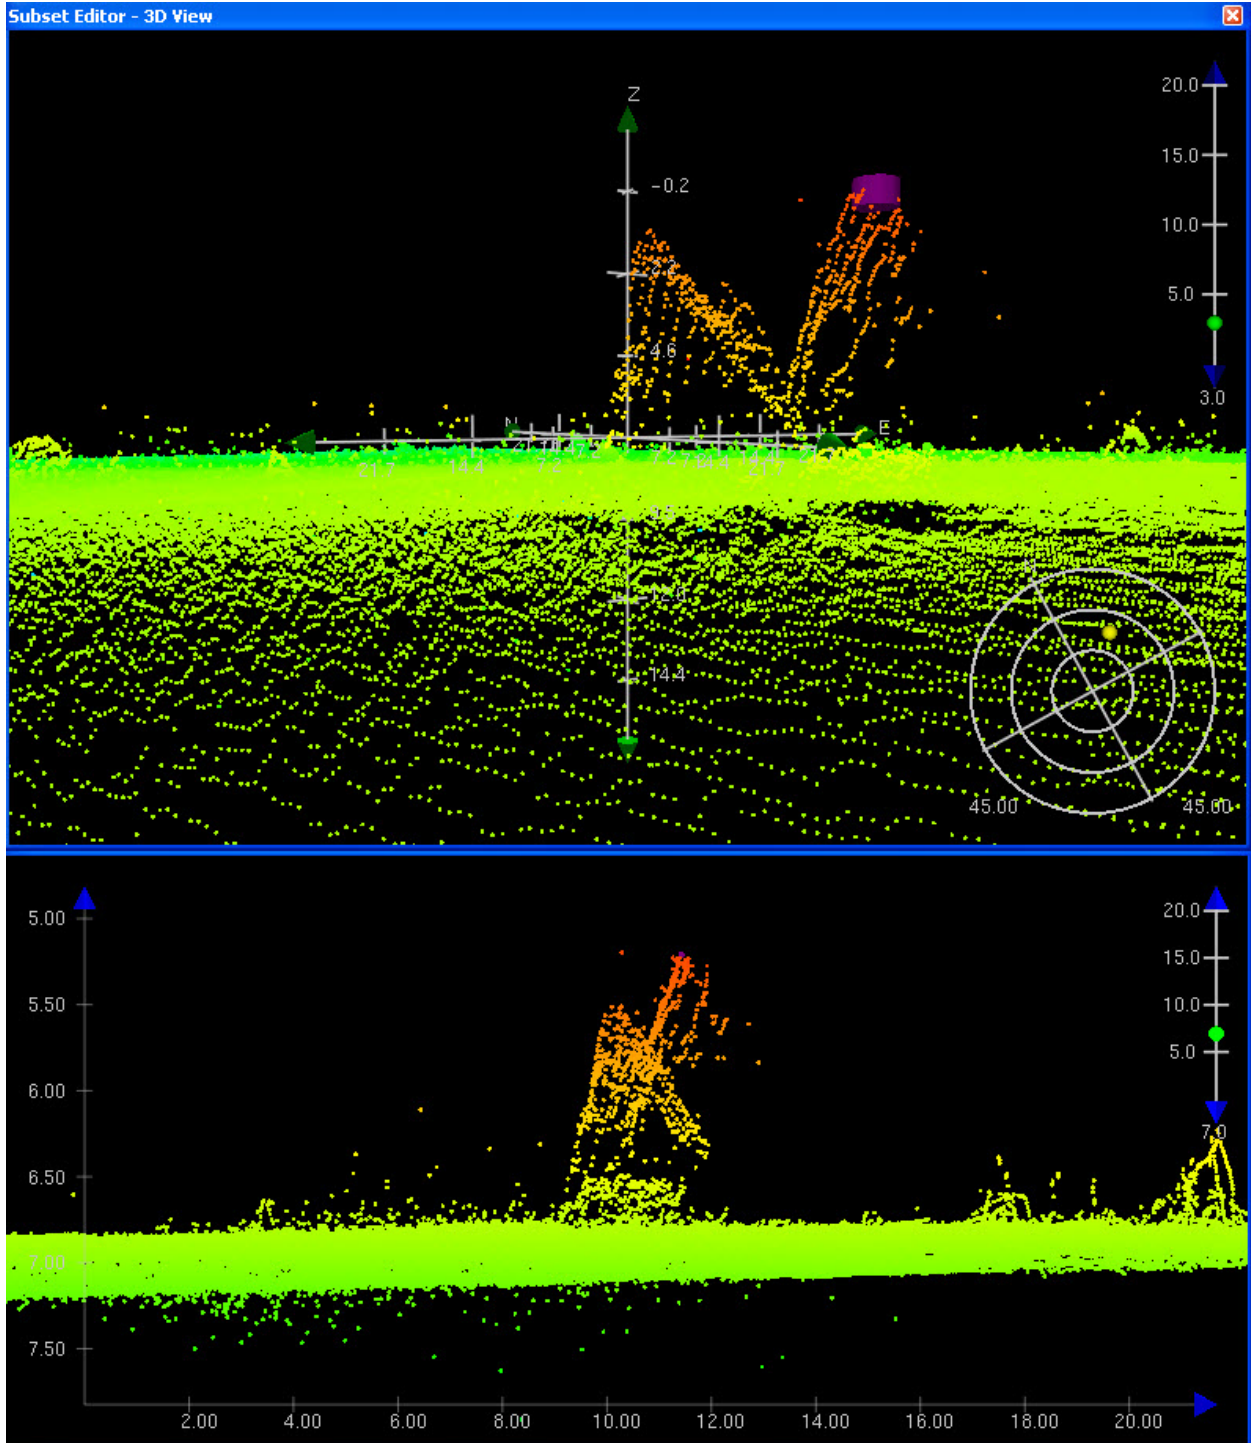
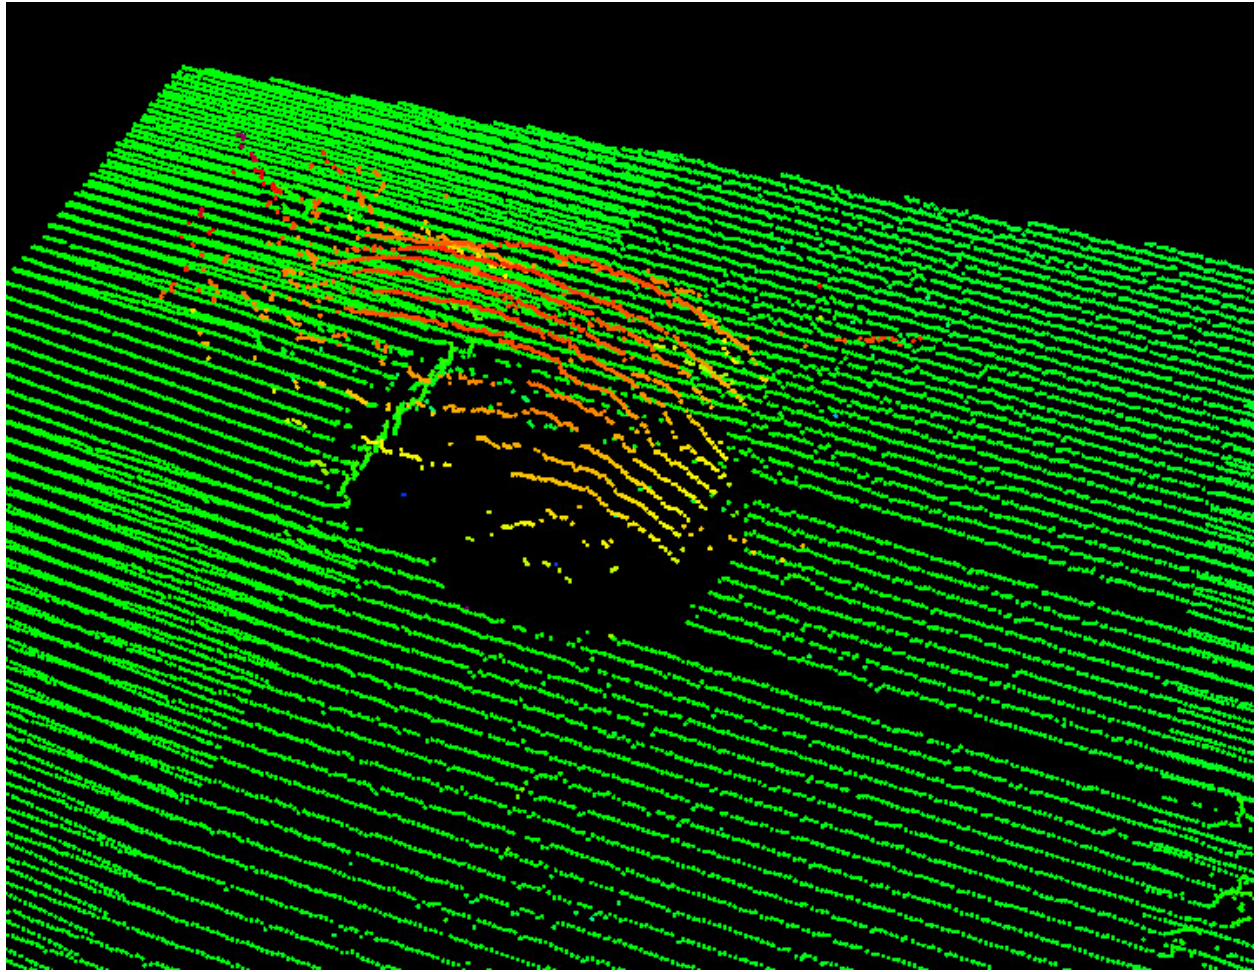
Figure 3.1.1

UWTROC/remrks: Submerged rock found by reson 7125 ODMB. Data was acquired to the ellipsoid and reduced to MLLW using VDATUM separation model.

Compile: Chart DTON#1.5, a 19ft rock, at the survey position.

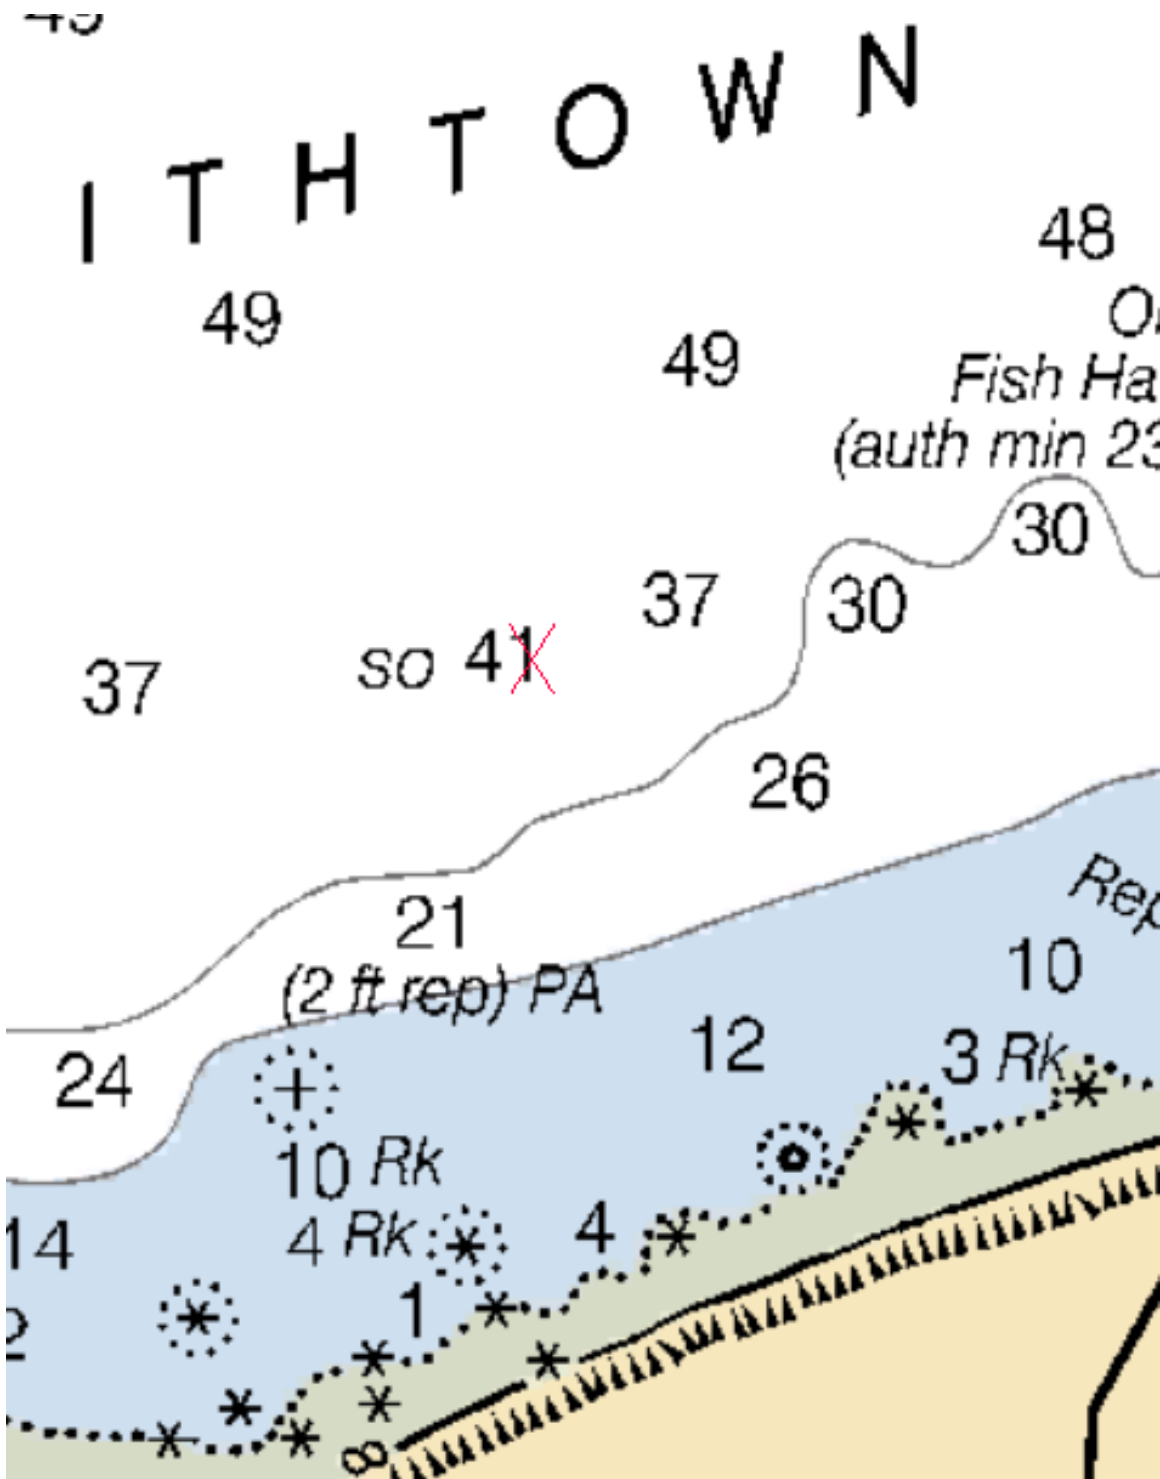
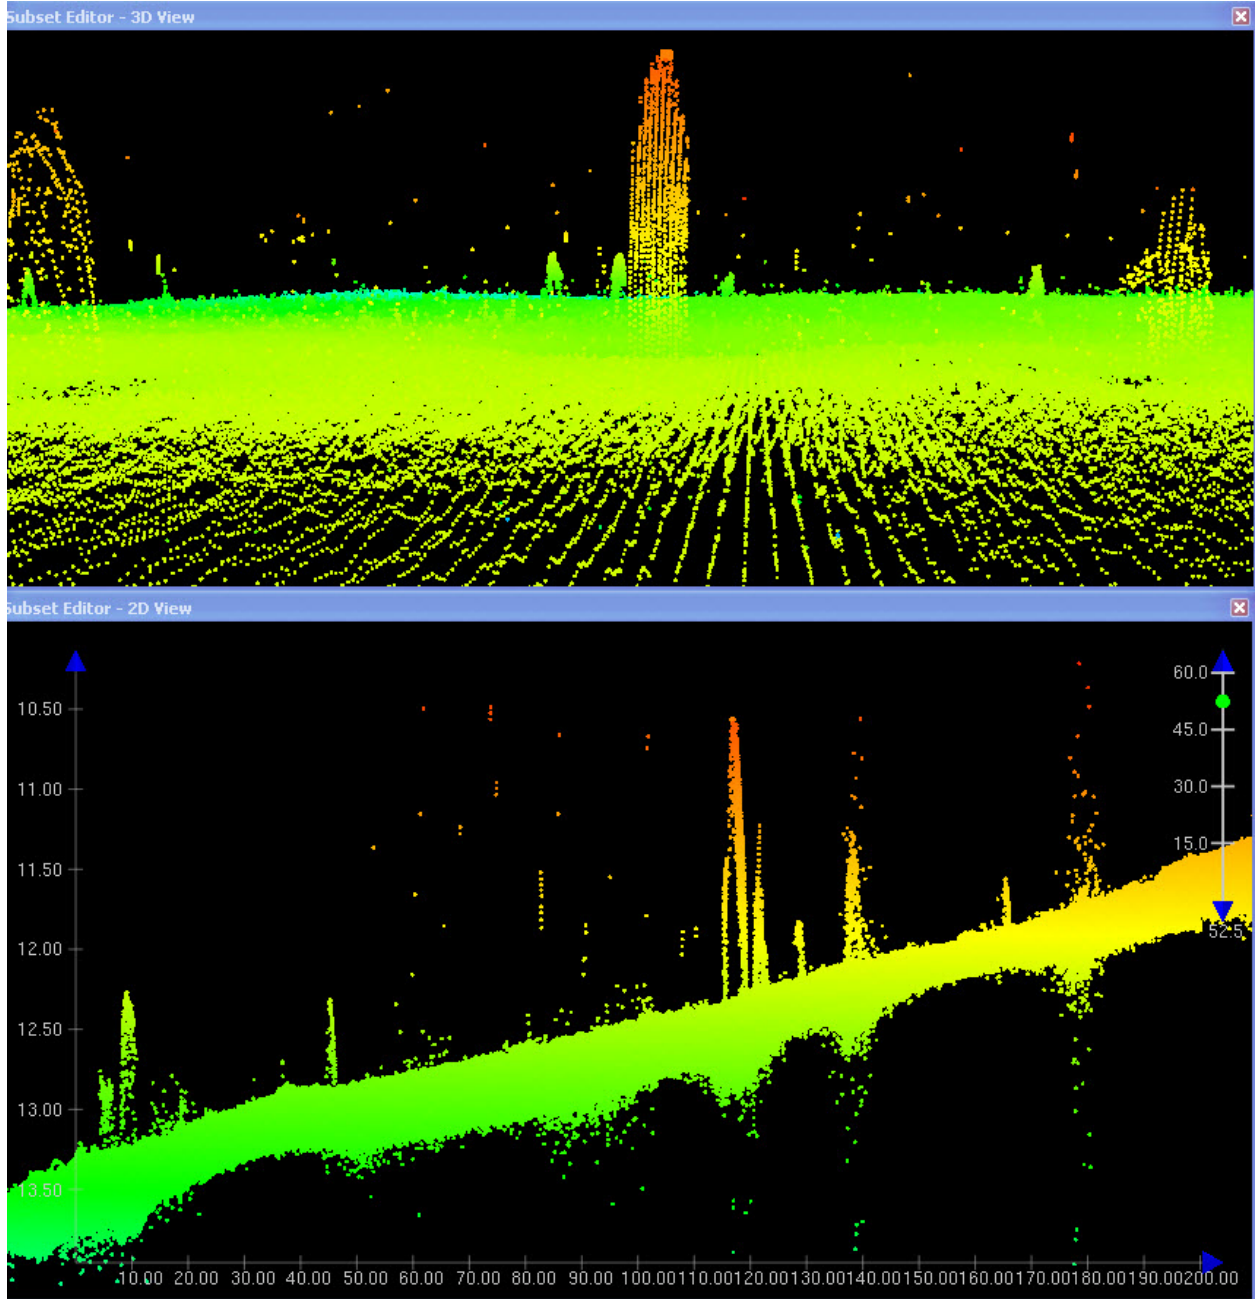
Figure 3.2.1

UWTROC/remrks: Submerged rock found by reson 7125 ODMB. Data was acquired to the ellipsoid and reduced to MLLW using VDATUM separation model.

Compile: Delete DTON#1.6, a 34ft rock. The rock will be represented as a sounding instead.

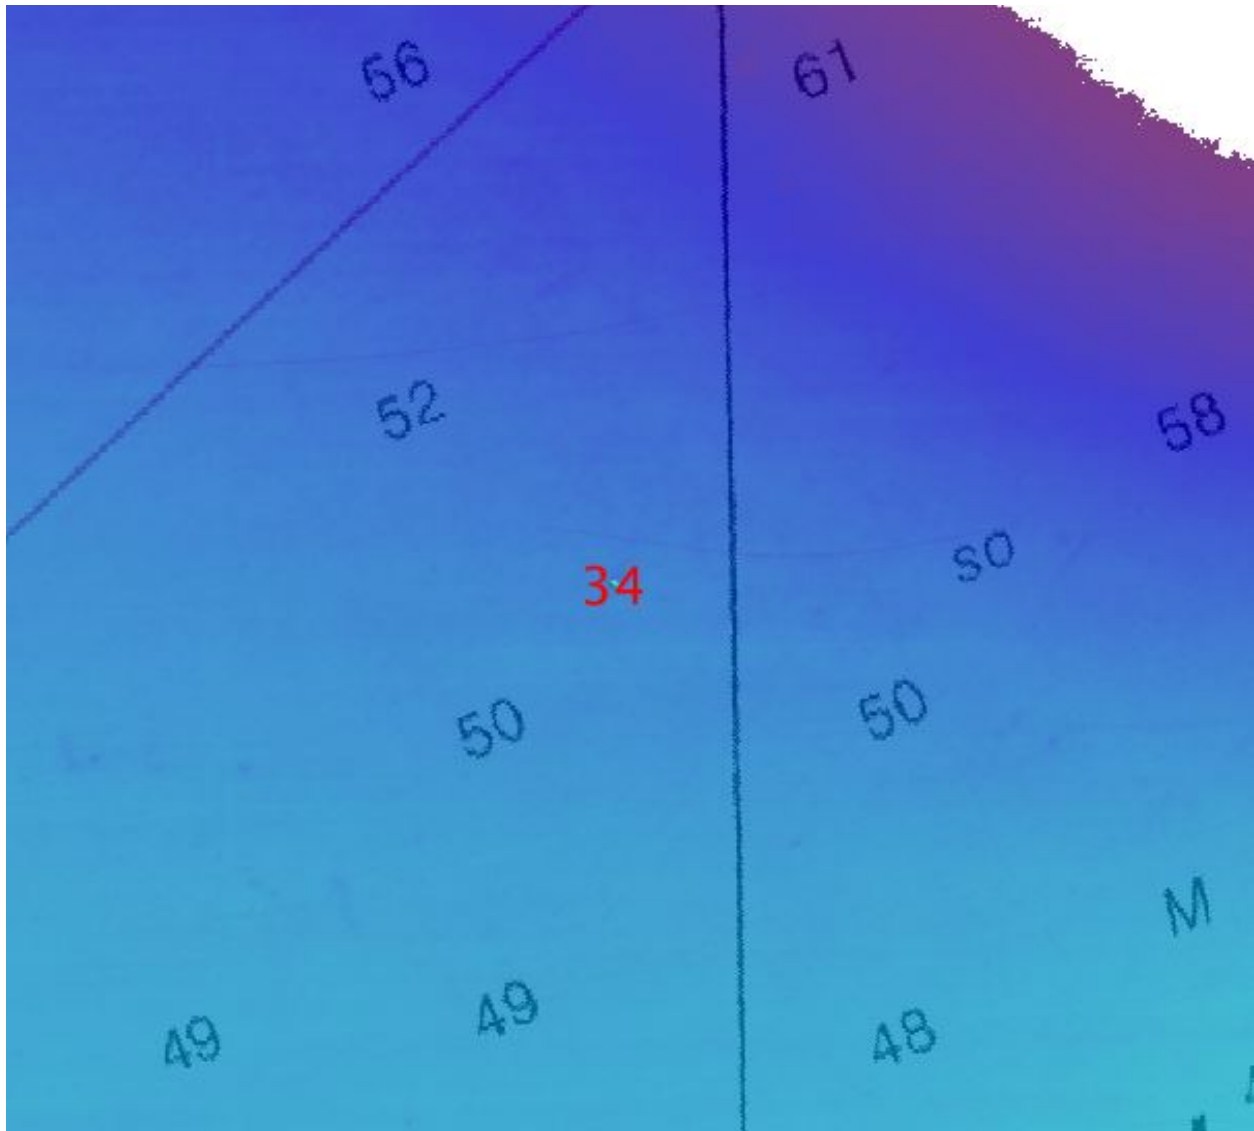
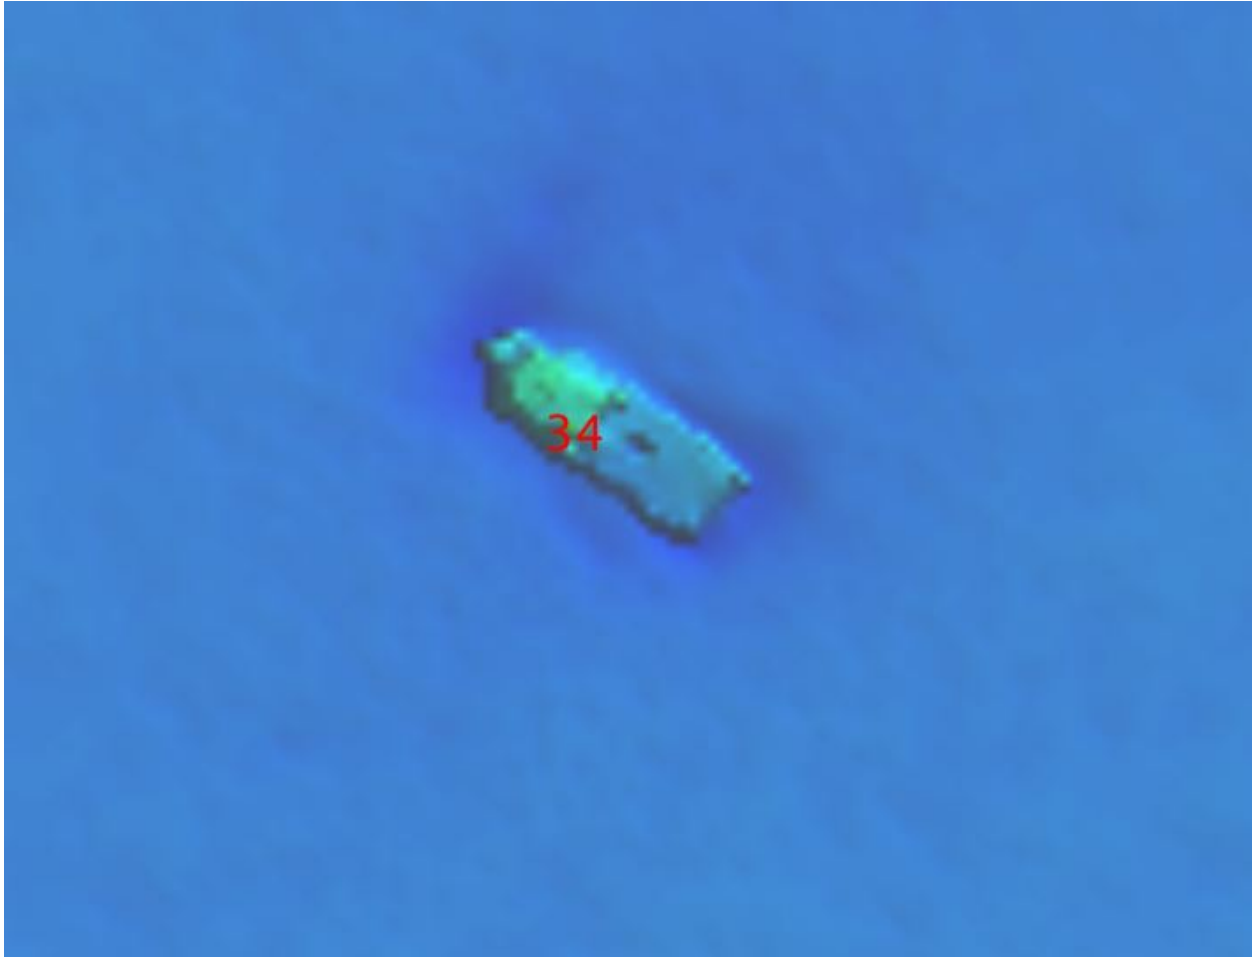
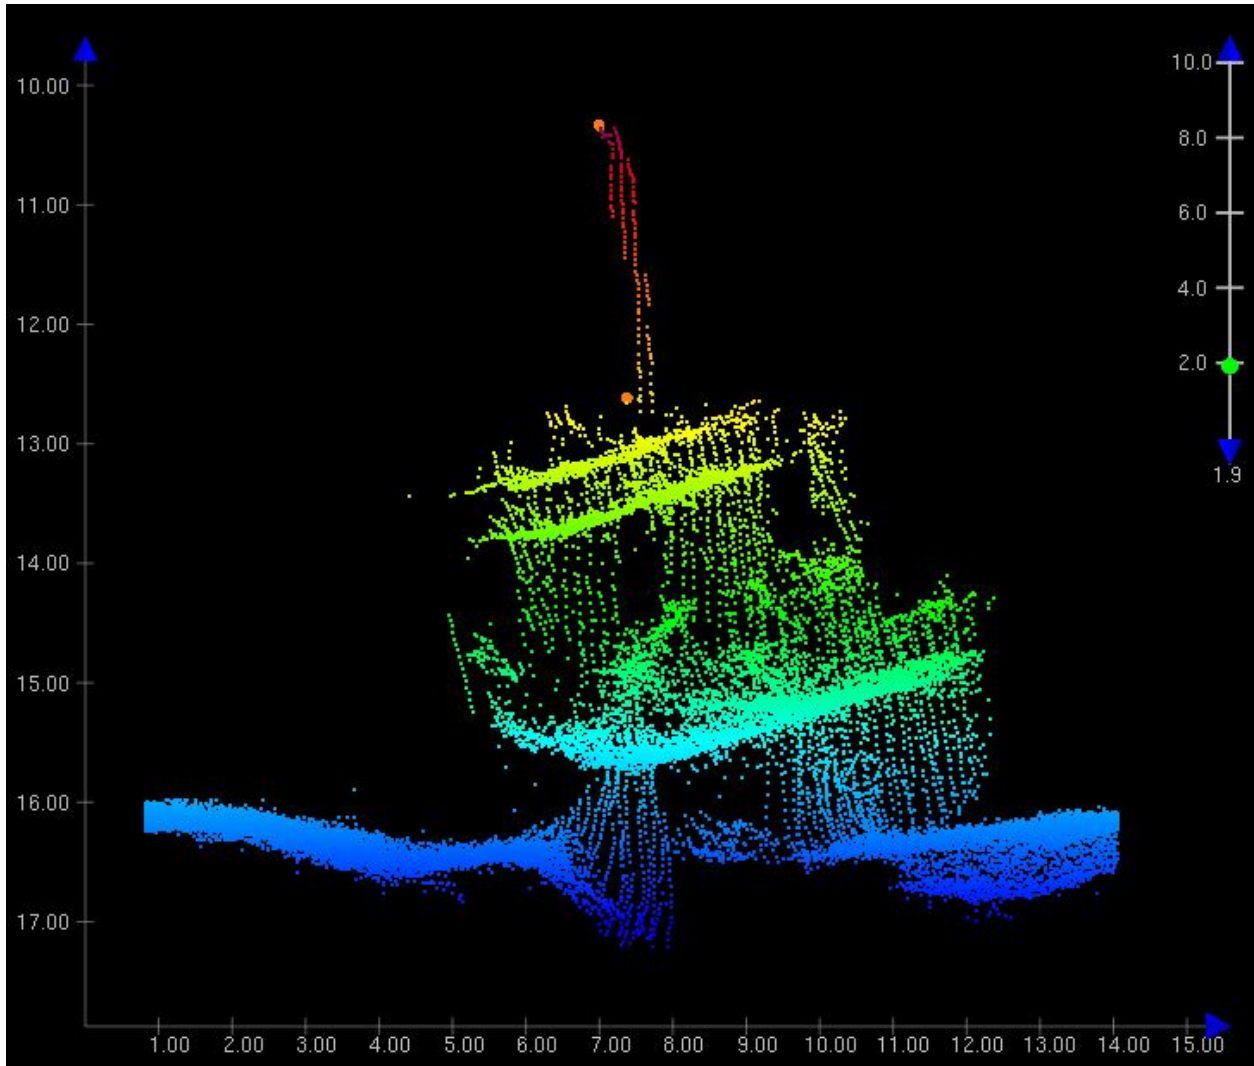
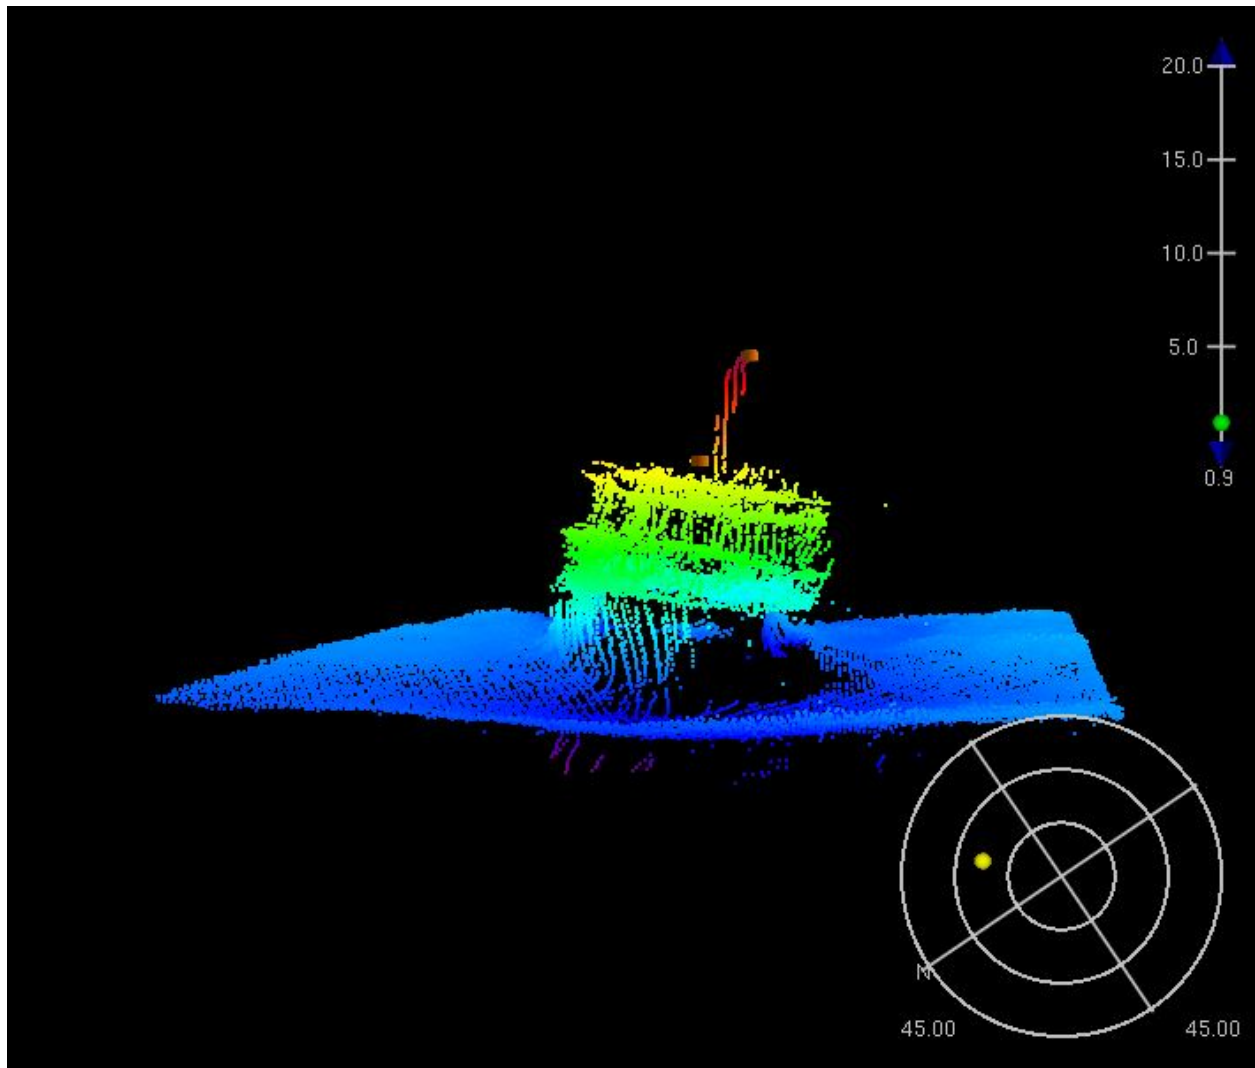
Figure 3.4.1

WRECKS/remrks: Uncharted Wk Found

Compile: Chart DTON#2.2, a 34ft wreck, at the survey position.

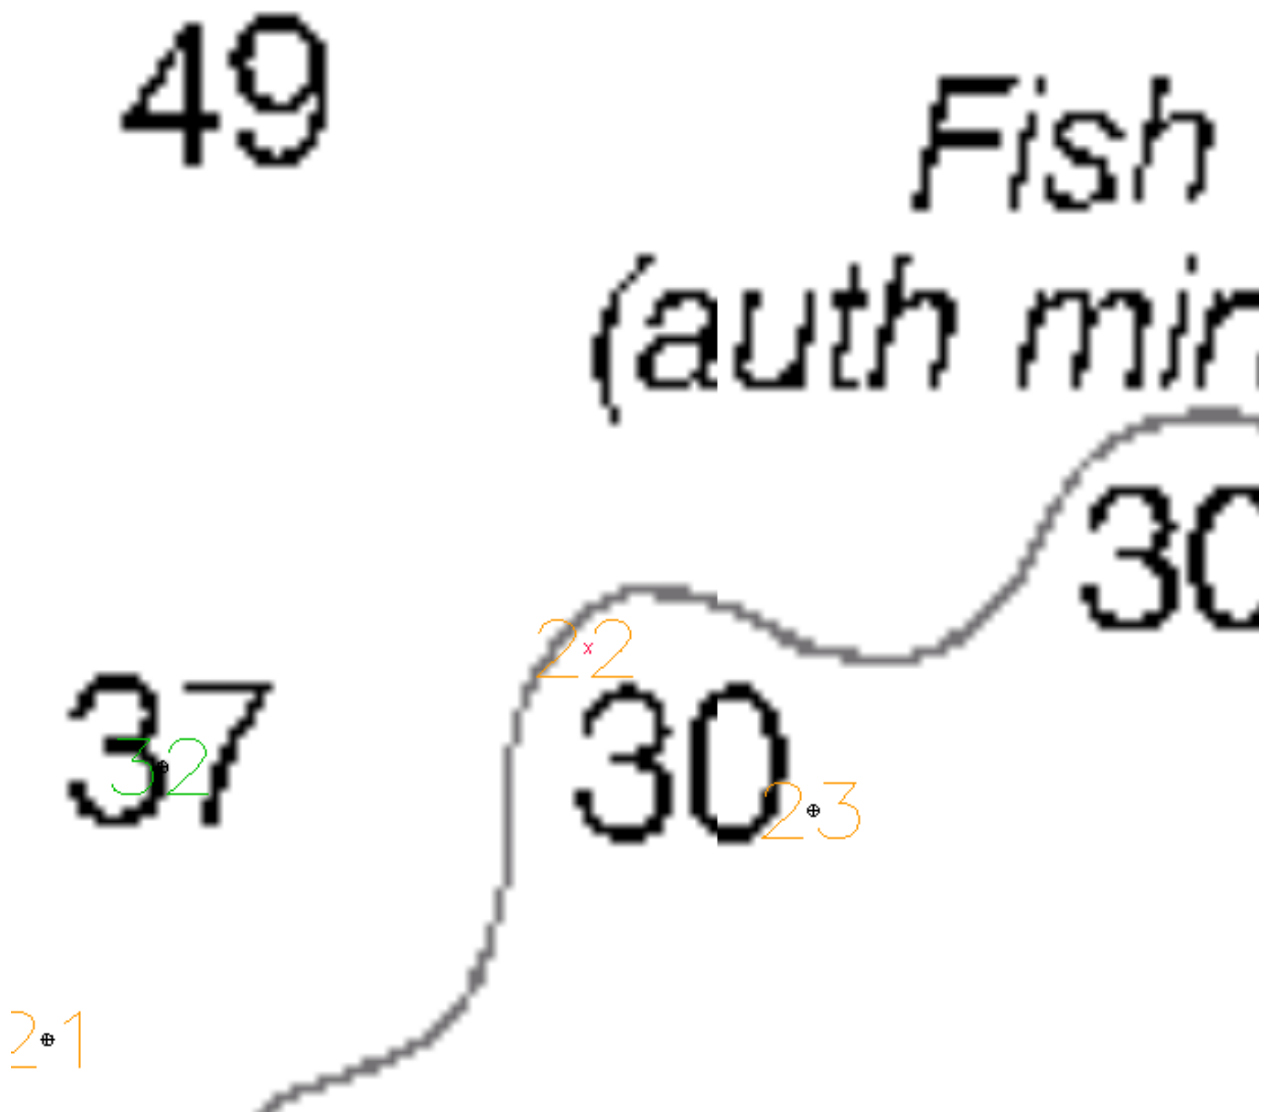
Figure 3.5.1

UWTROC/remrks: Submerged rock found by reson 7125 ODMB. Data was acquired to the ellipsoid and reduced to MLLW using VDATUM separation model.

Compile: Chart DTON#1.4, a 22ft rock, at the survey position.

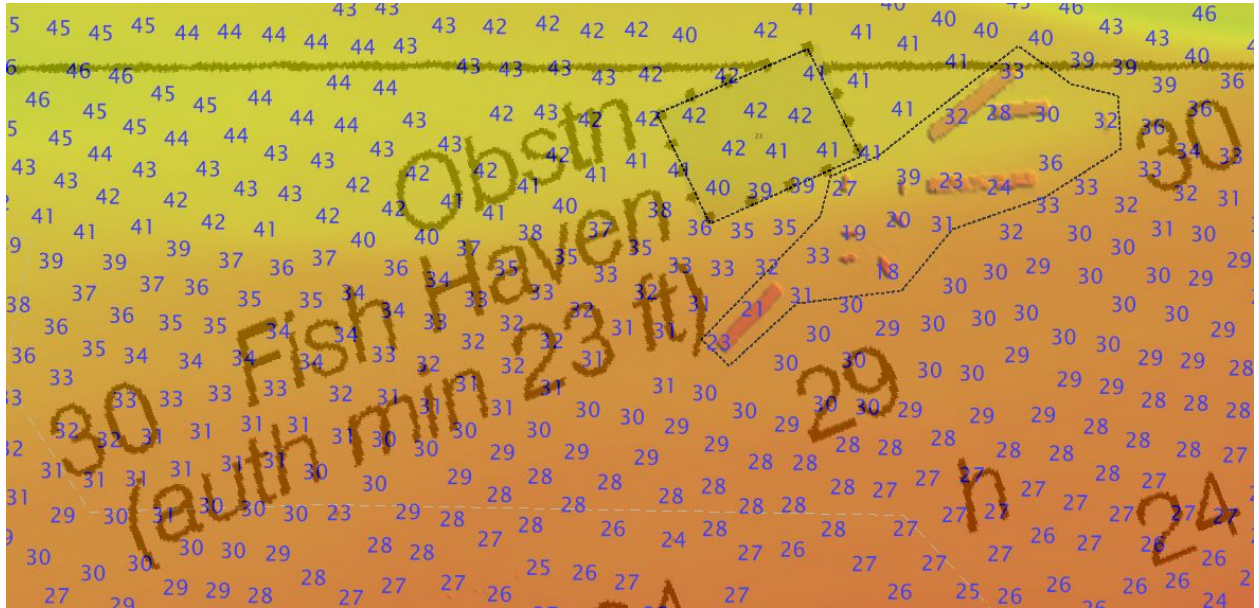
Figure 3.6.1

OBSTRN/remrks: Wks and Obstns abound outside of Fish Have with least Depth of 16.759.  
 This is similar to an AFF assigned item and AWOIS 2640 description. No Obstns or comparable soundings were found in the Fish Haven that justify a 23ft Auth min depth. Shoal soundings were found in the Obstn area south. That area appears to have most of the items described in the AWOIS text.

SAR: A series of wrecks and obstructions that compose an artificial reef (AWOIS 2640) were intended to be located within the charted fish haven to the northwest, but instead lie within these bounds. Recommend to either update the bounds of the fish haven to encompass the obstructions as they exist, or to chart a new area obstruction. The least depth within the area obstruction was verified via object detection multibeam.

Chart new Wk AREA with least depthof 4.289m. Inform NY state environmental authorites of conditions near this Fish Haven

Compile: Chart DTON 2.3, Area Obstruction, at the survey position.
