#### **DESCRIPTIVE REPORT**

Type of Survey:	Basic Hydrographic Survey
Registry Number:	H12596
	LOCALITY
State(s):	New Jersey
General Locality:	New Jersey Coast and Vicinity, NJ
Sub-locality:	Vicinity of Barnegat Inlet
	2013
	CHIEF OF PARTY
	Jonathan L. Dasler, PE, PLS, CH
	LIBRARY & ARCHIVES
Date:

#### **Descriptive Report to Accompany Survey H12596**

Project: OPR-C308-KR-13

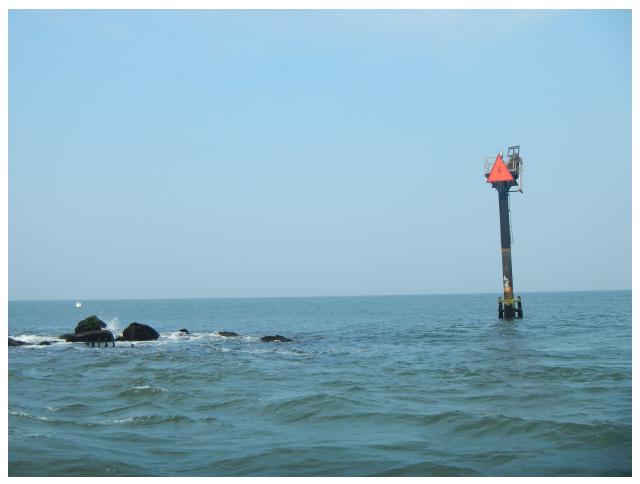
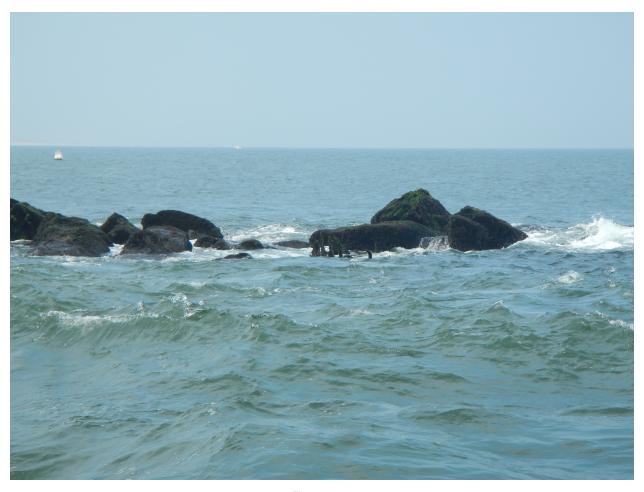
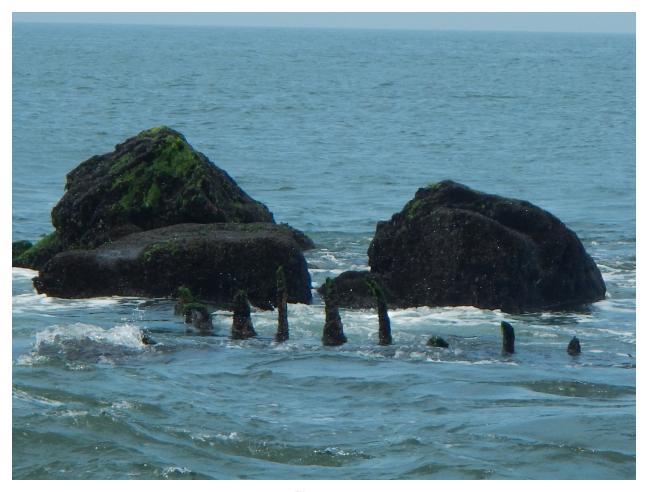
## 2.1) Awash Wreck

WRECKS/remrks: Observed visually.

Compile: Retain Wreck.
