DESCRIPTIVE REPORT

Type of Survey: Navigable Area

Registry Number: H12601

Sub-locality: Vicinity of Shinnecock Inlet

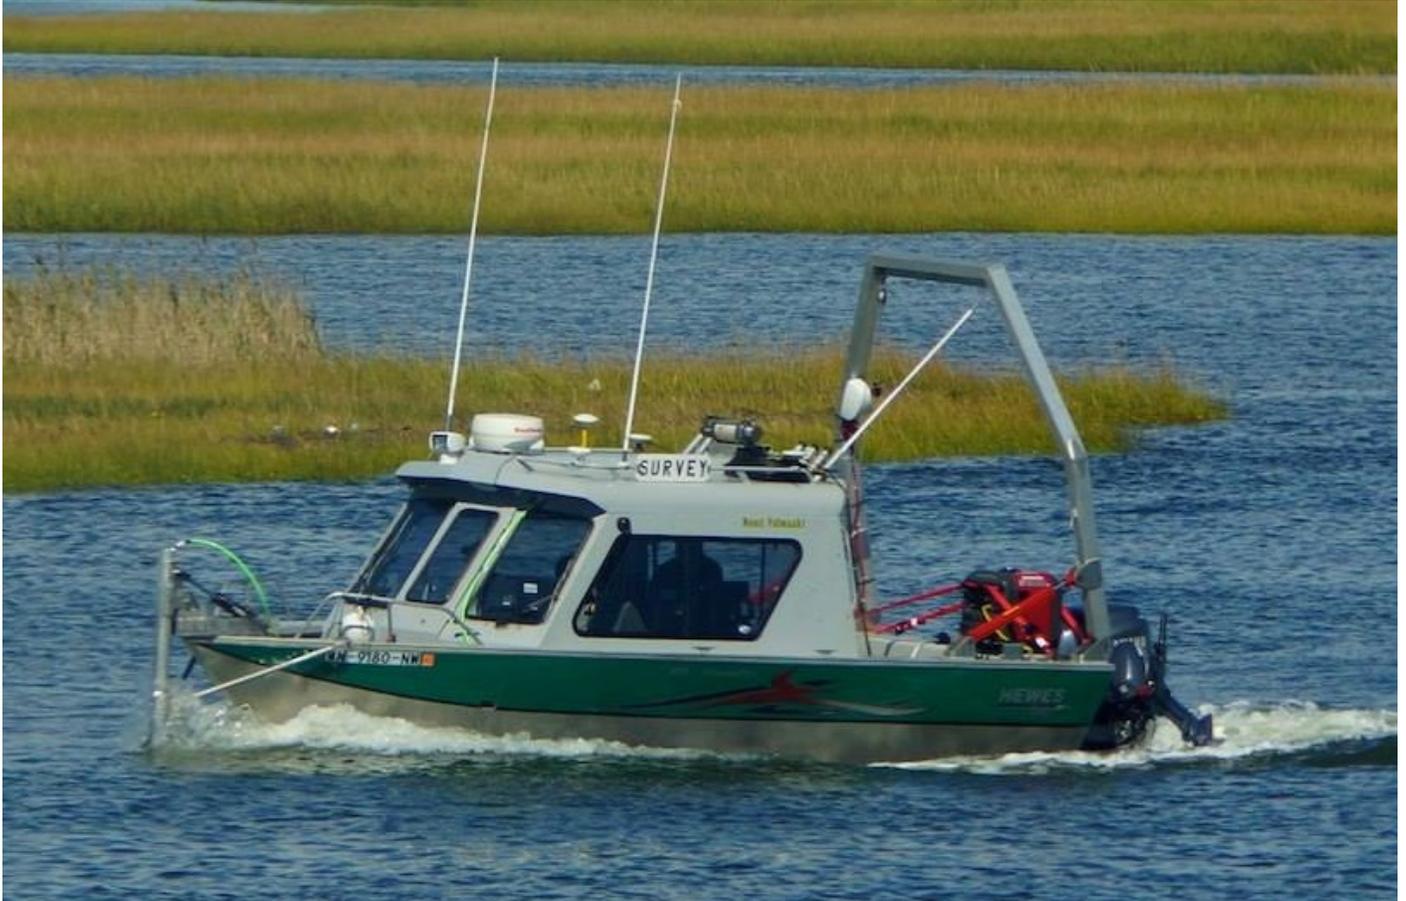
Figure 5: M/V Nooit Volmaakt from the port side. The pole mount on the bow for the Edge Tech SSS can be seen.

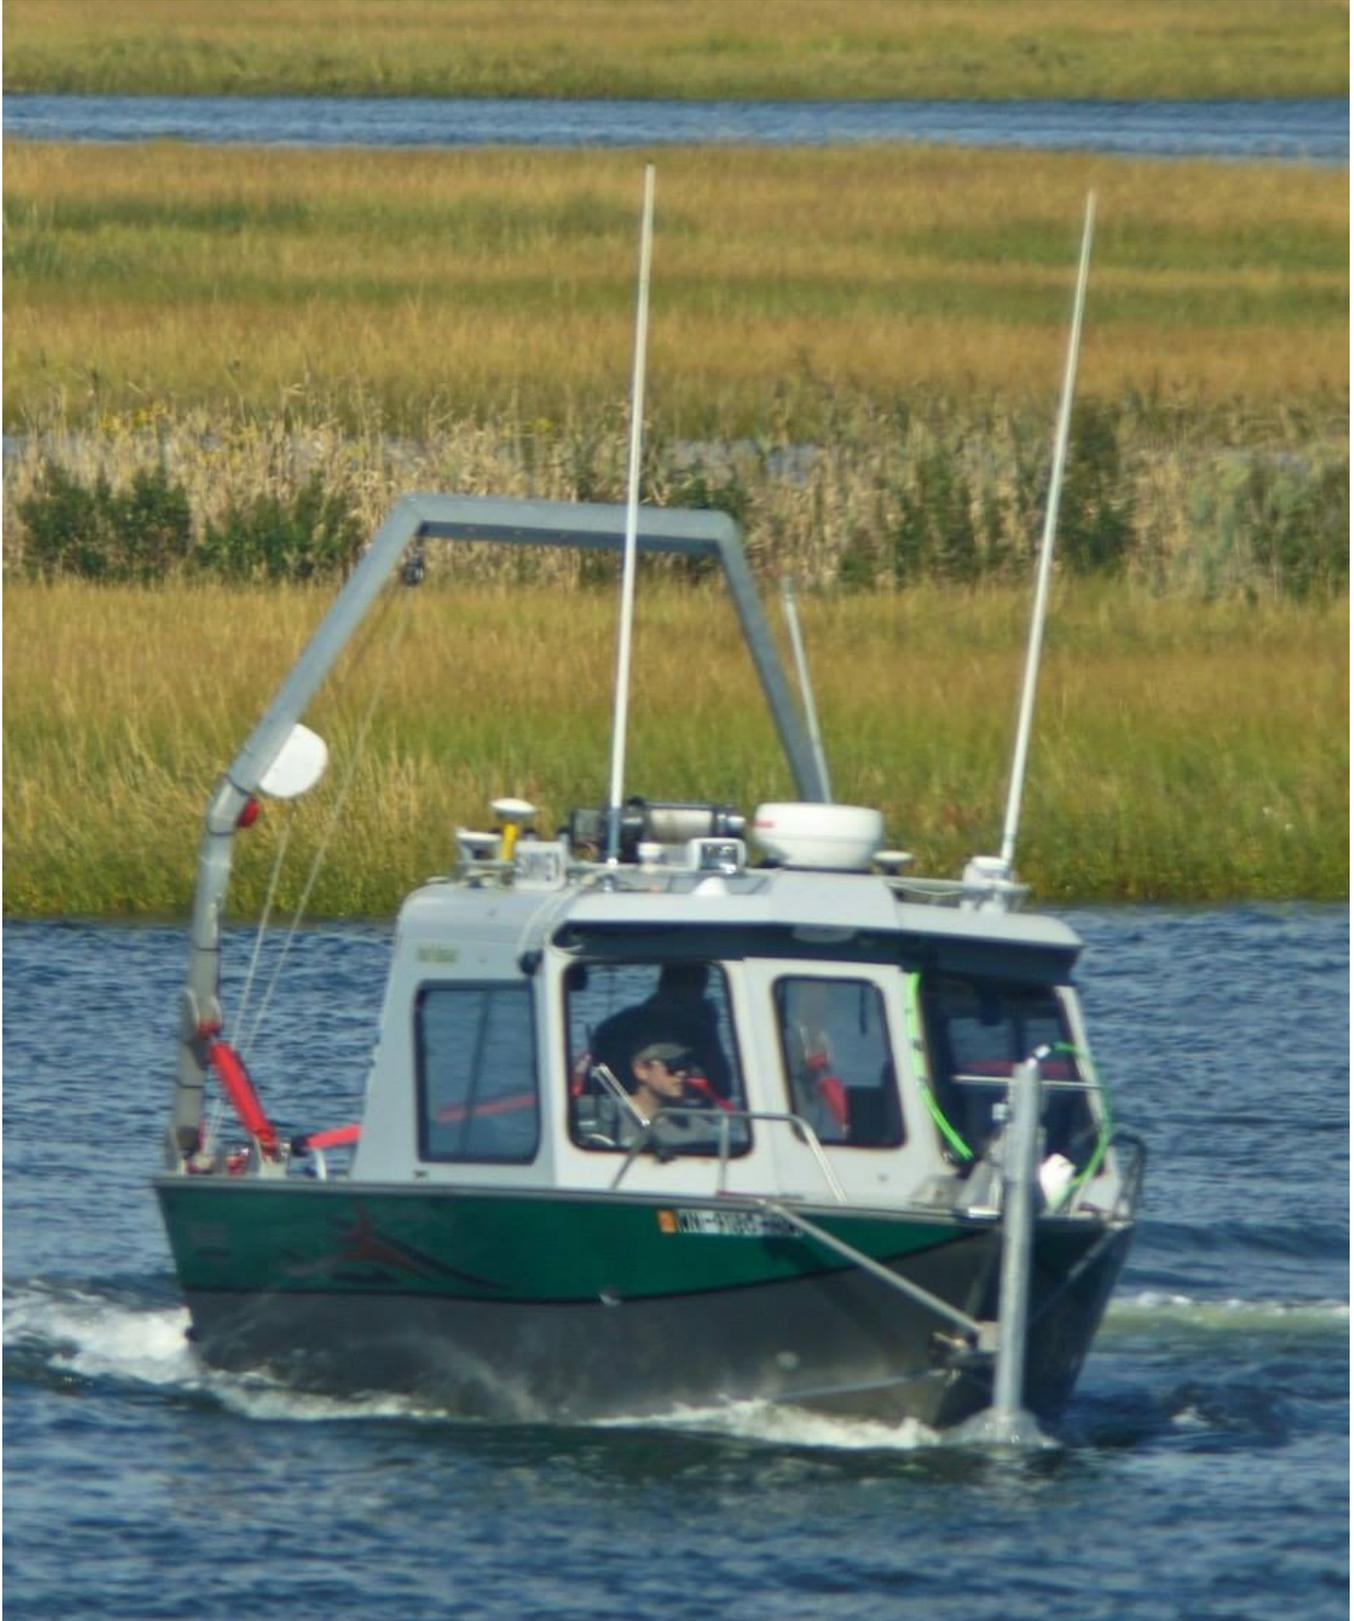
Figure 6: M/V Nooit Volmaakt from the starboard bow. The pole mount on the bow for the Edge Tech SSS can be seen.
