U.S. Department of Commerce National Oceanic and Atmospheric Administration National Ocean Survey		
	DESCRIPTIVE REPORT	
Type of Survey:	Navigable Area	
Registry Number:	H12602	
	LOCALITY	
State(s):	New York	
General Locality:	Vicinity of Southern Long Island	
Sub-locality:	Vicinity of Moriches Inlet	
	2013	
CHIEF OF PARTY Ransom C. White III		
	LIBRARY & ARCHIVES	
Date:

# **Descriptive Report to Accompany Survey H12602**

Project: OPR-C331-KR-13 Locality: Vicinity of Southern Long Island Sublocality: Vicinity of Moriches Inlet Scale: 1:20000 October 2013 - December 2013 **Williamson & Associates, Inc.** Chief of Party: Ransom C. White III

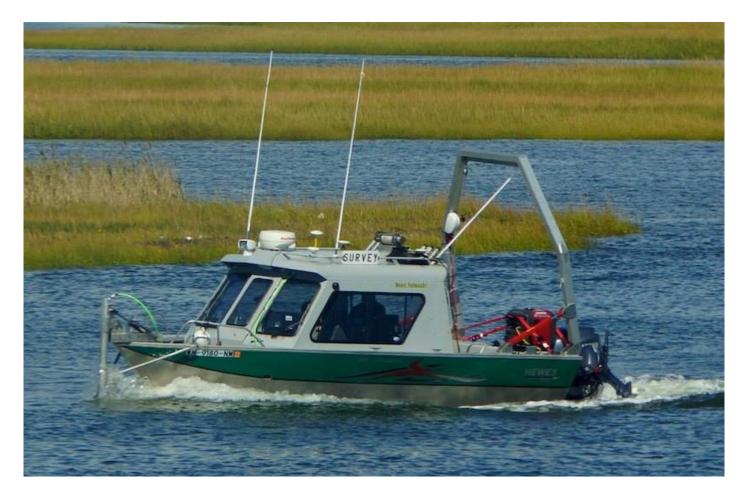
Figure 5: *M/V* Nooit Volmaakt from the port side. The pole mount on the bow for the Edge Tech SSS can be seen.

The M/V Nooit Volmaakt acquired all multibeam data with a pole mounted R2Sonic 2024 at 400kHz and a pole mounted EdgeTech 4600 at 540 kHz using a POSMV for position, orientation and motion corrections. For more detailed information on equipment and vessel please refer to OPR-C331-KR-13 DAPR submitted under a different cover.

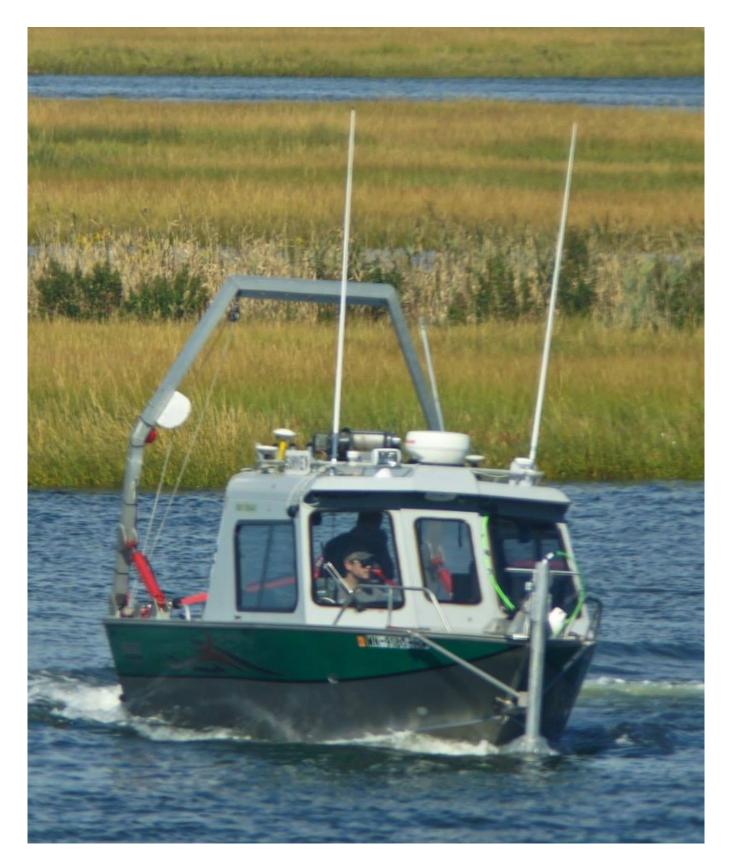
Figure 6: *M/V* Nooit Volmaakt from the starboard bow. The pole mount on the bow for the Edge Tech SSS can be seen.
